WisDOT Local Bridge Improvement Assistance Program

Eligible Bridge List Guidance and Template Report Example

Inspection Report for
B-17-366
CTH HH over SPRING CREEK
Jul 13, 2022

B-17-366
CTH HH over SPRING CREEK

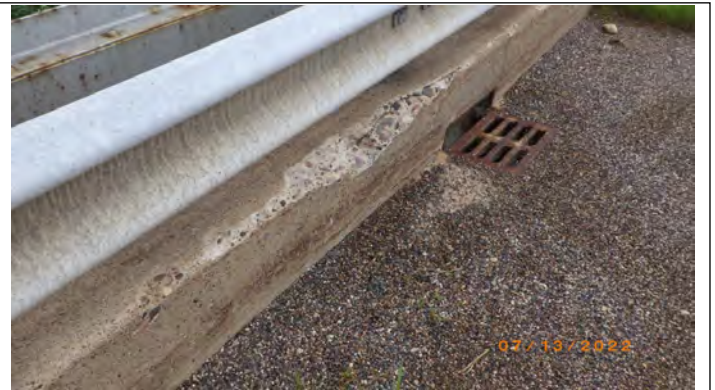
Routine Item 2

CS3 spall bridge railing curb side.

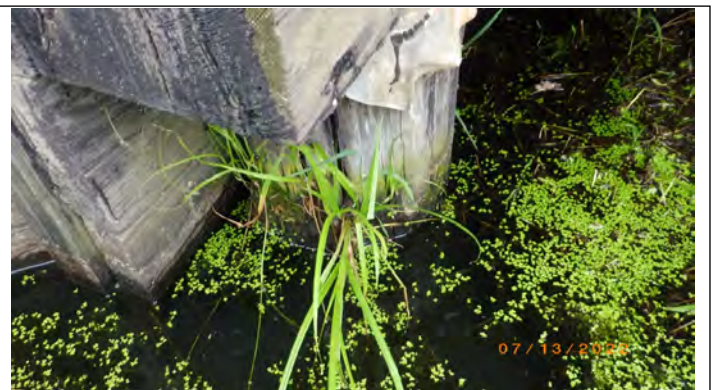
Routine Item 4

CS3 decay timber piles, grass growing from pile.

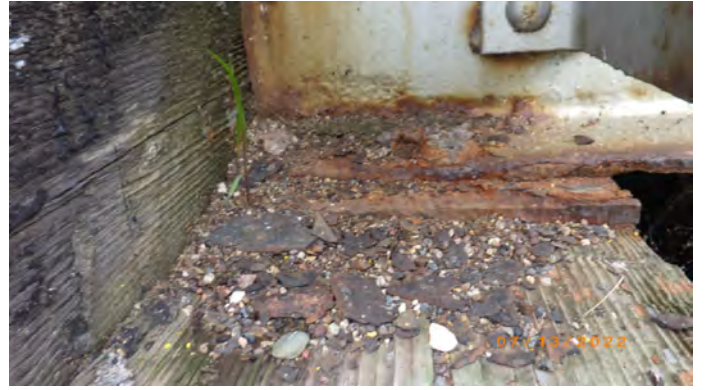
Routine Item 5

CS3/4 paint, CS3 corrosion, steel girder.

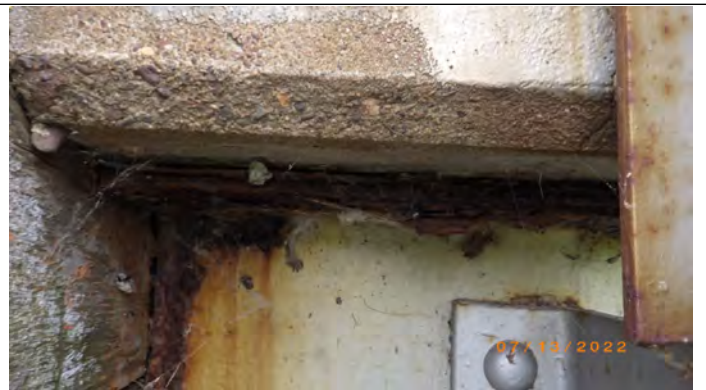
Routine Item 6

CS3 top flange steel girder

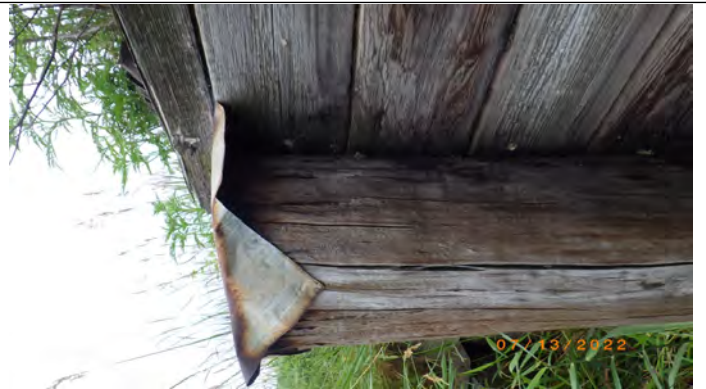
Routine Item 7

8902	Wall Movement	EA		0	1	3	0
			SE wing top (4) planks pushing inward +/-3". All 4 wing pilings CS3 decay.

CS3 wingwall pile decay.

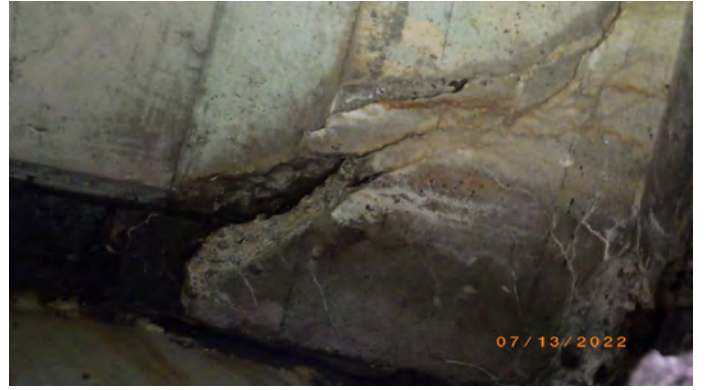
Routine Item 8

CS3 deck spall/crack

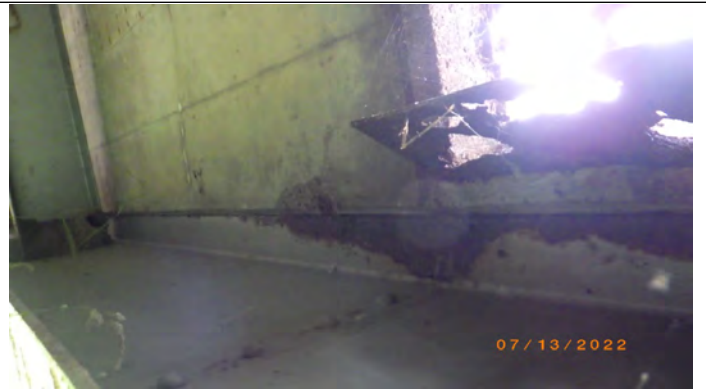
Routine Item 9

CS3 deck spall at girder.

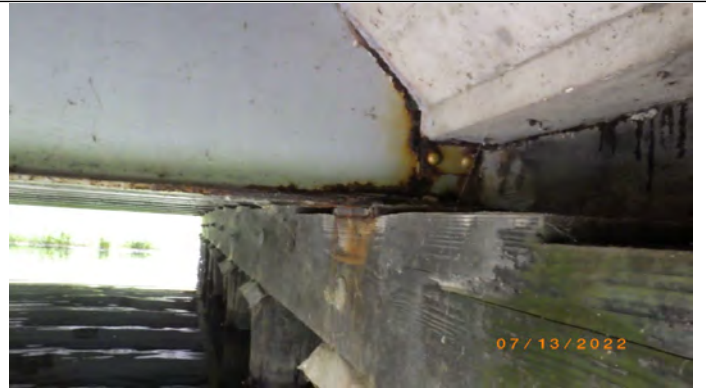
Routine Item 10

CS3 fixed bearing corrosion.
