# I-90 Madison to Tomah Needs Study

Corridor Needs Report

ID. 1010-11-00

AECOM I.D. 60609449

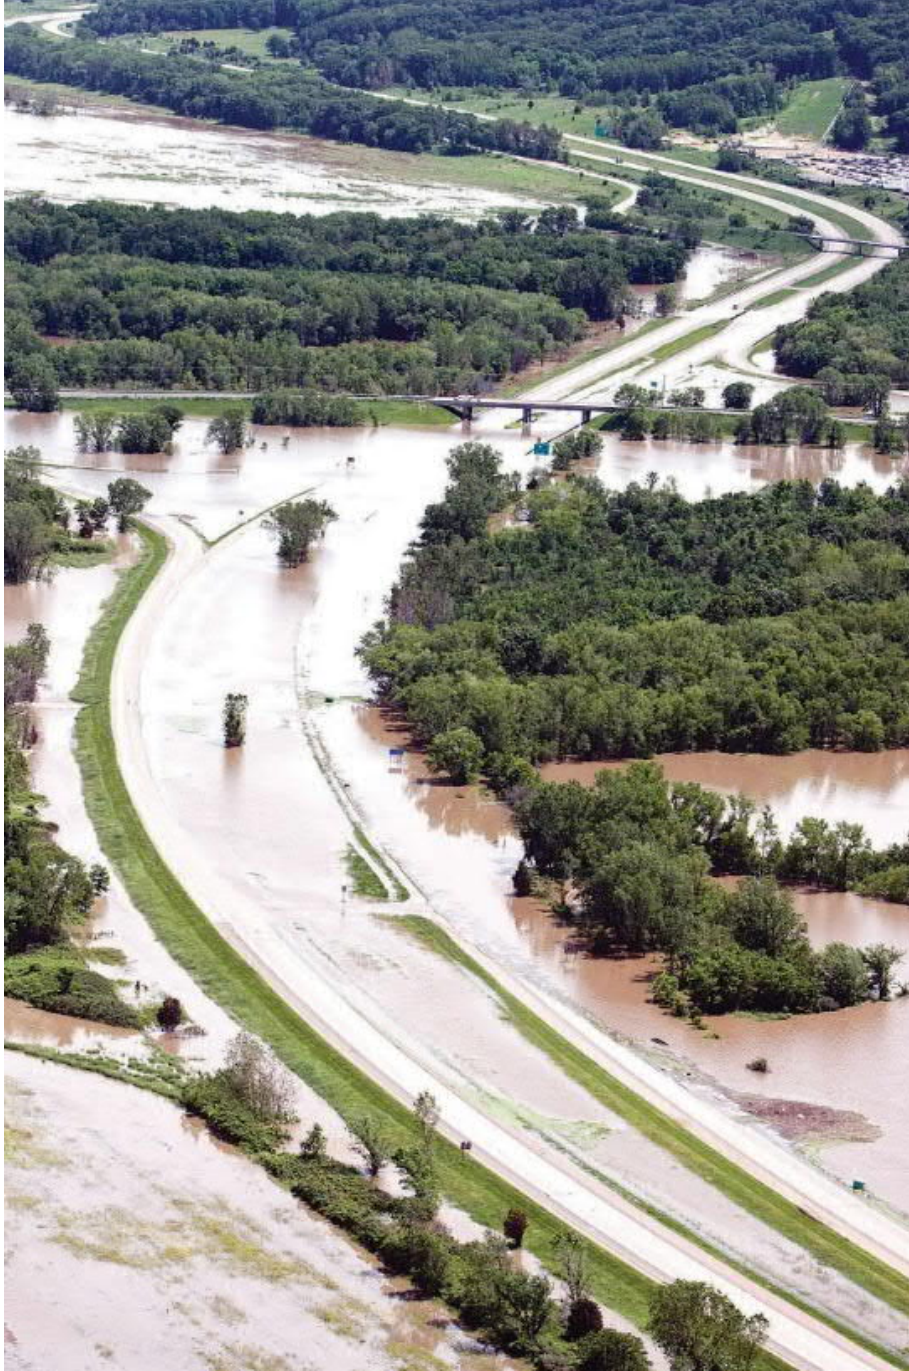
**Major flooding events have demonstrated that I-90 faces resiliency challenges.** There have been 4 major flooding events on the Baraboo and Lemonweir Rivers that resulted in partial or full closure of the interstate in this corridor since 2008. Local alternate routes to I-90 have limited and low-capacity river crossings, intersection delays, and bottlenecks. High-capacity alternate routes to the interstate involve long-distance detours that impact commerce by delaying freight.

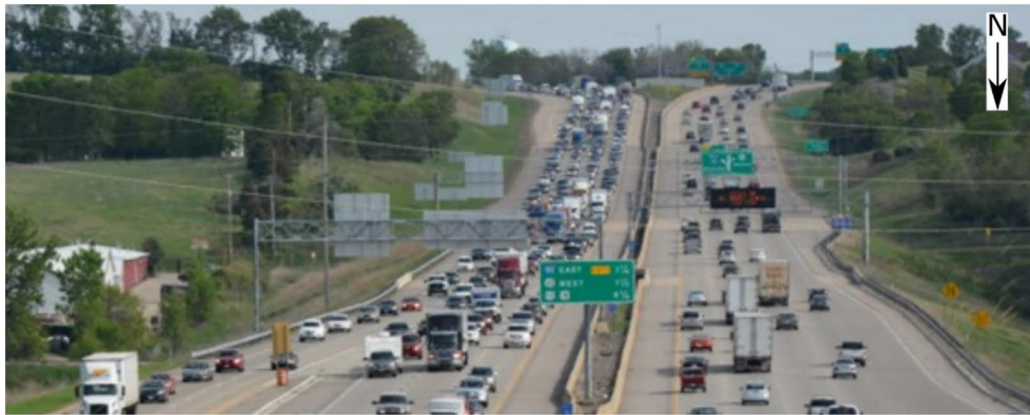
**Figure 9. I-39/90/94 Looking South from High Crossing Blvd.**

Queues from the single-lane ramps can form along the freeway mainline, creating unsafe speed differential between ramp traffic and mainline traffic. Congestion is further exacerbated by poor lane utilization at the NB I-39/90/94 exit to the US 151 / High Crossing Boulevard collector-distributor (CD) road. The CD road exit is two lanes, but only the outside lane is predominantly used because of the large volume of traffic headed to take the single lane ramp to NB US 151. NB I-39/90/94 congestion at the CD road exit is shown in Figure 9.

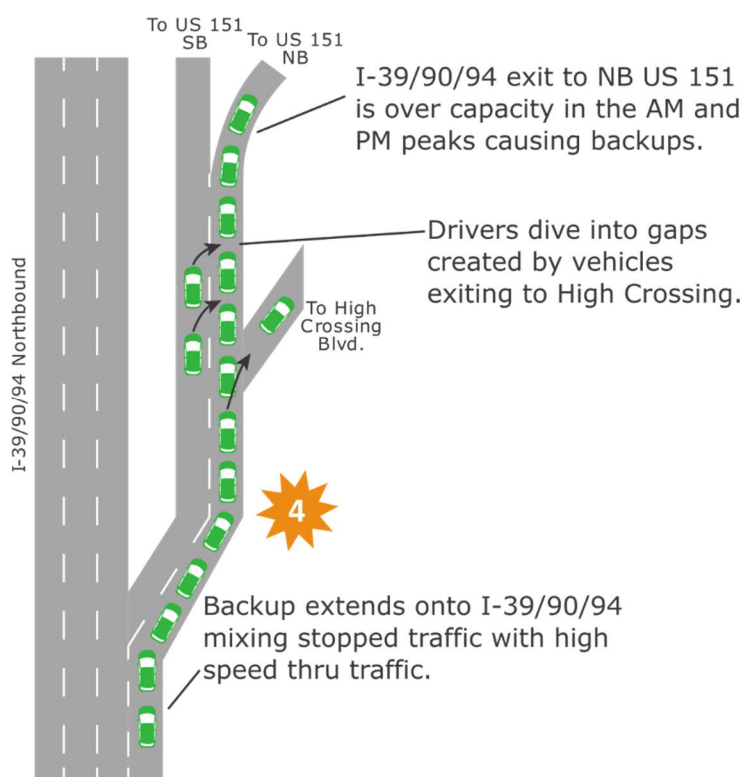
**Figure 18. Northbound I-39/90/94 Exit to US 151 CD Road**

There are also concerns with traffic attempting to merge in small gaps between the exit to High Crossing Blvd, and the exit to northbound US 151. Aggressive drivers use the left lane of the CD road to try to bypass the queue in the right lane, hoping some of the vehicles will exit to High Crossing Blvd. These drivers will force their way into the right lane causing sharp braking and further delay for vehicles behind.

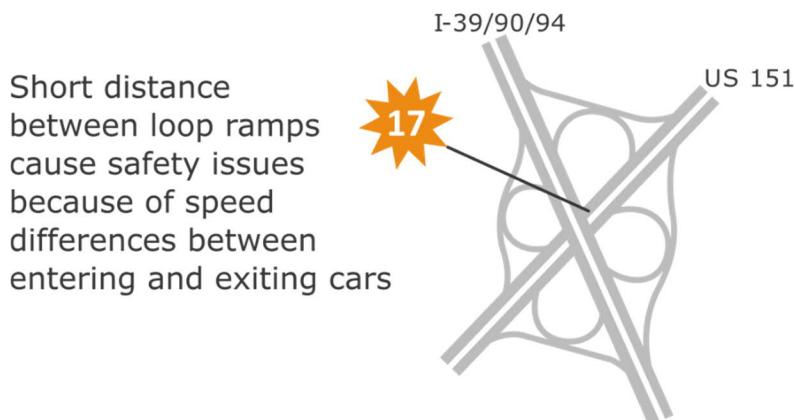
**Figure 19. Short Distance Between Loops Ramps US 151**

**17** In addition to these congestion issues, there is also not adequate distance between the loop ramps on each of the legs of the interchange. This lack of distance prevents cars from accelerating or decelerating effectively, causing dangerous speed differentials between the weaving movements with the loop ramps and the mainline

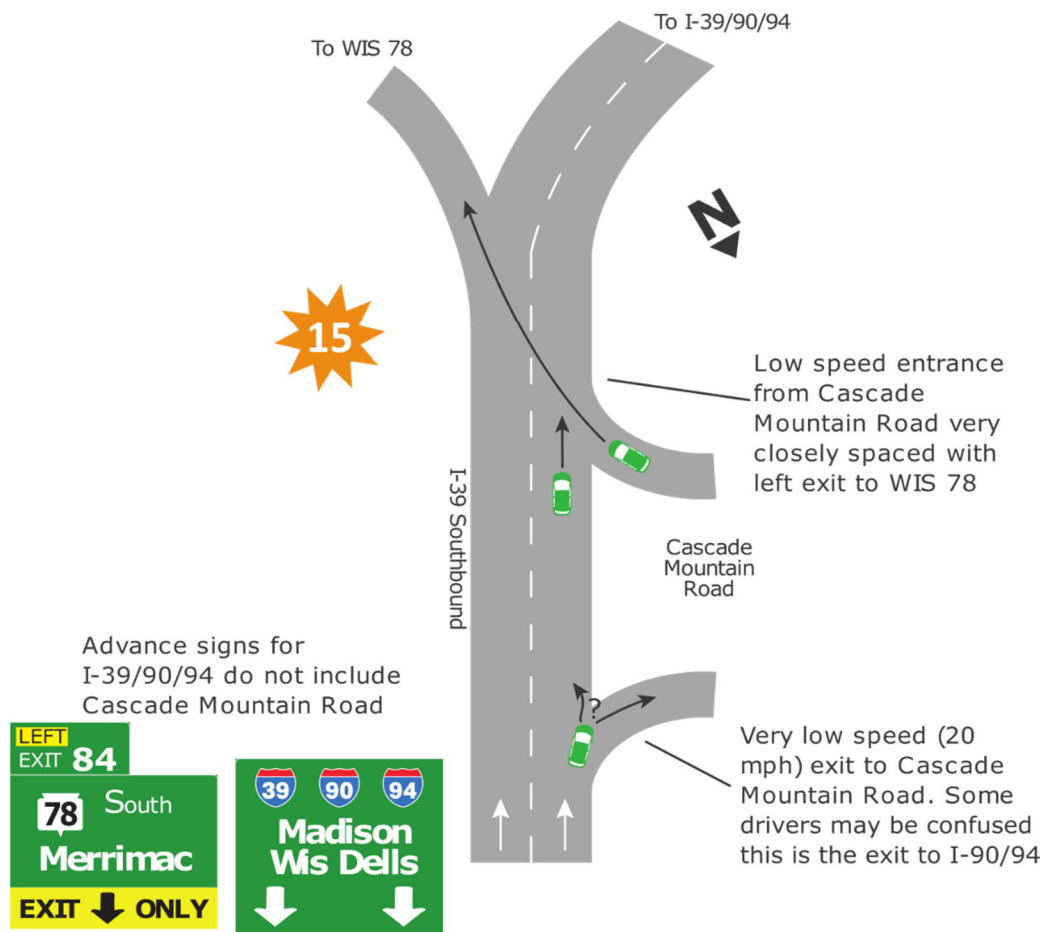
**Figure 20. I-39 between Cascade Mountain Road and I-90/94**

On the southside of the Cascade Mountain interchange there are also safety concerns dealing with speed differentials and geometry. There is not adequate space between the on ramp from Cascade Mountain Rd. and the off ramps to both WIS 78 and I-39/90/94. All of these ramps are spaced very closely together requiring vehicles to make lane changes in a small amount of space in order to take their desired routes. This combined with the slow speeds required by the geometry of the Cascade Mountain Rd. on ramp create conditions with large speed differentials, and many lane changes.

WisDOT also has a planned project (WisDOT project ID 1161-00-36) to improve the safety conditions in the northern stretch of I-39 in this section. The project will install new median cable barrier in response to a cross median crash analysis. This project began in 2021.

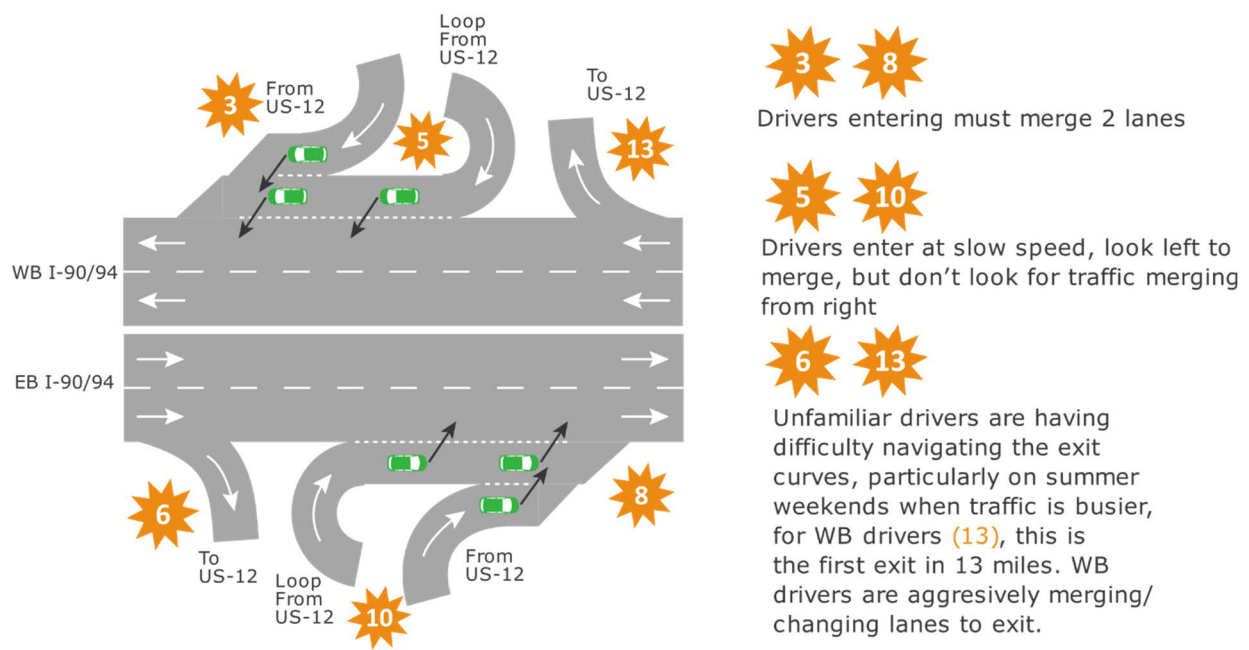
**Figure 21. I-90/94 at the US 12 Interchange**

In addition to US 12, this section also has top twenty locations at the WIS 33 interchange, WIS 23 interchange, WIS 13 interchange, and on the mainline between US 12 and WIS 23 interchanges.

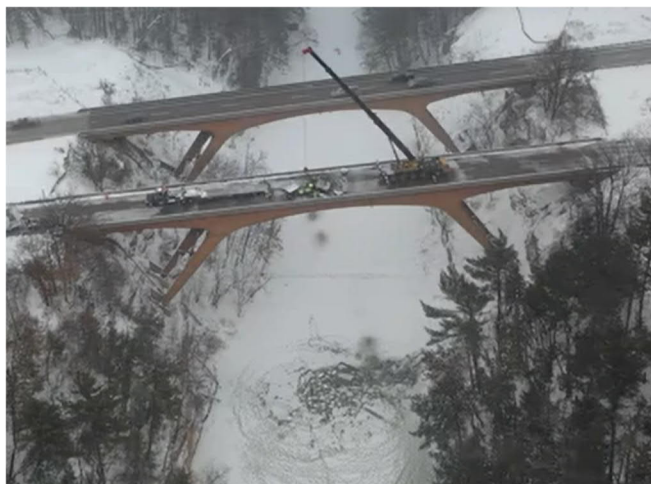
**Figure 22. Fatal Crash at the Mirror Lake Bridges**

**The I-90/94 bridges over Mirror Lake are unique structures that are reaching the end of their useful life.** The existing 320 foot long K-frame structures were constructed in 1961 and are fracture critical. The bridges are narrow (32 feet) and experience high summer traffic making traffic control challenging for maintenance activities. In addition, the over 100 foot drop from the bridge to the water has been a crash severity issue. In the past 10 years, three vehicles have dropped into the lake below resulting in three fatalities in two fatal crashes.

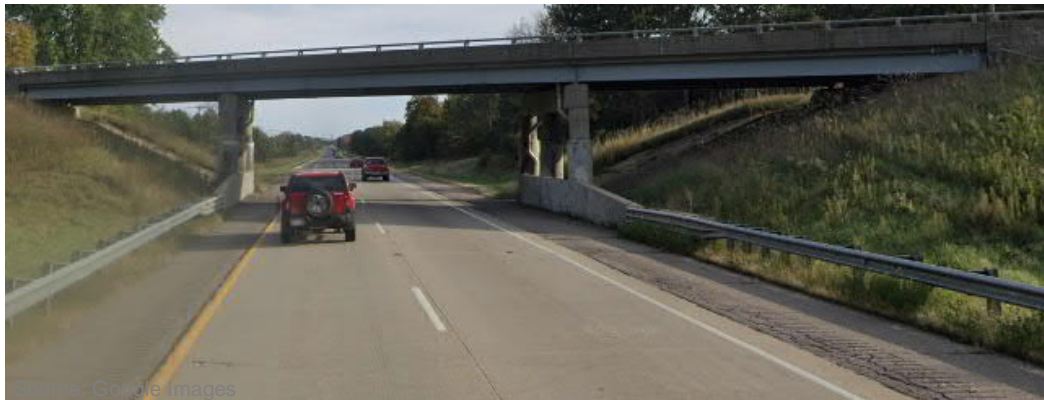
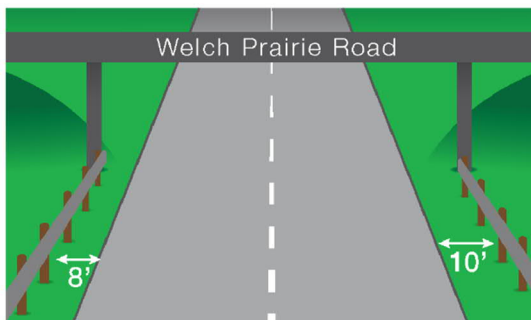
**Figure 23. Welch Prairie Road Bridge over EB I-90/94**

**1 Welch Prairie Overpass**

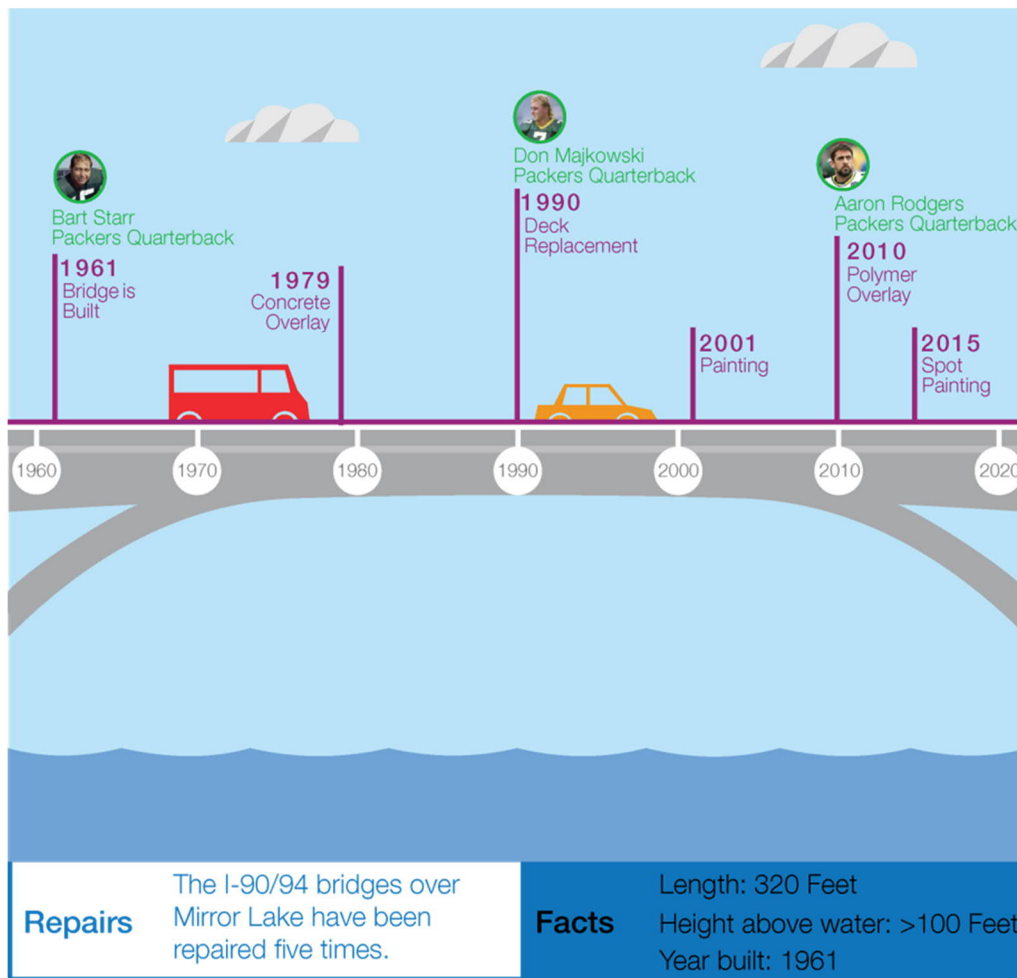
**Figure 36. Mirror Lake Summary**

The Mirror Lake bridges have been repaired five times over their lifespan consistently needing maintenance before the scheduled time and will need continuing maintenance to extend their life. In the ideal bridge life, a new bridge deck will last 45 years until a new bridge is needed. The Mirror Lake bridge deck was replaced in 1990. Using the ideal maintenance schedule, the existing bridge deck is expected to last until approximately 2035. Regular inspections of the structure will refine the expected lifespans as it reaches the end of its useful life. Because of the narrow width and high recreational traffic volumes in the summer, a project to replace the Mirror Lake bridge deck would likely require a temporary structure to maintain traffic. It may be more cost effective to replace the structure rather than the continued maintenance projects. The comparison between the expected maintenance cycle and the actual maintenance cycle for the Mirror Lake Bridges can be seen in Figure 37.

Because of the complexity of the traffic management needed for the Mirror Lake bridges maintenance and the timing of the next recommend project as overlapping with many other projects, these bridges will likely control the section in terms of timing of improvements for adjacent needs.
