AESTHETIC COATINGS FOR STEEL BRIDGE COMPONENTS

WisDOT ID no. 0092-11-07

November 2013

FINAL REPORT

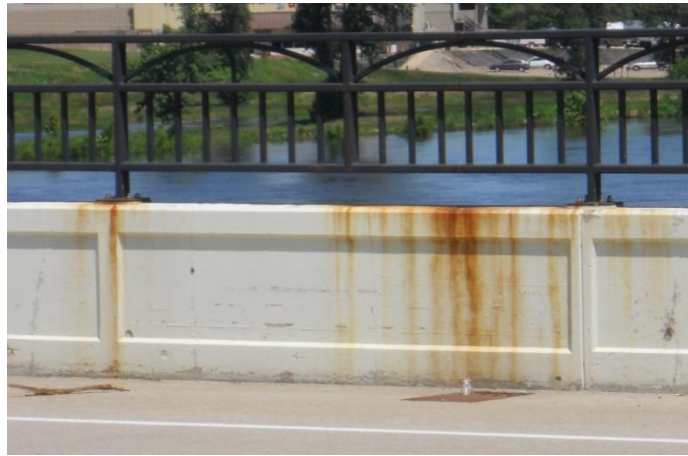
Figure 2: Sauk City, WI Bridge

poor aesthetics of a bridge is shown in Figure 2. Here, poor geometric details of the railing lead to a coating failure, which caused rust bleeding and staining of the concrete parapet.

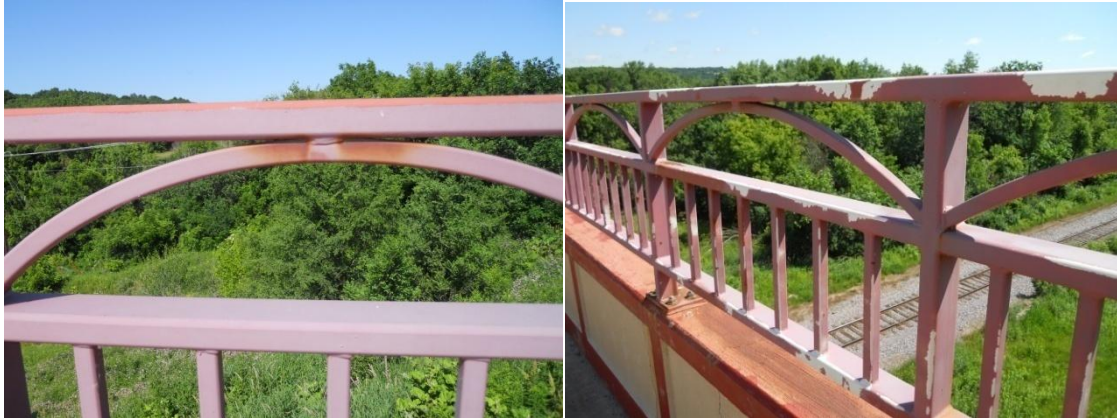
Figure 3: Baraboo Bridge Railing Top-Coat Failure

the coating. The top-coat on some areas of the railing with the east side sun exposure has been peeled off and leaving only the white epoxy mid-coat exposed, shown in Figure 3.

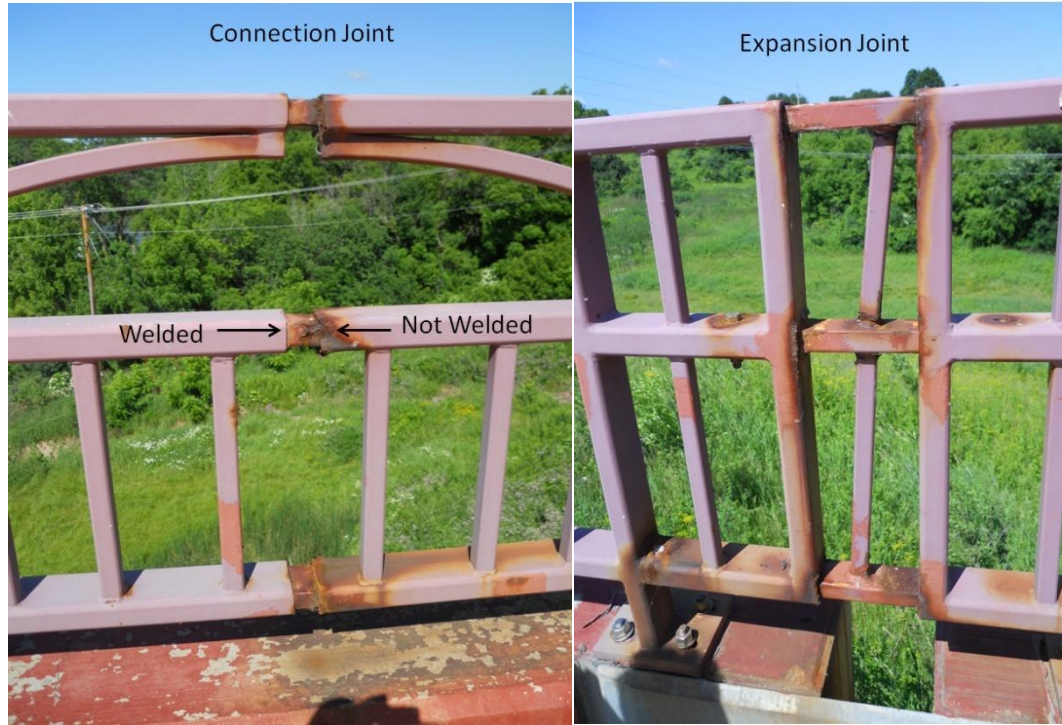
Figure 4: Baraboo Bridge Railing Connection/Expansion Joint

An additional railing failure that was observed at the bridge was due to poor expansion joint and railing details that allowed penetration and accumulation of water inside the railing elements. Freezing and expansion of entrapped water inside the railing members during the winter months caused excessive tensile stresses to form inside the railing members leading to stretching and bulging of the walls of the tube structure. This lead to major structural damage to the railing (elongation and rupture of the walls) and destruction of the coating layers in the local areas. As a result, additional corrosion was initiated in these local areas due to the failure of the coating. These problems were observed in several sections of the railings along the length of the bridge, see Figure 5.

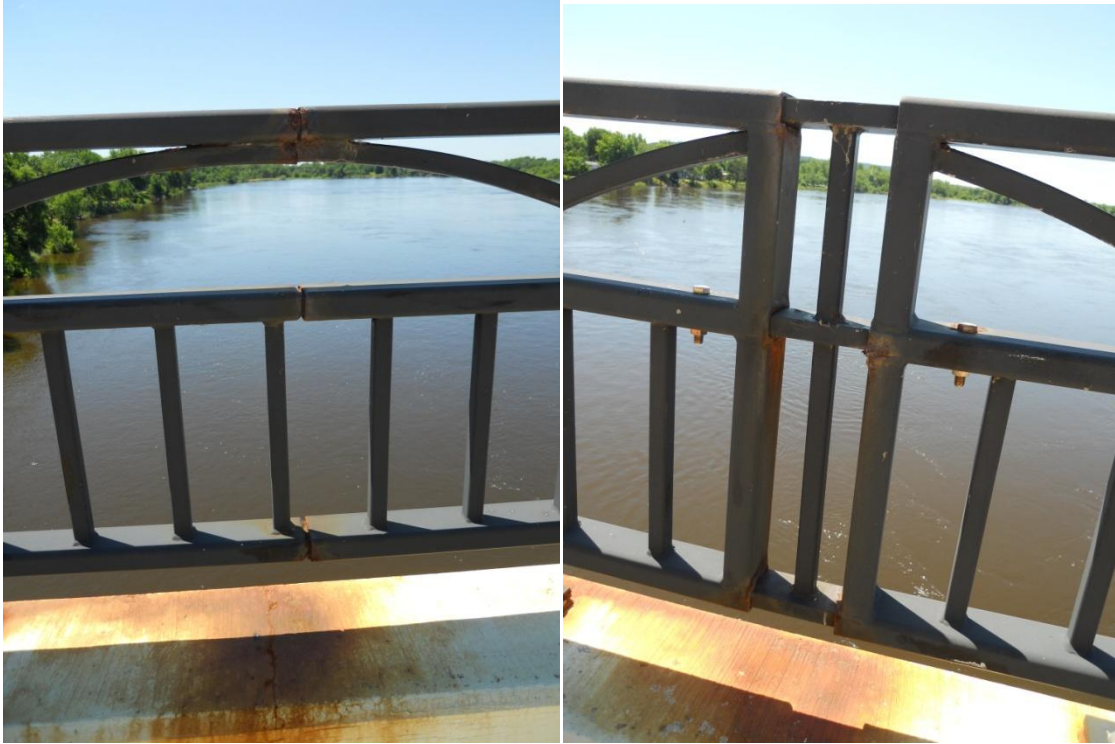
Figure 6: Sauk City Bridge Railing Connections

Connection and expansion joints constructed in the railings of the bridge are shown in Figure 6. At both connection types, poor construction details were used and there were easy access points where water could penetrate and accumulate inside the tubular members of the railings. Due to insufficient drainage, accumulated water froze and expanded during the winter months that lead to excessive expansion and failure of both the tubular railing members and the coating system in the local areas, see Figure 7. It appeared that the WisDOT maintenance personnel or others attempted to remedy the water accumulation problem inside the railing members for this bridge after the initial construction by drilling small holes in some areas of the railings, see Figure 8. However, it was found that additional drainage were needed and most of the drilled holes were plugged with debris since they were small and located close to the base of the railing where debris tend to accumulate more frequently.

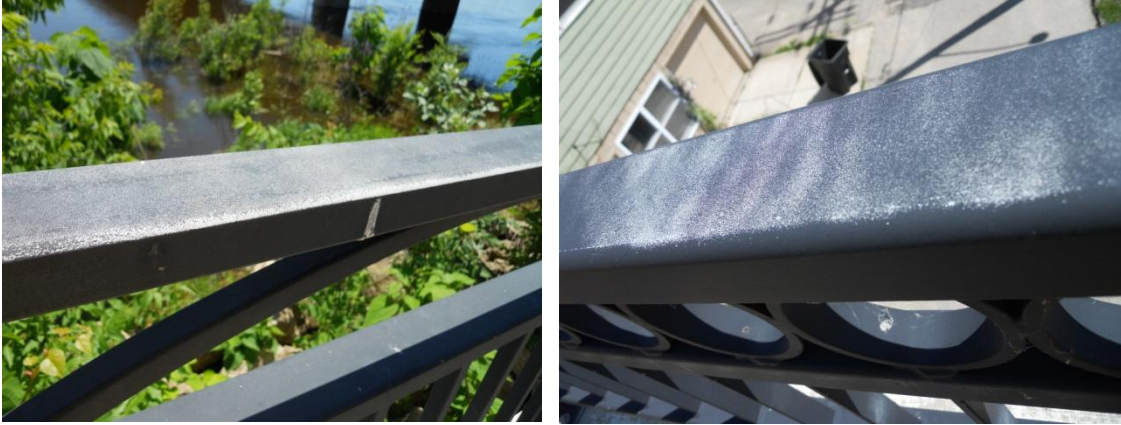
Figure 9: Jefferson Bridge Railing Exposed Tie-Coat

The Jefferson Bridge (B-28-89) is located in Jefferson County, Wisconsin, on US Highway 18 crossing the Rock River. The bridge was constructed in 1998. The bridge received galvanized decorative railings with a black two-coat coating system applied over the galvanized steel. The research staff found uniform fading of the coating system throughout the length of the railings. They also observed fading and degradation of the top-coat in some areas directly on the top of the railings where the tie-coat was exposed, see Figure 9. It was also observed in some areas of the railings that the tie-coat peeled off from the galvanized steel, see Figure 10. It was also observed that the galvanization of the steel railing was effective and prevented steel corrosion and rust staining of the concrete parapets even though some coating failures were seen in the railings of this bridge.

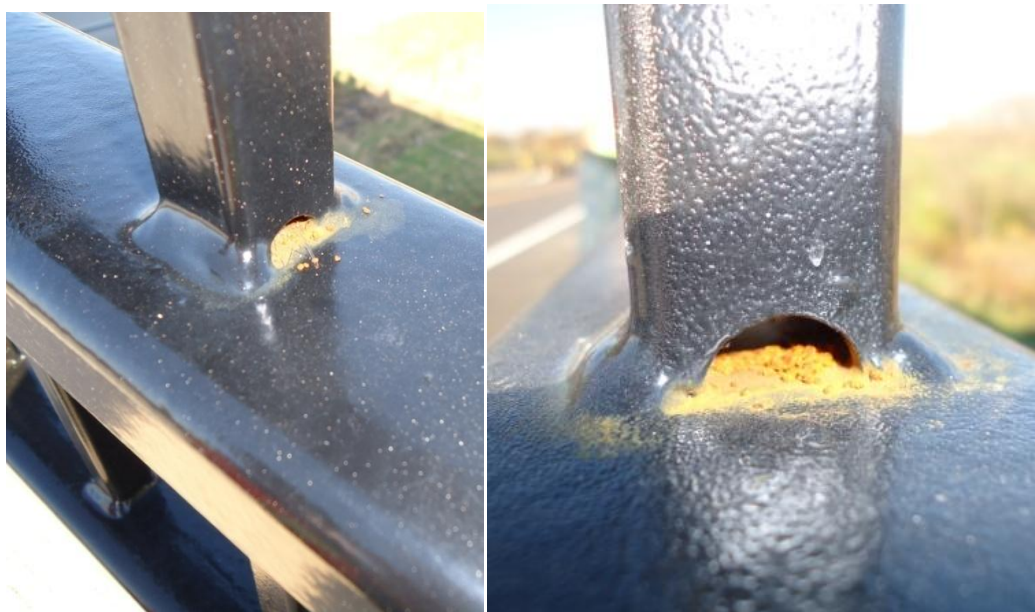
Figure 14: Highland Ave and I-43 Bridge Railing Corrosion

The Highland Ave and I-43 Bridge (B-45-21) is located in Ozaukee County, Wisconsin, on Highland Ave crossing Interstate 43. This bridge was constructed in 2011. The bridge received galvanized decorative railings with a black two-coat coating system applied over the galvanized steel. The bridge railing contains vent holes cut at the base of each vertical member as shown in Figure 13. These vent holes were made to facilitate the galvanization process and prevent water or moisture from being trapped in the railings. It was observed that there are signs of corrosion particles in the vicinity of the vent holes, see Figure 14.

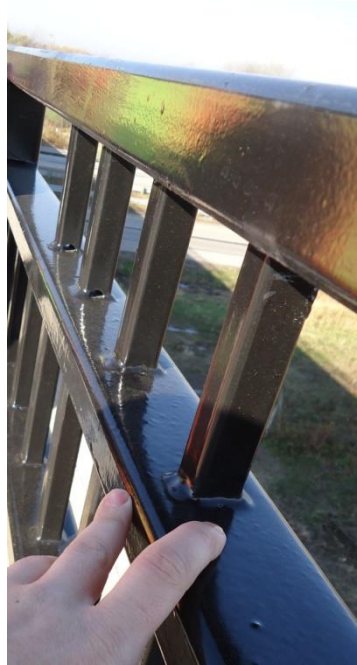
Figure 15: Highland Ave and I-43 Bridge Railing Blocked Vent Holes

It was found that several of these vent holes were unintentionally blocked during the galvanization process, see Figure 15. This could have led to entrapped moisture inside railings causing subsequent corrosion of the steel.

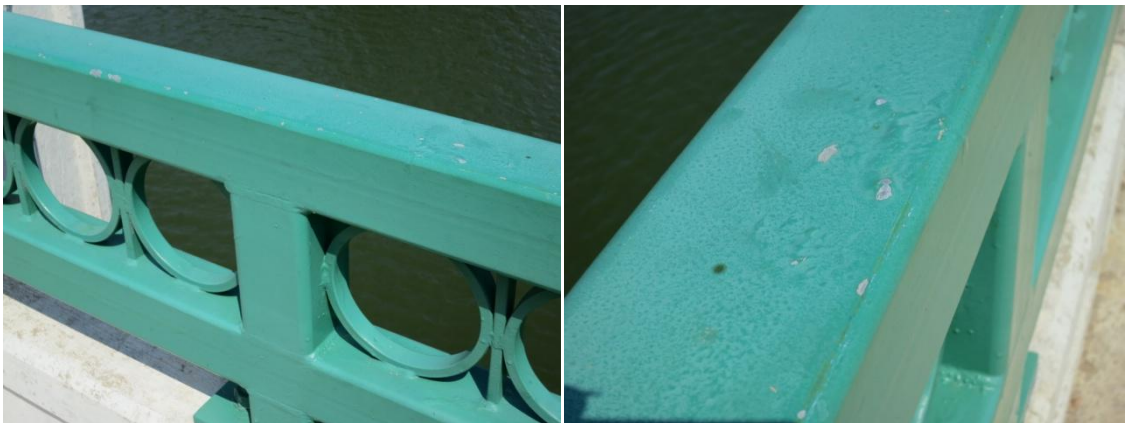
Figure 16: Beloit Bridge Railing Galvanized Railing

of aggressive exposure as the darker color coatings. Again, it was observed that the galvanization of the steel railing was effective in preventing occurrence of corrosion even though the coating system has shown signs of failure at different areas of the railing at this bridge site. No mechanical connections or expansion joints are used in the railings of this bridge as adjacent sections of the railing are interrupted by short concrete pedestals rising from the top of the parapet supporting the railings, see figure 17. Also, there was no evidence of peeling of the coating from the galvanized steel in the railing of this bridge. Overall, it was concluded that the choice of appropriate structural details, coating system, and application has largely contributed to the relatively successful performance of the railings in this bridge for more than 15 years.

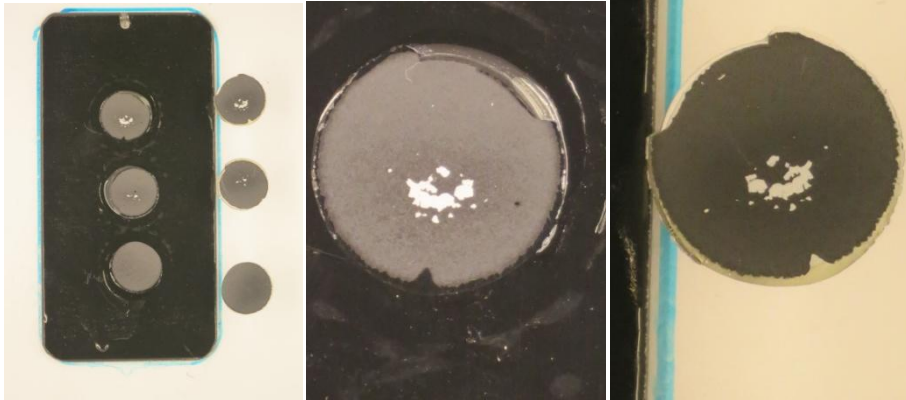
Figure 90: Initial Cohesion Failure of Top-Coat (PPG-3P)

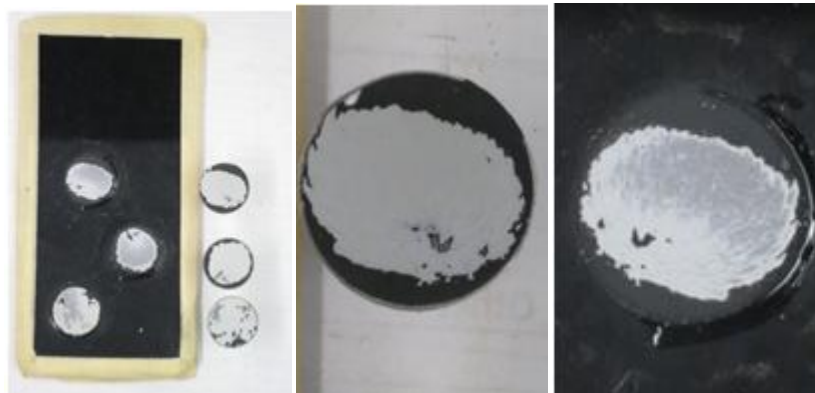
Figure 91: Final Cohesion Failure of Mid-Coat (PPG-3P)

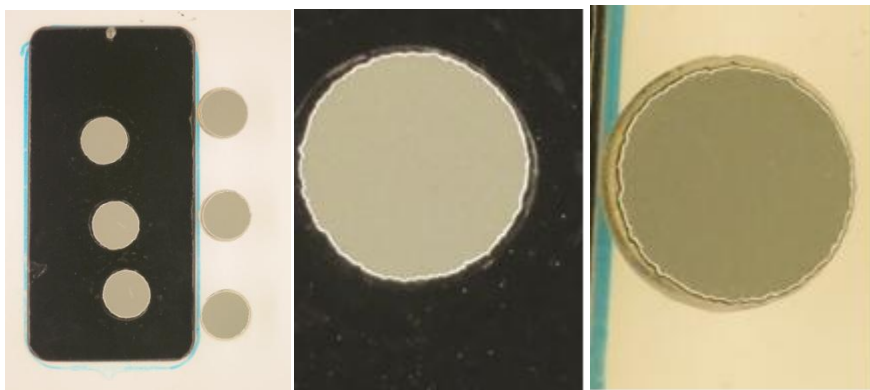
Figure 92: Initial Cohesion Failure of Zinc Coating (SW-3P)

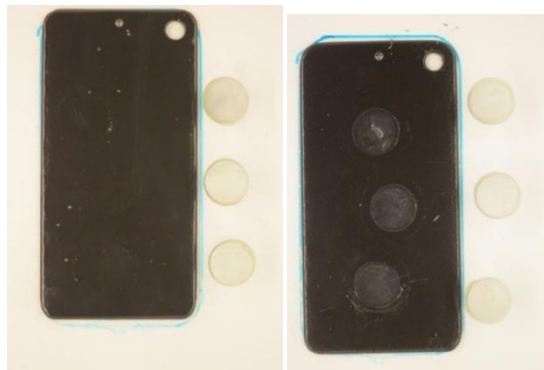
Figure 95: Initial Glue Failure (SW-05PD and SW-04PD)

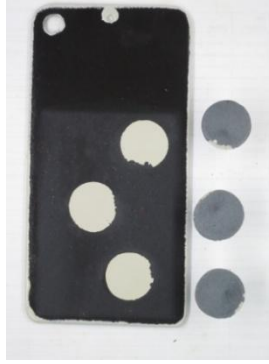
Figure 96: Final Adhesion Failure SW-PD04
