Optimizing Bridge Abutment Slope Protection at Stream Crossings

WisDOT ID no. 0092-21-02

December, 2022

WISCONSIN HIGHWAY RESEARCH PROGRAM

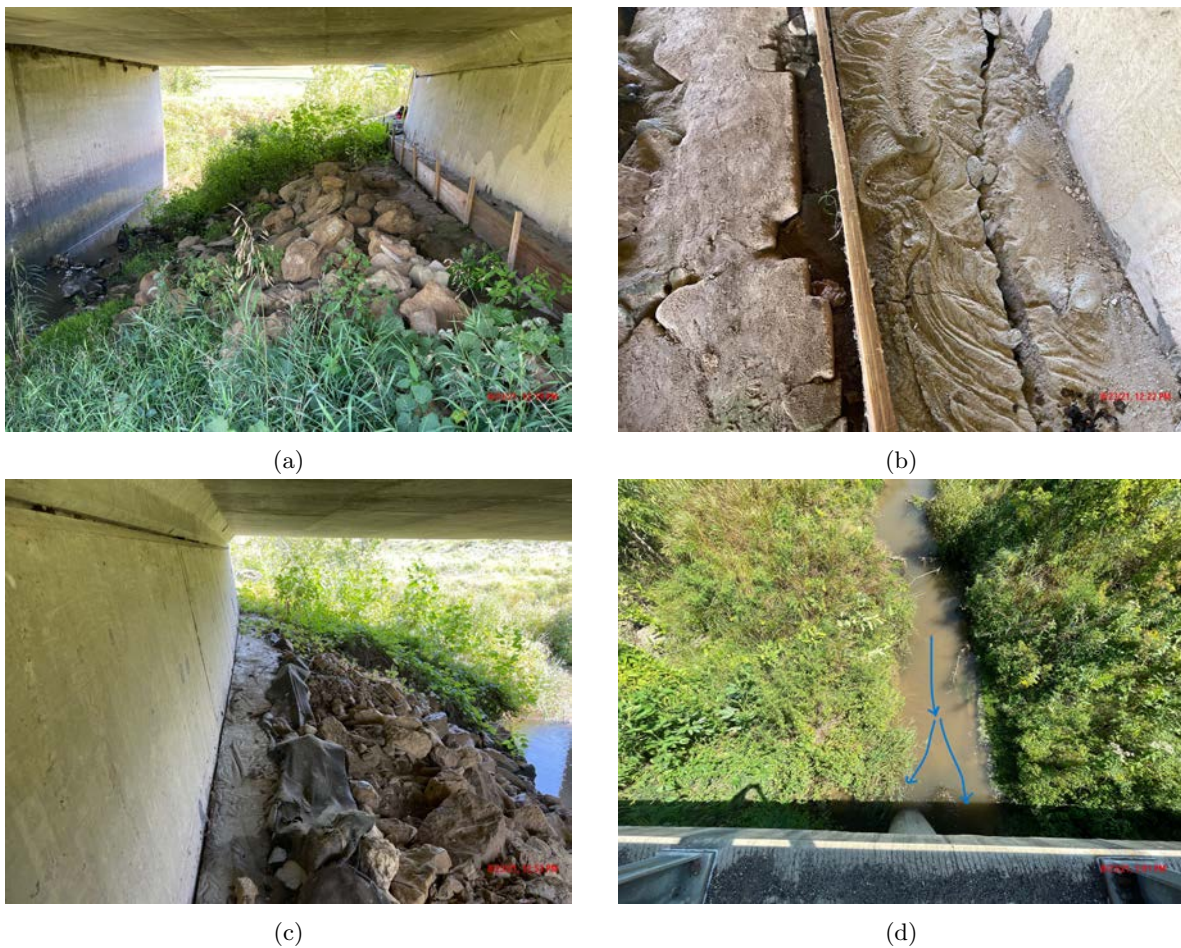
Figure 15: B-52-114 a) South abutment, overall view, b) Zoomed in photo of wide crack in closure pour, c) North abutment concrete pour repair noted with a gap between the abutment and pour repair indicating movement of repair. Abutment stem (typical for both abutments) is 8 degrees out of plumb inwards towards the pier, d) Upstream at center pier. Blue arrows indicate water flow.

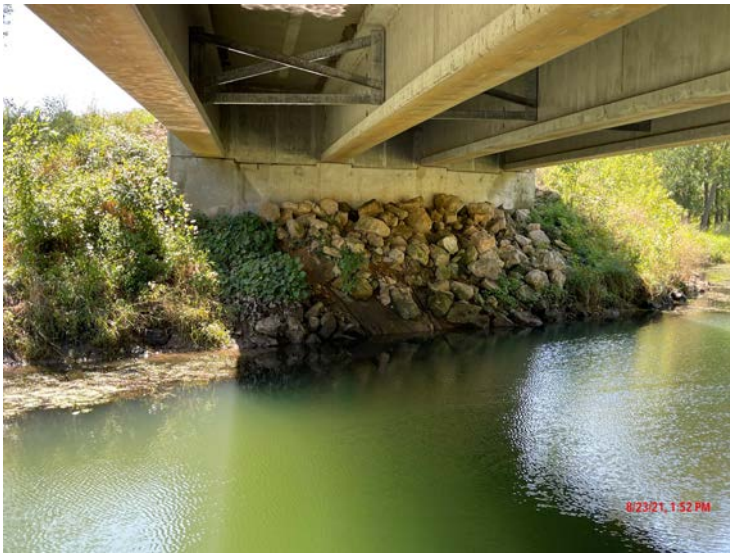
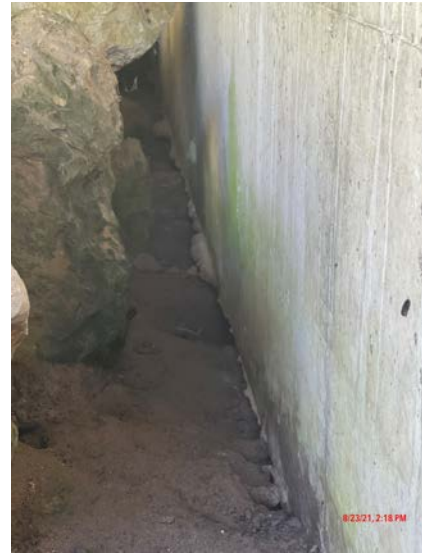
Figure 16: B-12-102 a) South abutment, overall, b) Erosion along the south abutment

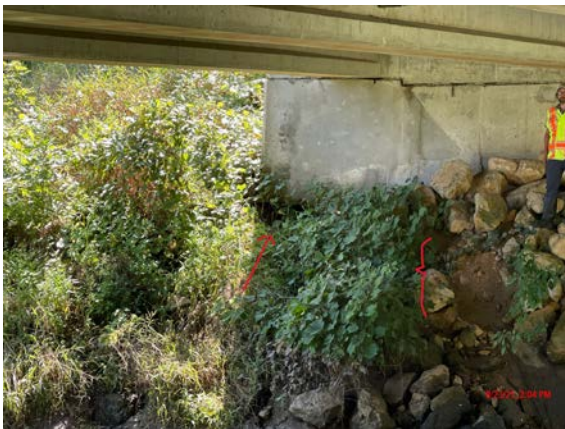
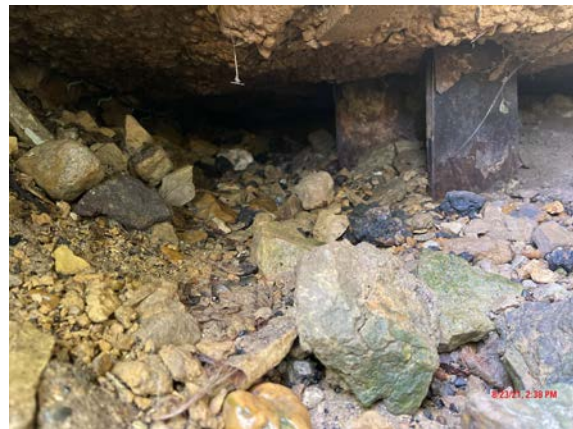
Figure 17: B-12-102 a) Southwest corner noted with localized erosion b) Exposed pile, at location indicated in Figure 17a

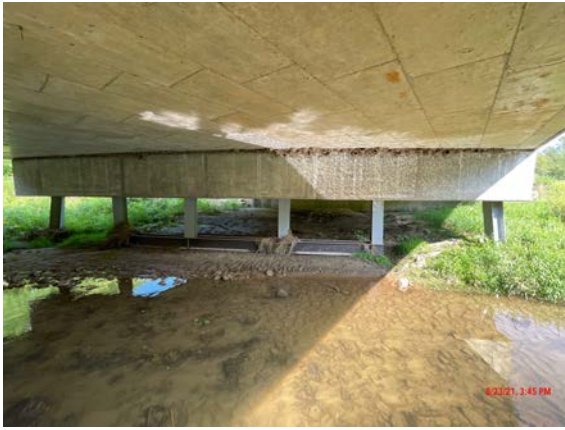
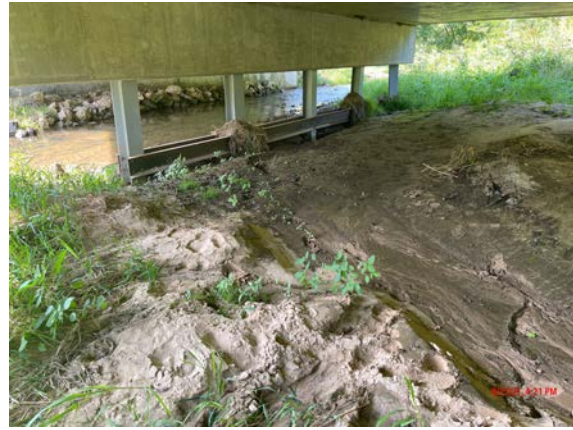
Figure 18: B-12-076 a) Middle pier with retrofit, b) Water marks near the east abutment indicating the flow has diverged away from the east abutment

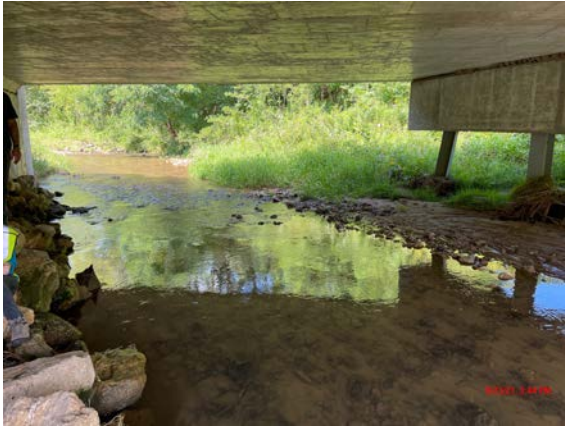
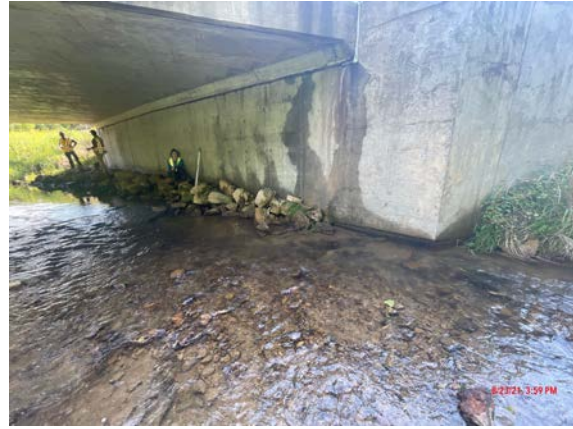
Figure 19: B-12-076 a) Looking downstream, b) Riprap scoured at north end of west abutment

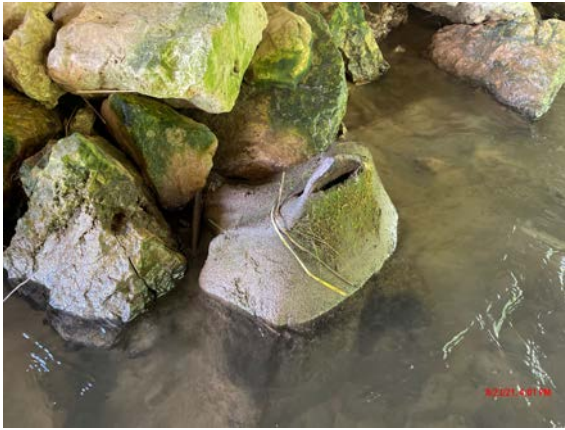
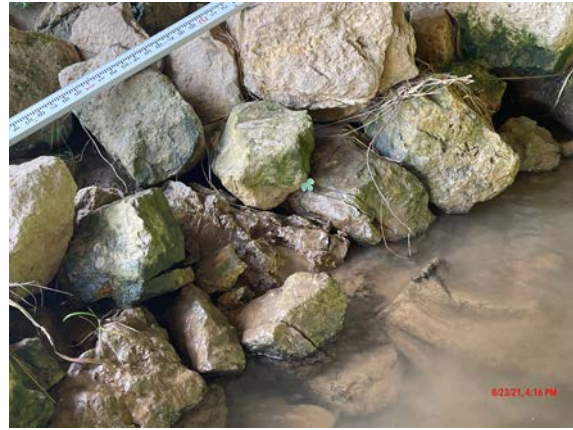
Figure 20: B-12-076 a) Filter fabric is caught by the existing piles and tearing/damaging the fabric, b) Typical fractures noted in the riprap rocks

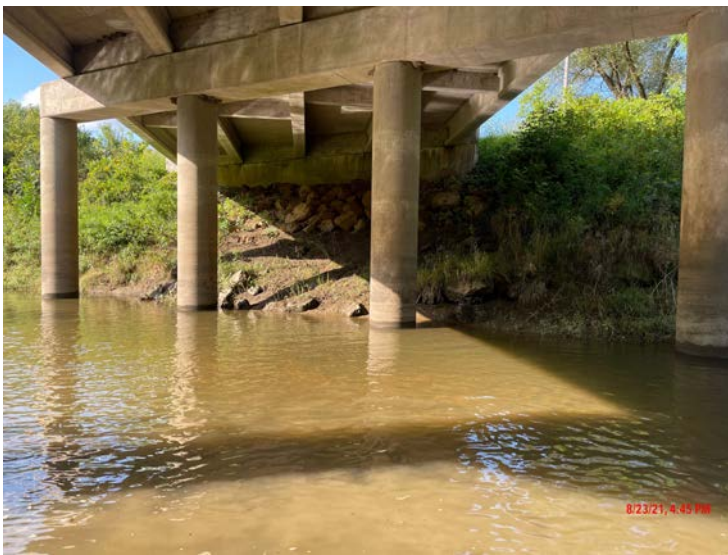
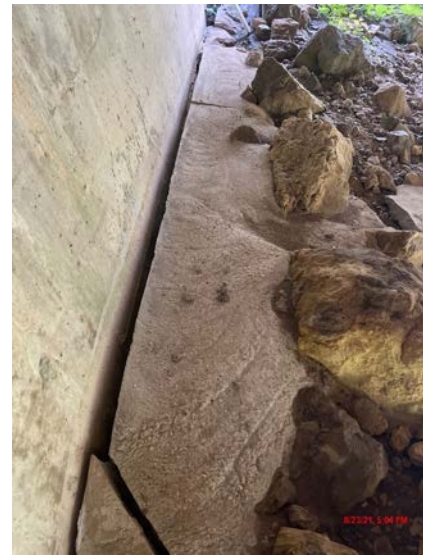
Figure 21: B-62-017 a) North abutment and north pier overall b) Corrective concrete slurry at north abutment

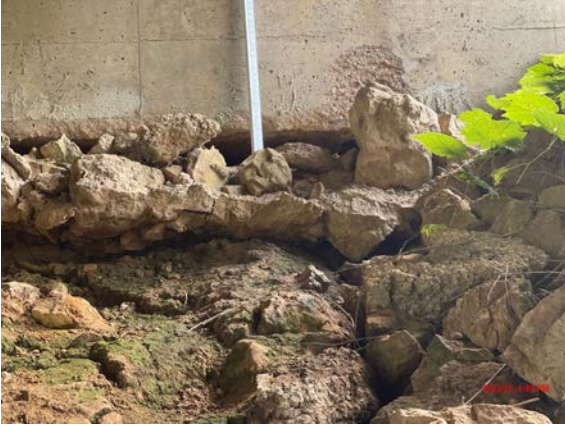
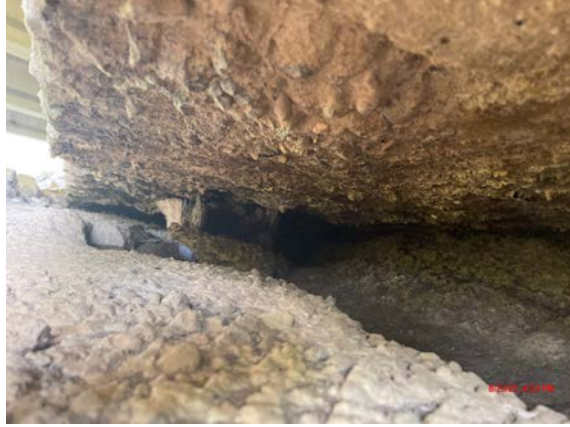
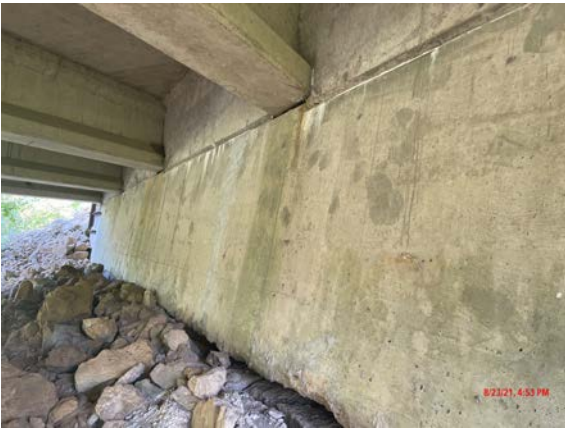
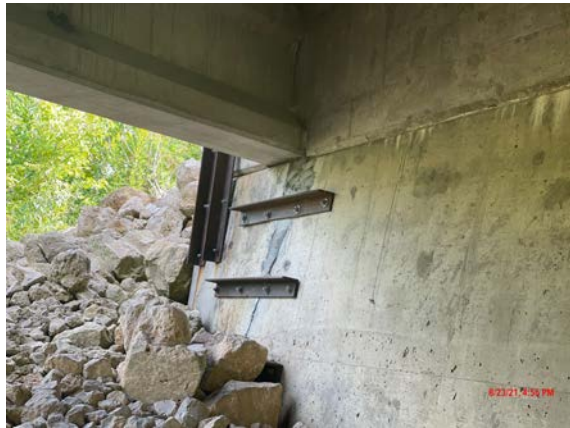
Figure 22: B-62-017 Photos showing abutment under-mining at the southwest end.

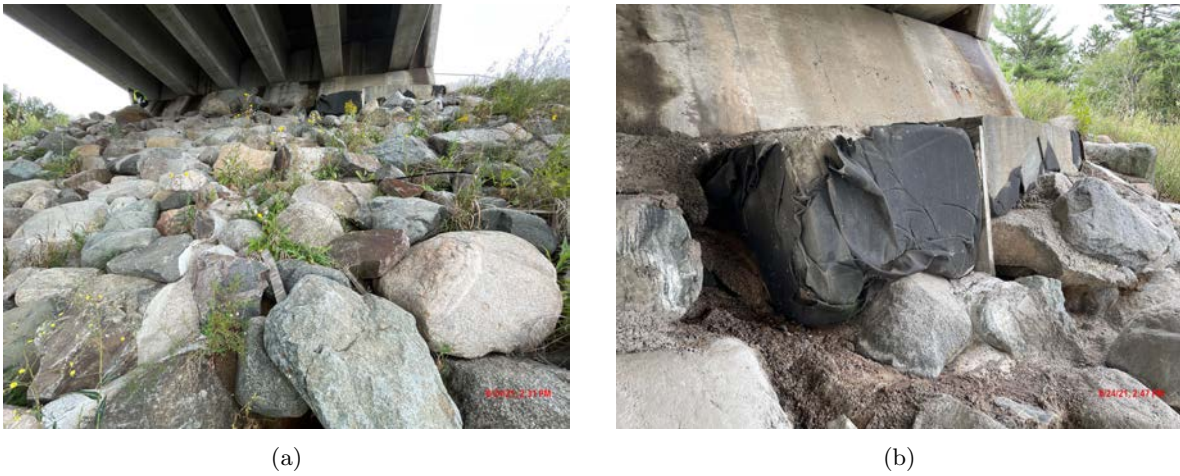
Figure 23: B-35-063 a) North abutment overall, b) Riprap repair near east end of north abutment

parapet ends at northwest and northeast locations. The east corner of the north abutment was noted with heavy erosion with concrete blocks used as repairs in 2017 (Figure 23b). A steep change in slope was observed at the northeast wingwall seemingly from the concrete repair applied at that location; see Figure 24a. The riprap at the east end of the north abutment was noted with watermarks along the riprap. The northwest wingwall has a gap between the wingwall concrete and the riprap (Figure 24b).

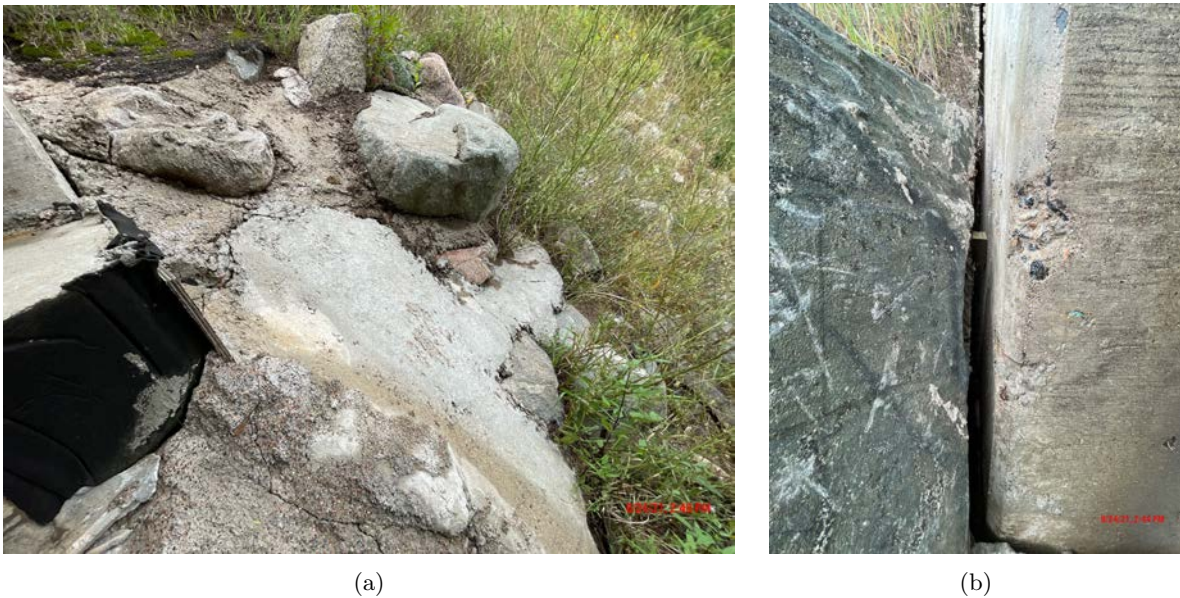
Figure 24: B-35-063 a) Steep change in slope at northeast wingwall, b) Gap between abutment and side riprap along wingwall

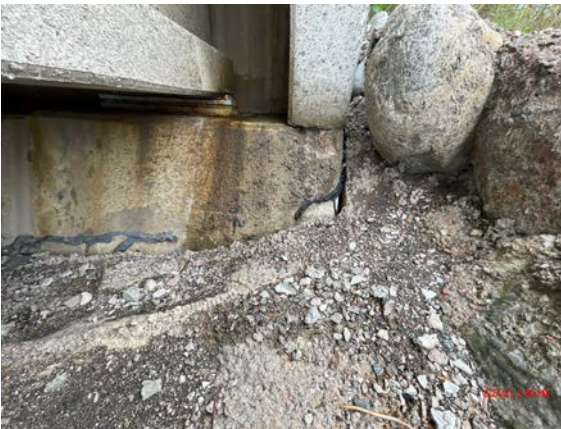
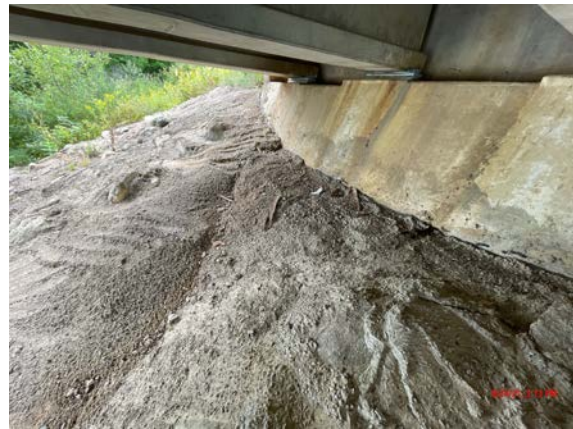
Figure 26: B-35-062 a) Gap between bridge and riprap at east end of north abutment, b) West end of north abutment

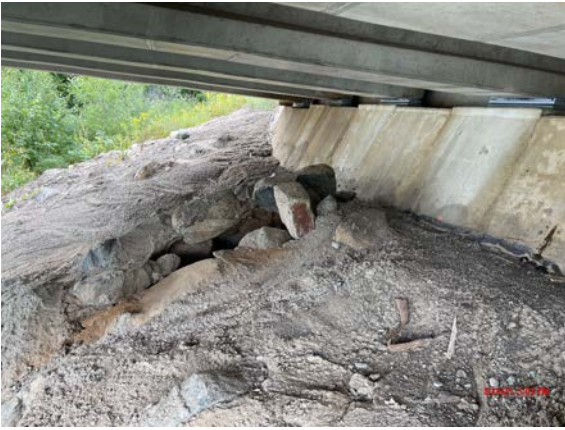
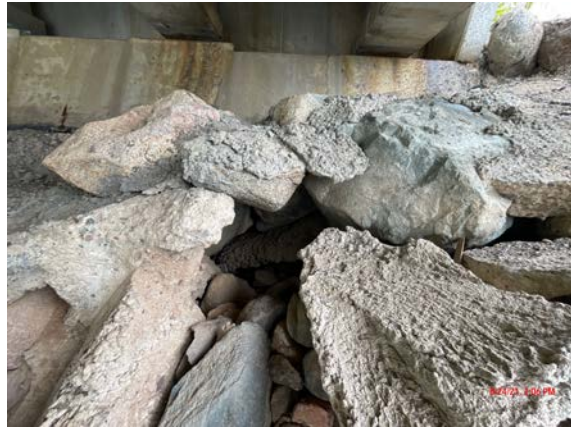
Figure 27: B-35-062 a) Riprap near west half of north abutment, b) Hole noted near west half of abutment

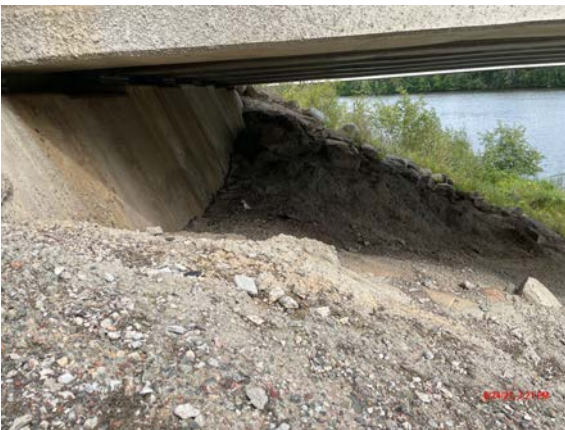
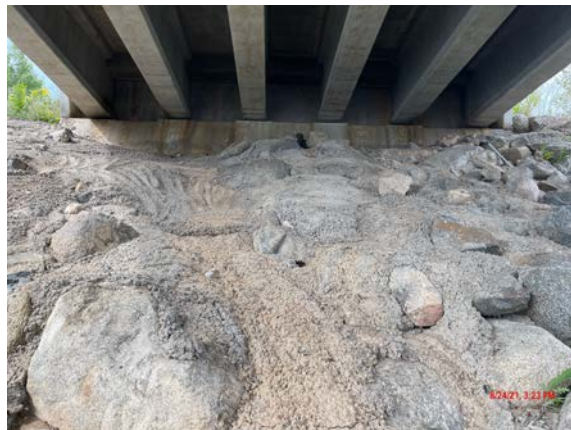
Figure 28: B-35-062 a) Riprap existing condition at north abutment, b) Riprap at north abutment from bottom of riprap

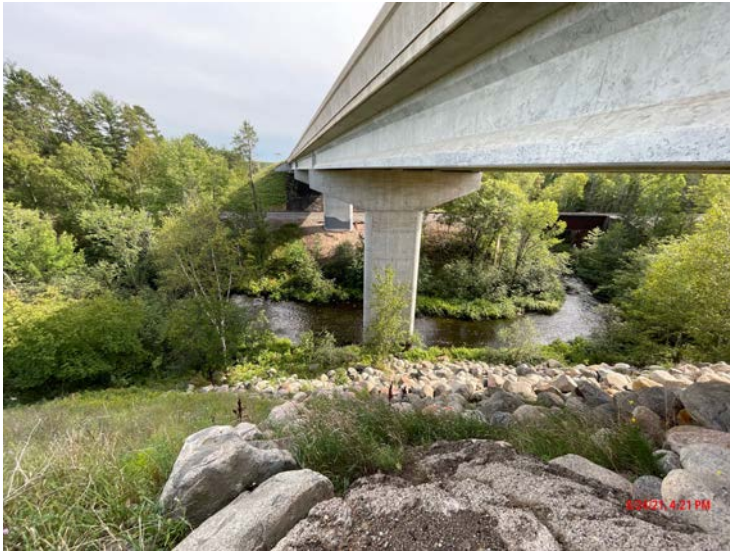
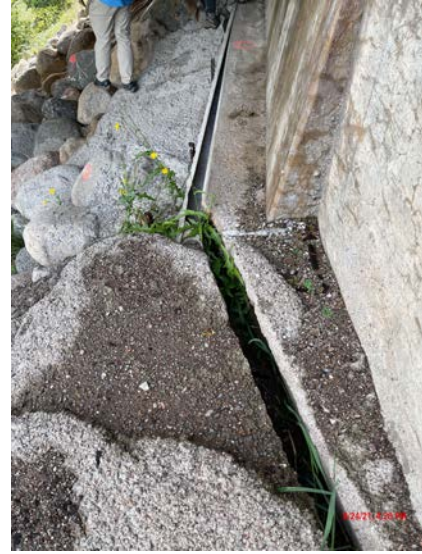
Figure 29: B-43-018 a) Looking south from bridge, b) Gap at north abutment of riprap

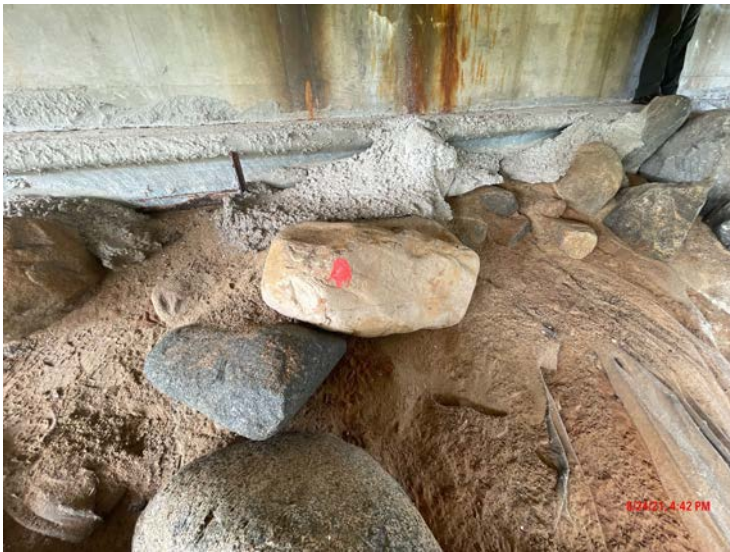
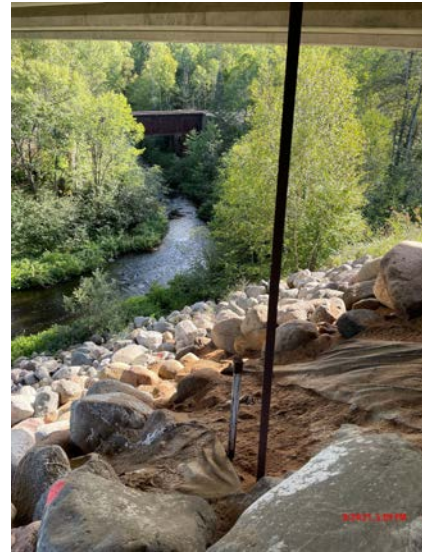
Figure 30: B-43-018 a) Scour near center half of north abutment. Red dots on riprap indicates riprap elements surveyed, b) Inclinometer device

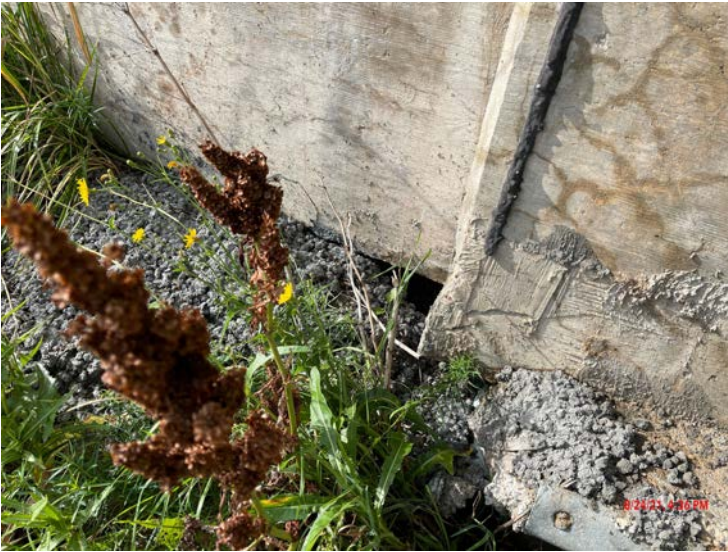
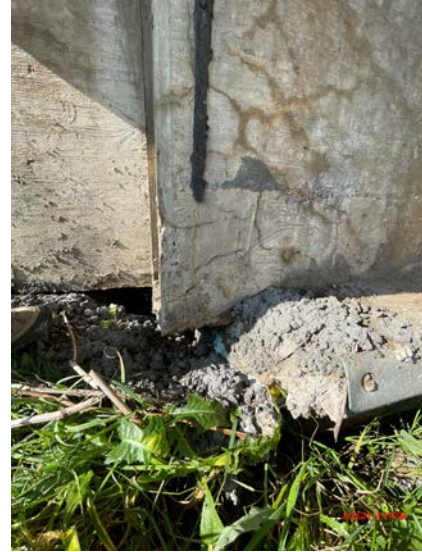
Figure 31: B-43-018 a) Scour under the west wingwall, b) Drain relative location compared to wingwall and abutment

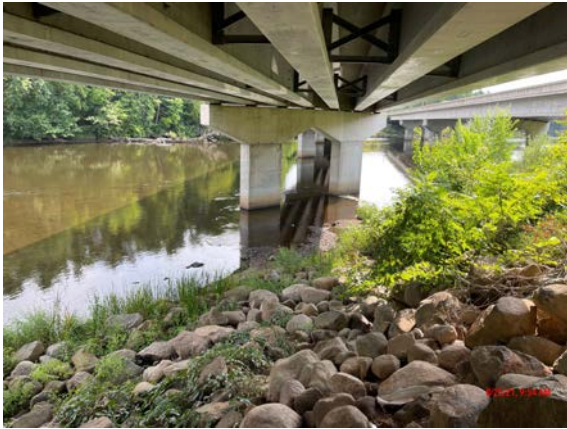
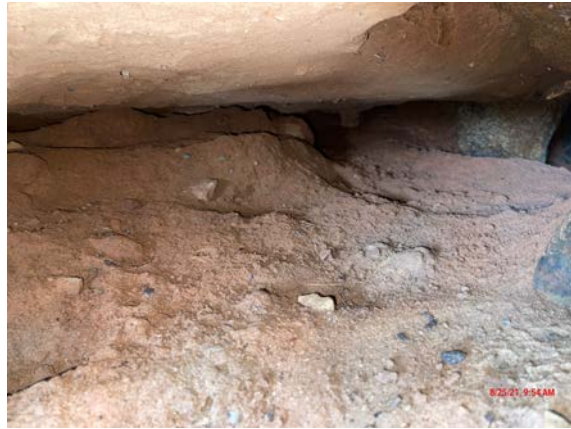
end of the west abutment was noted with an exposed pile; Figure 32b.

Figure 32: B-58-075 a) Looking east along the bridge, b) Exposed piles under the abutment due to noted scour/erosion

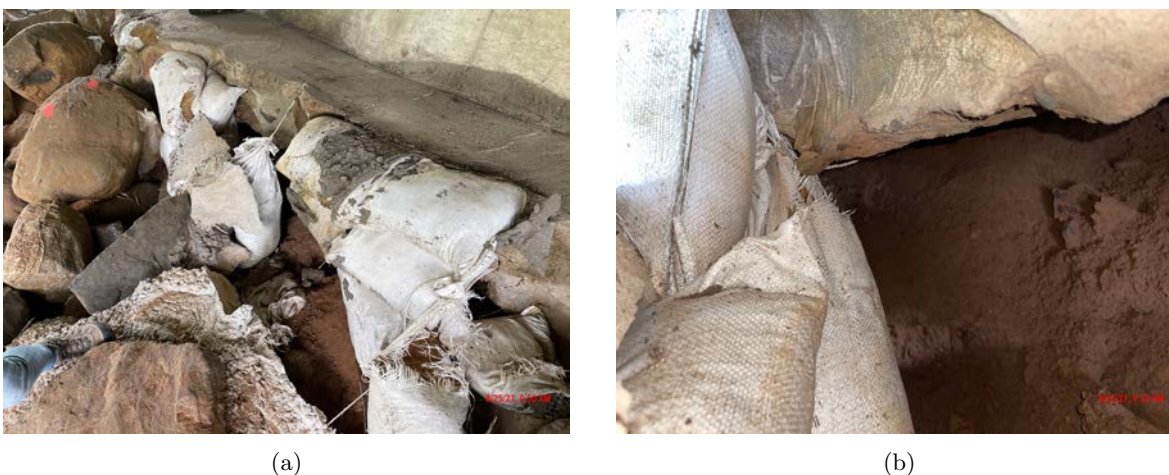
Figure 34: B-58-075 a) Concrete slurry repair with sand bags left in place attached to the repair and adding dead weight due to soil erosion under repair, b) Scour under the abutment
