I-90 Madison to Tomah Needs Study

Corridor Needs Report

ID. 1010-11-00

ID. 1014-10-01

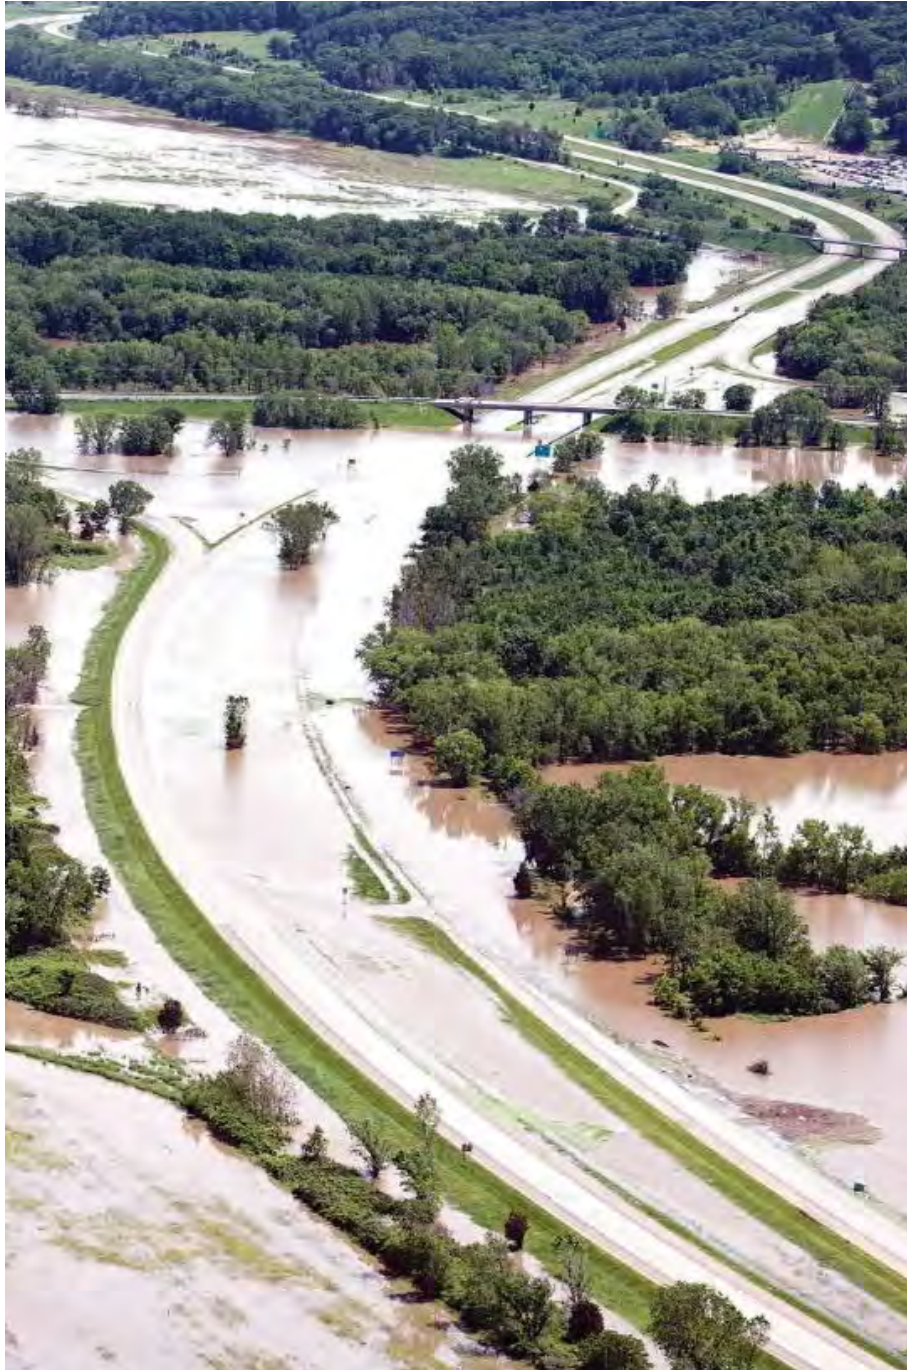
Photo Source: Portage Daily Register, June 14, 2018

Major flooding events have demonstrated that I-90 faces resiliency challenges. There have been 4 major flooding events on the Baraboo and Lemonweir Rivers that resulted in partial or full closure of the interstate in this corridor since 2008. Local alternate routes to I-90 have limited and low-capacity river crossings, intersection delays, and bottlenecks. High-capacity alternate routes to the interstate involve long-distance detours that impact commerce by delaying freight.

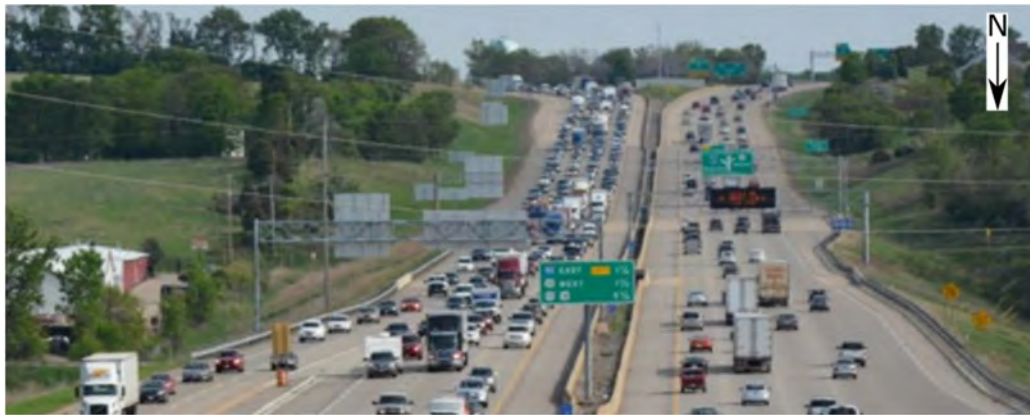
Figure 9. I-39/90/94 Looking South from High Crossing Blvd.

Queues from the single-lane ramps can form along the freeway mainline, creating unsafe speed differential between ramp traffic and mainline traffic. Congestion is further exacerbated by poor lane utilization at the NB I-39/90/94 exit to the US 151 / High Crossing Boulevard collector-distributor (CD) road. The CD road exit is two lanes, but only the outside lane is predominantly used because of the large volume of traffic headed to take the single lane ramp to NB US 151. NB I-39/90/94 congestion at the CD road exit is shown in Figure 9.

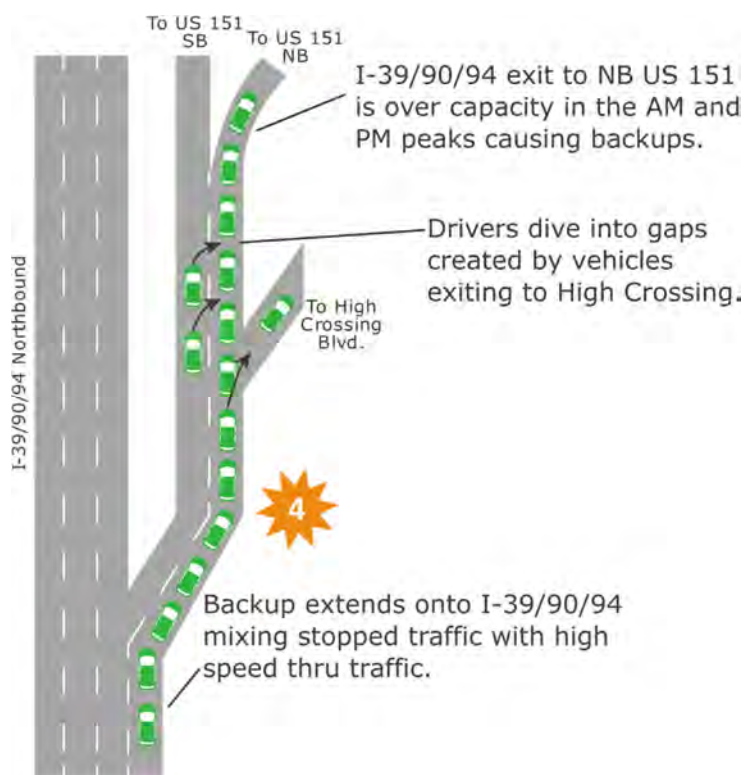
Figure 18. Northbound I-39/90/94 Exit to US 151 CD Road

There are also concerns with traffic attempting to merge in small gaps between the exit to High Crossing Blvd, and the exit to northbound US 151. Aggressive drivers use the left lane of the CD road to try to bypass the queue in the right lane, hoping some of the vehicles will exit to High Crossing Blvd. These drivers will force their way into the right lane causing sharp braking and further delay for vehicles behind.

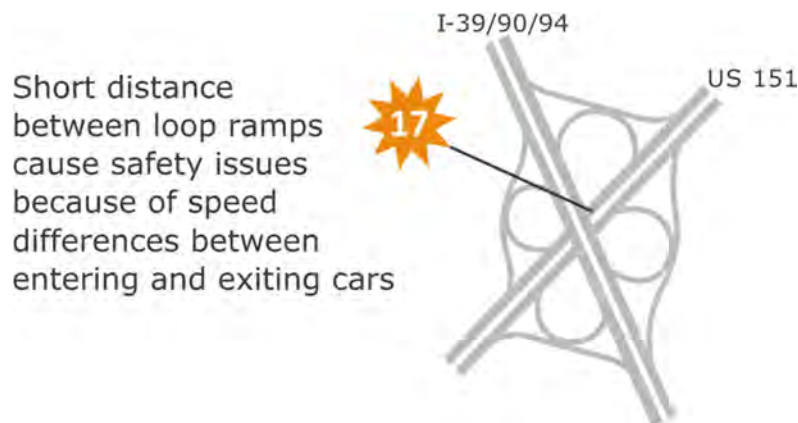
Figure 19. Short Distance Between Loops Ramps US 151

17	I-39/90/94 NB C/D Road at US 151	Short distance between loop ramps causing safety issue because of speed differentials.
18	I-39/90/94 NB between WIS 19 & County V	Flat grades in these areas cause hydroplaning in wet weather and slippery spots. ⁵
19	I-39/90/94 SB between County V & WIS 19	Flat grades in these areas cause hydroplaning in wet weather and slippery spots. ⁷
20	I-90/94 EB between WIS 80 & WIS 83	Platooning vehicles limit gaps for merging vehicles.

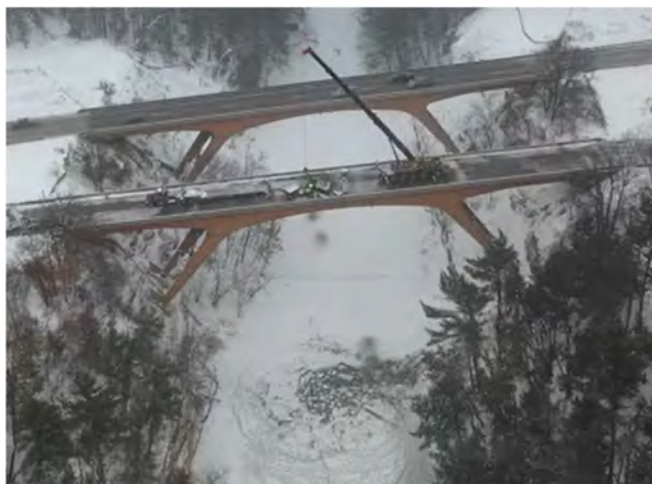
Figure 22. Fatal Crash at the Mirror Lake Bridges

The I-90/94 bridges over Mirror Lake are unique structures that are reaching the end of their useful life. The existing 320 foot long K-frame structures were constructed in 1961 and are fracture critical. The bridges are narrow (32 feet) and experience high summer traffic making traffic control challenging for maintenance activities. In addition, the over 100 foot drop from the bridge to the water has been a crash severity issue. In the past 10 years, three vehicles have dropped into the lake below resulting in three fatalities in two fatal crashes.

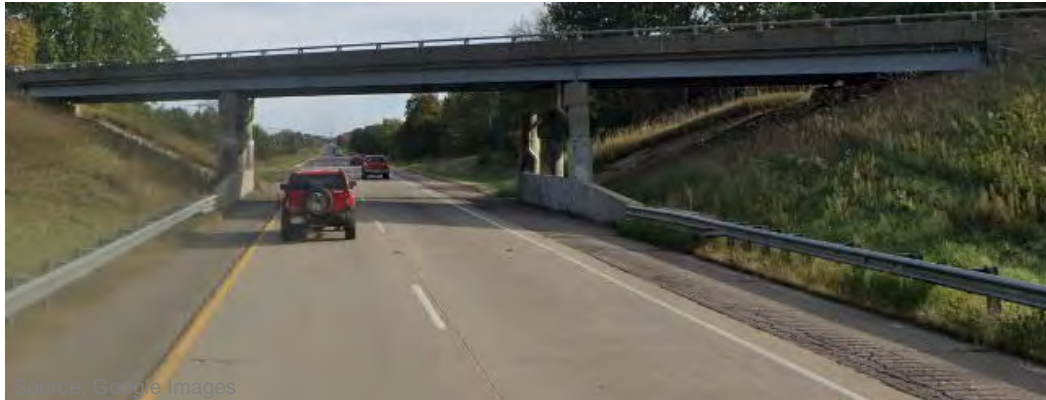
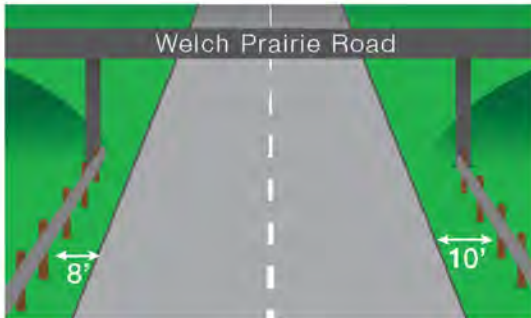
Figure 23. Welch Prairie Road Bridge over EB I-90/94

I-90 EB is constricted by the guardrail and bridge piers at the Welch Prairie Road. Multiple instances of vehicles leaving road to the left of the guardrail and hitting the bridge including two fatal crashes

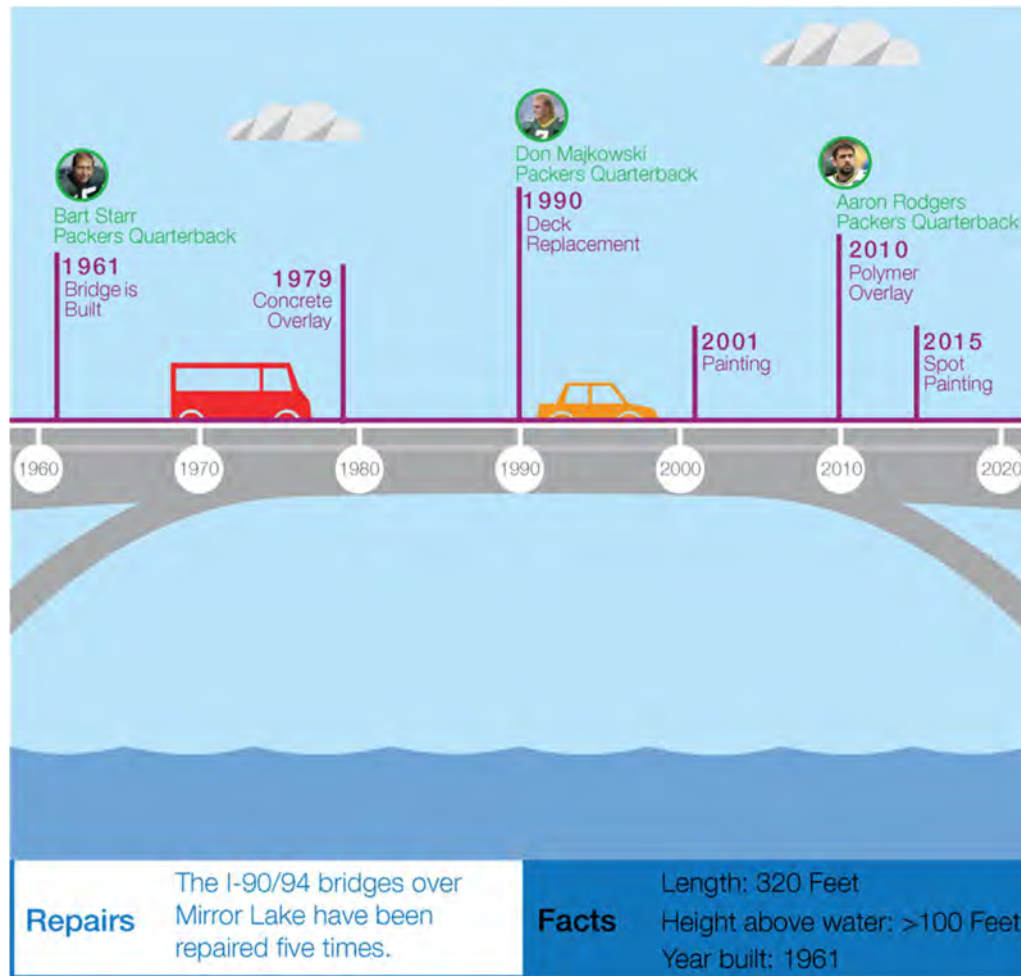
Figure 36. Mirror Lake Summary

The Mirror Lake bridges have been repaired five times over their lifespan consistently needing maintenance before the scheduled time and will need continuing maintenance to extend their life. In the ideal bridge life, a new bridge deck will last 45 years until a new bridge is needed. The Mirror Lake bridge deck was replaced in 1990. Using the ideal maintenance schedule, the existing bridge deck is expected to last until approximately 2035. Regular inspections of the structure will refine the expected lifespans as it reaches the end of its useful life. Because of the narrow width and high recreational traffic volumes in the summer, a project to replace the Mirror Lake bridge deck would likely require a temporary structure to maintain traffic. It may be more cost effective to replace the structure rather than the continued maintenance projects. The comparison between the expected maintenance cycle and the actual maintenance cycle for the Mirror Lake Bridges can be seen in Figure 37.

Because of the complexity of the traffic management needed for the Mirror Lake bridges maintenance and the timing of the next recommend project as overlapping with many other projects, these bridges will likely control the section in terms of timing of improvements for adjacent needs.
