Inspection Photo Best Practice Guidelines

March 2022

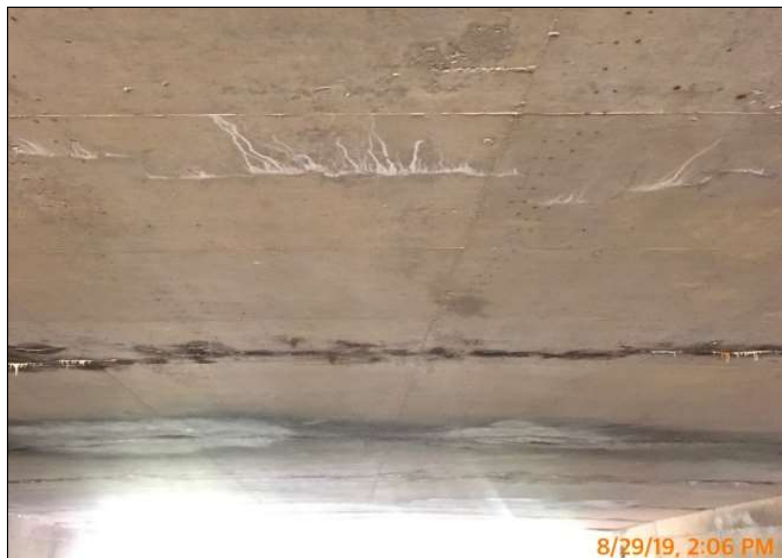
Figure 1.1.1.4-1: Example of exposure adjustment to capture details under structure, resulting in overexposed area at bottom of photo. Better framing to avoid outside area or changing direction photo is taken would improve photo.

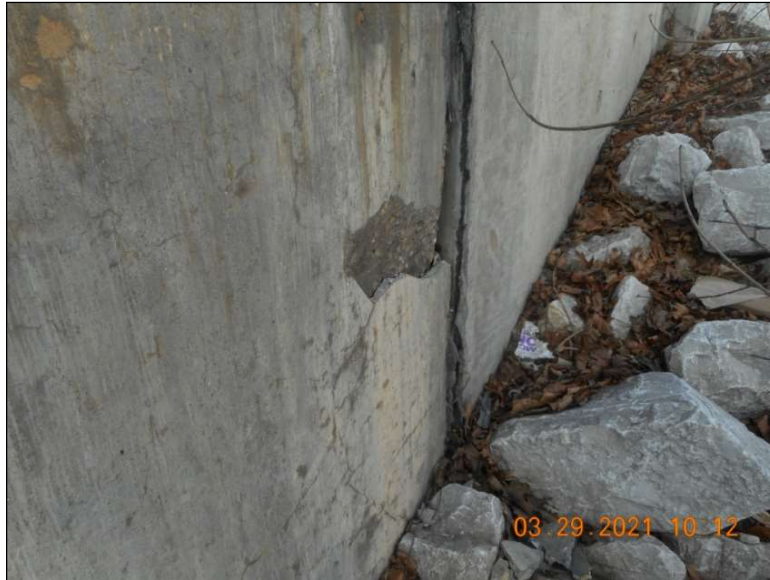
Figure 1.1.1.5-3: Good scale on photo: Leaves, riprap, trash present for scale, taken at angle that shows size of spall and offset of joint

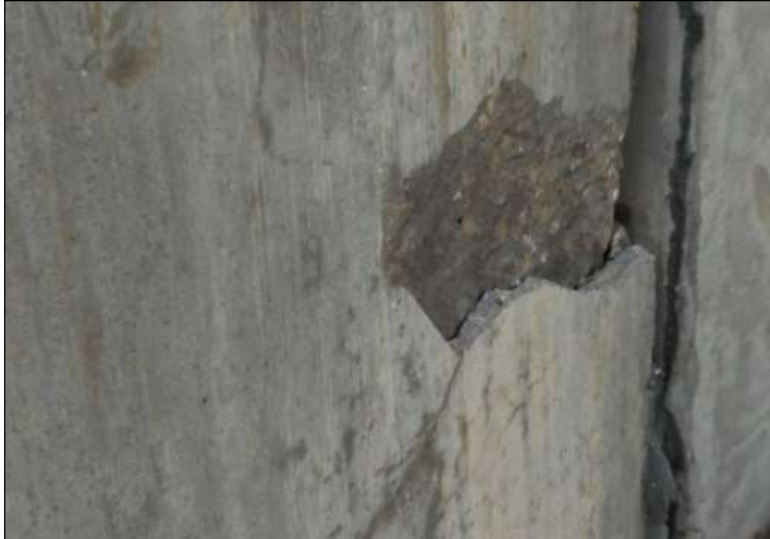
Figure 1.1.1.5-4: Same defect zoomed in too close – no sense of scale

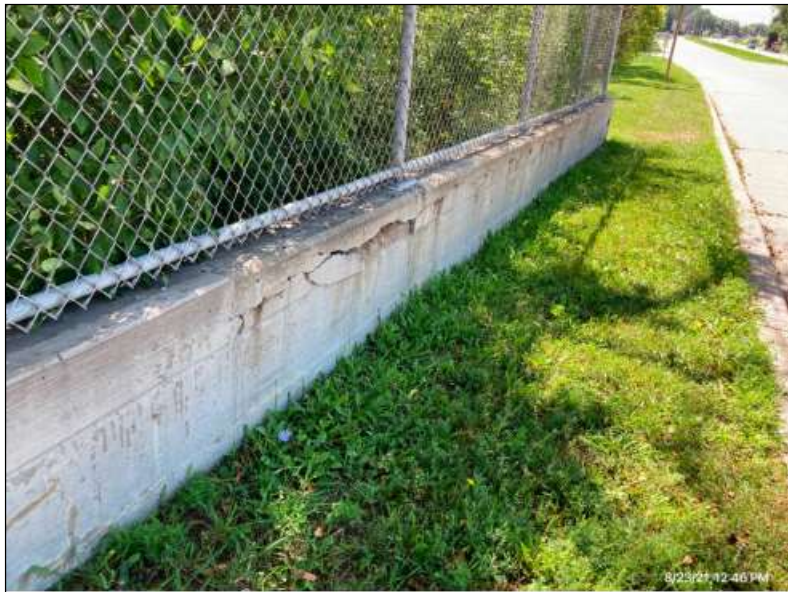
Figure 1.1.1.5-5: Extreme angle photo does not allow for viewing of detail, right quarter of photo is wasted on not the subject wall

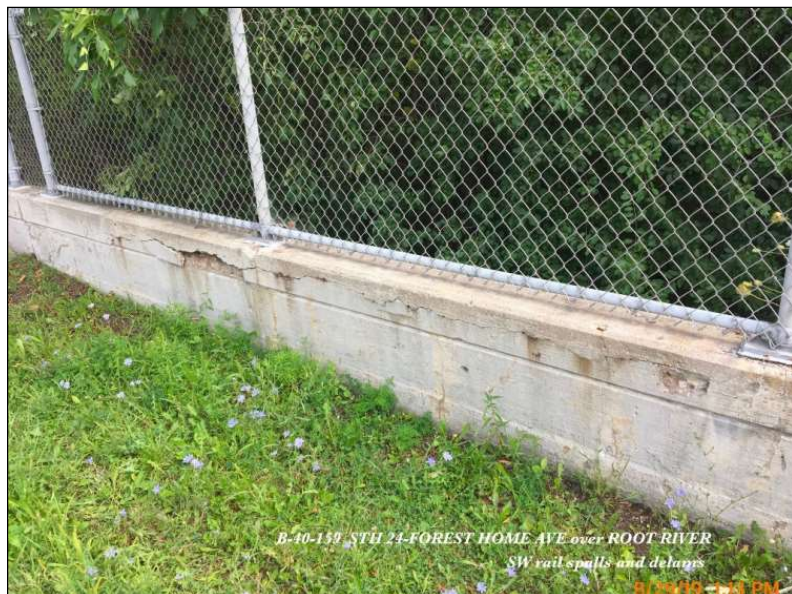
Figure 1.1.1.5-6: Same wall from medium angle clearly shows extent of defect

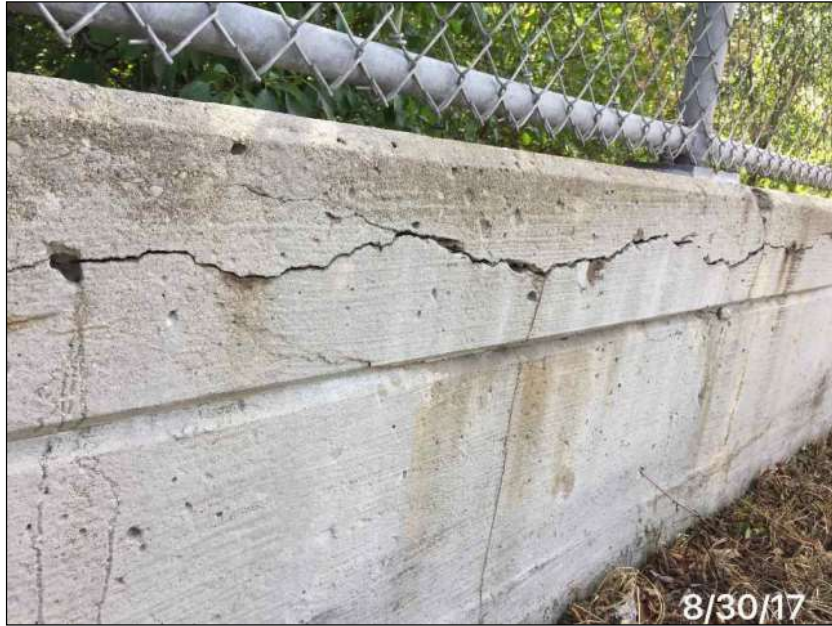
Figure 1.1.1.5-7: Too close and angled doesn't show extent of defect. Useful if included and labeled with one of the above photos

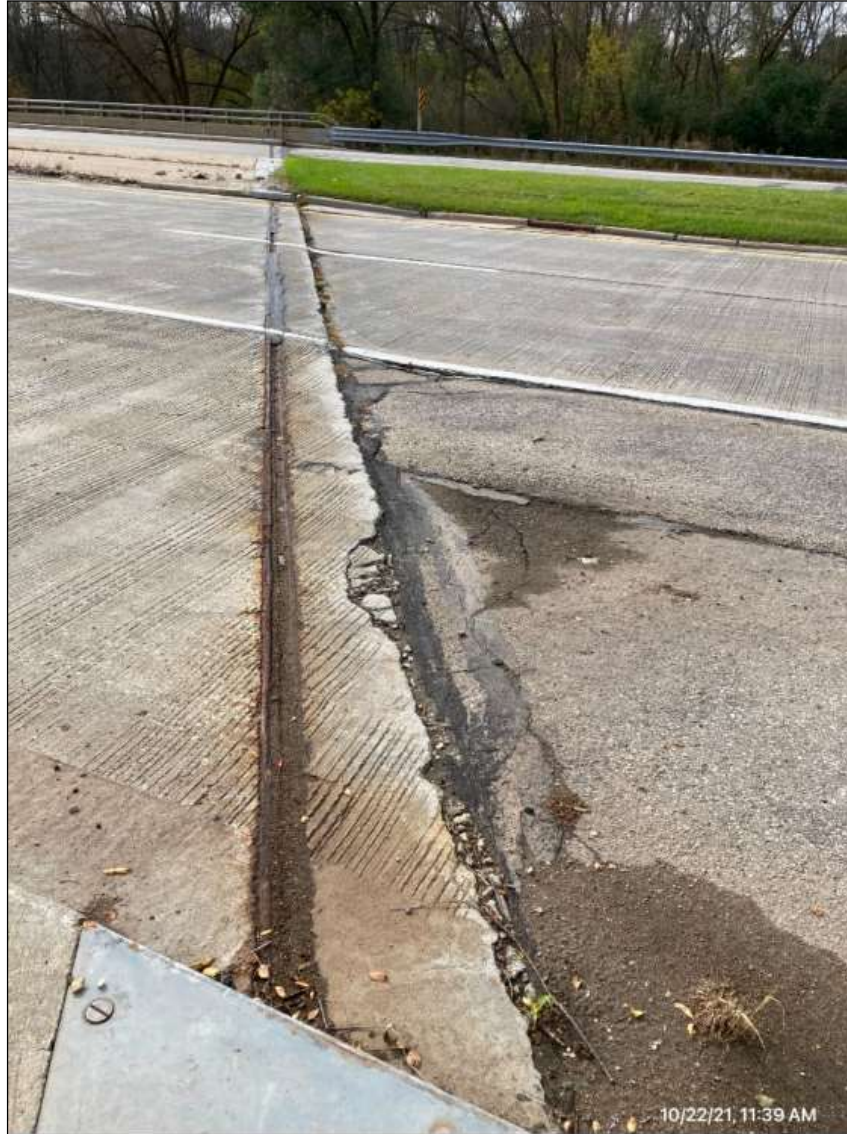
Figure 1.1.1.6-1: Good maintenance photo showing damage, location, and extent of header damage in shoulder. Provide notes to support photo. For repair of asphalt paving, additional photos of extents would be useful.

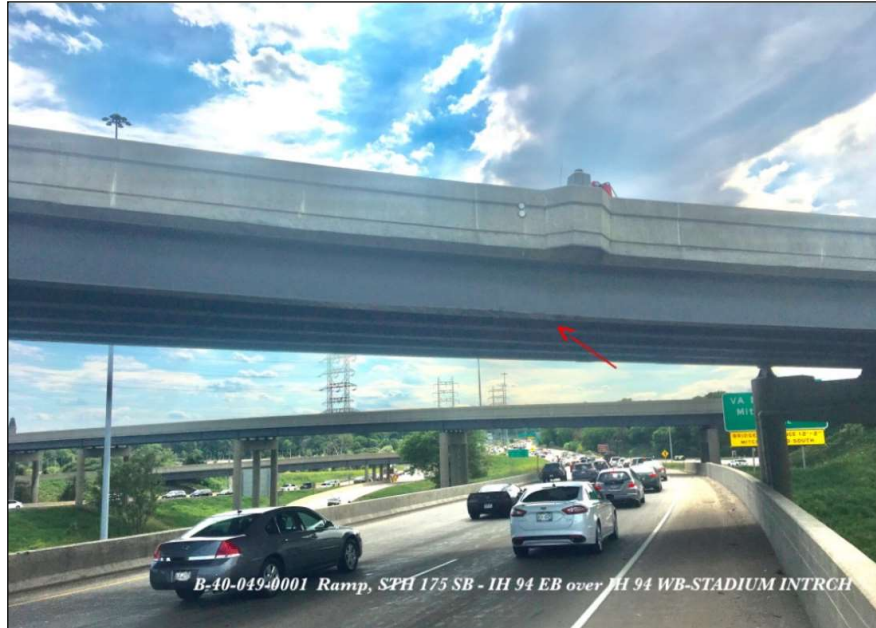
Figure 1.1.1.6-2: Photo showing location of damage in context of roadway. From this, right lane and shoulder closure would be required to repair the area with the arrow. Additional closer photos also would be required. Ideally this would be taken at an angle that clearly shows position relative to lane, but traffic did not allow.
