Table of Contents

4.4 Retaining Walls 3

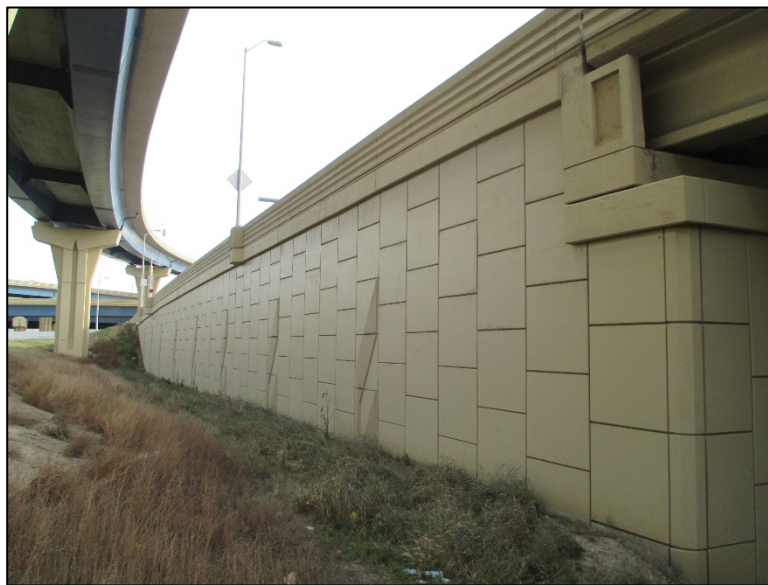
Figure 4.4.1-1: MSE "Fill" Wall

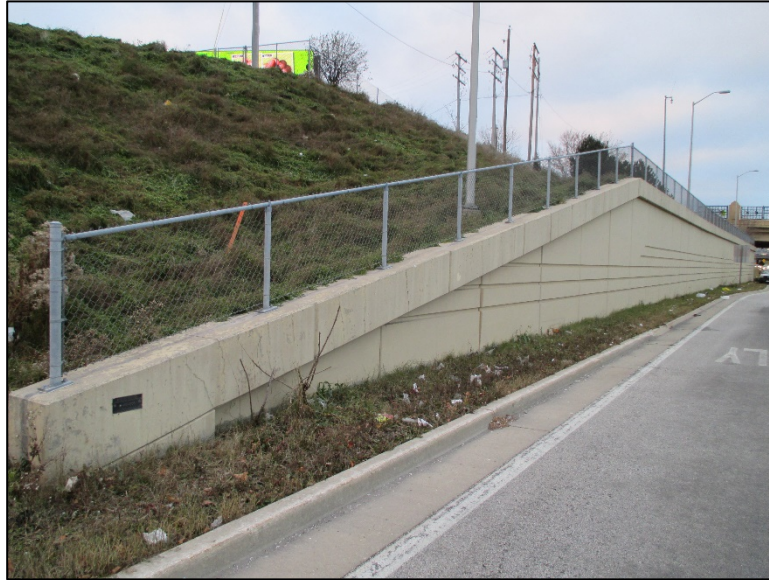
Figure 4.4.1-2: CIP “Cut” Wall

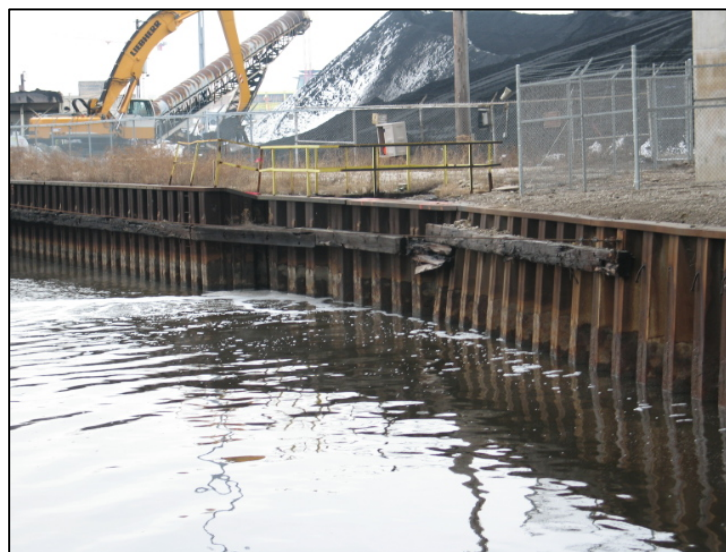
Figure 4.4.1-3: Steel Sheetpile Dockwall

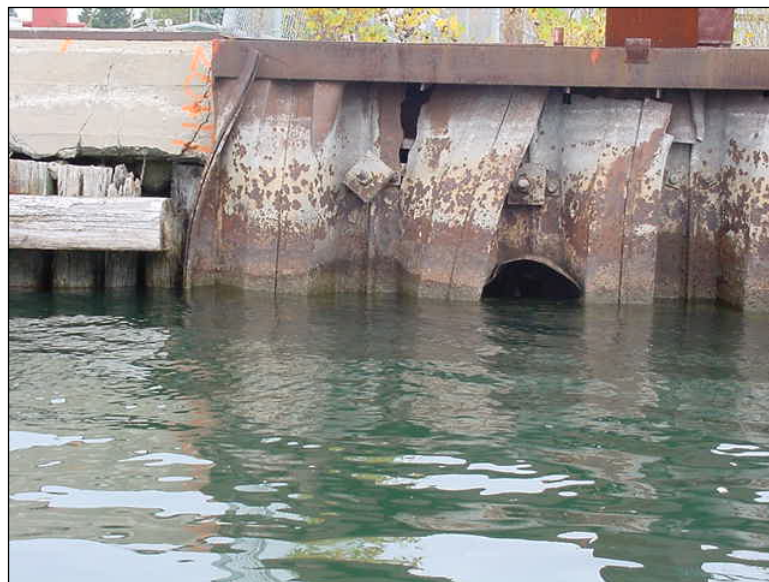
Figure 4.4.2-1: Impact Damage to a Steel Sheet Pile Dockwall.

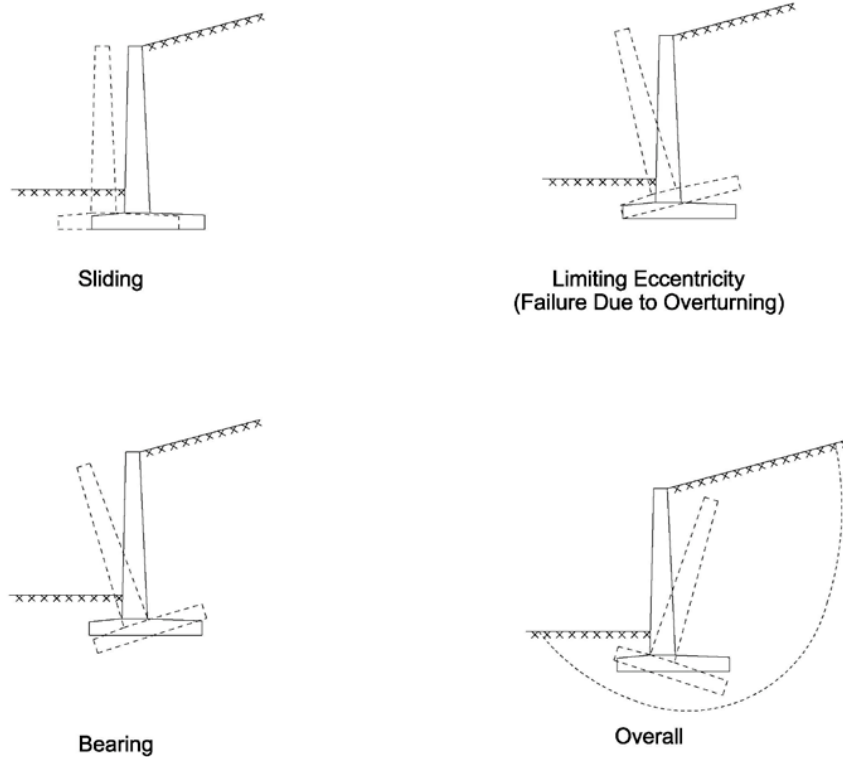
Figure 4.4.2-2: External Stability Failure of a CIP Semi-Gravity Wall

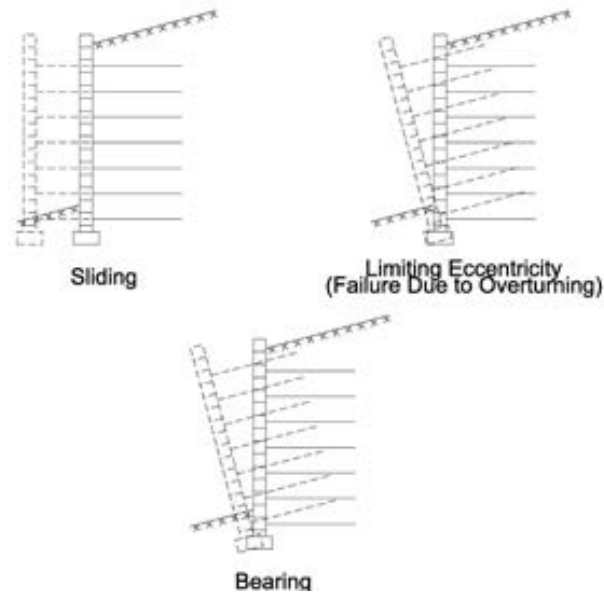
Figure 4.4.2-3: External Stability Failure of MSE Walls

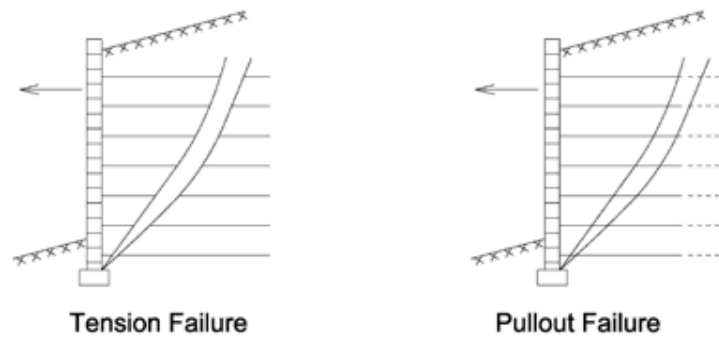
Figure 4.4.2-4: Internal Stability Failure of MSE Walls

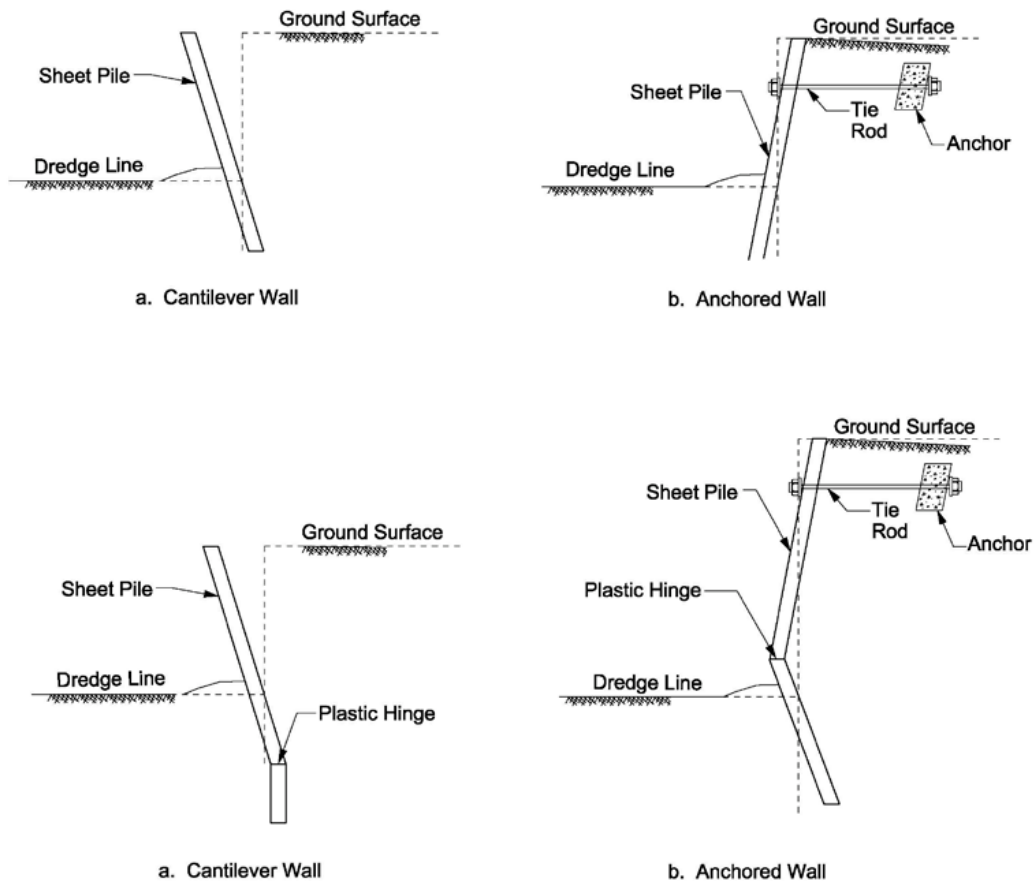
Figure 4.4.2-5: Flexural Failure of Non-Gravity Walls

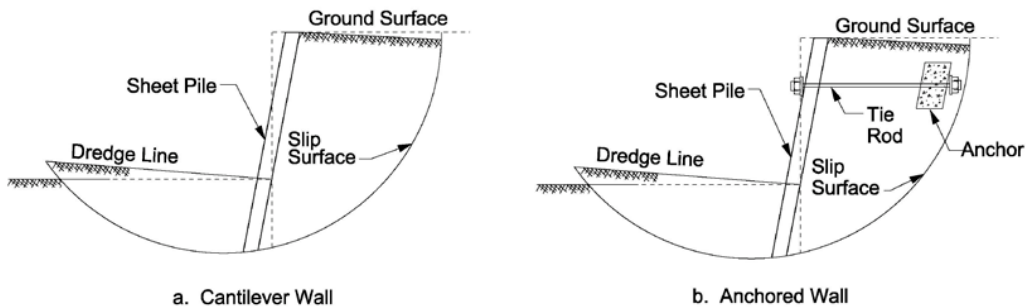
Figure 4.4.2-6: Deep Seated Failure of Non-Gravity Walls

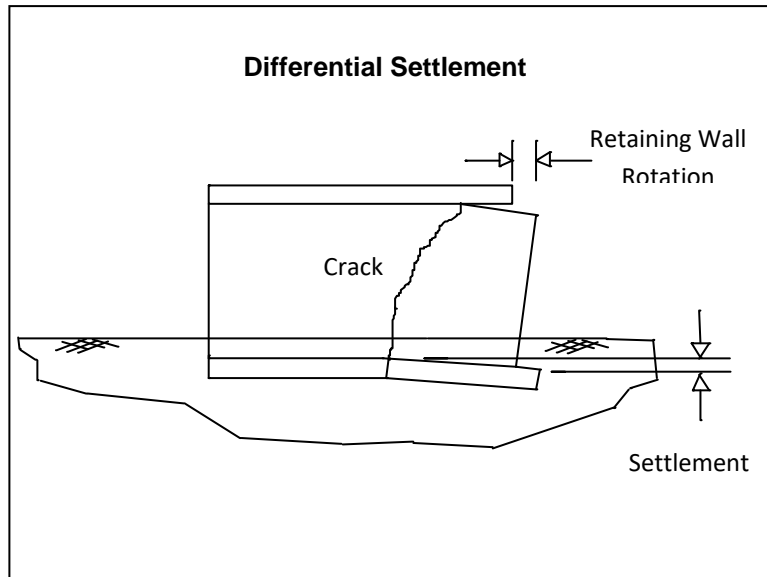
Figure 4.4.2-7: Differential Settlement Under a Retaining Wall.

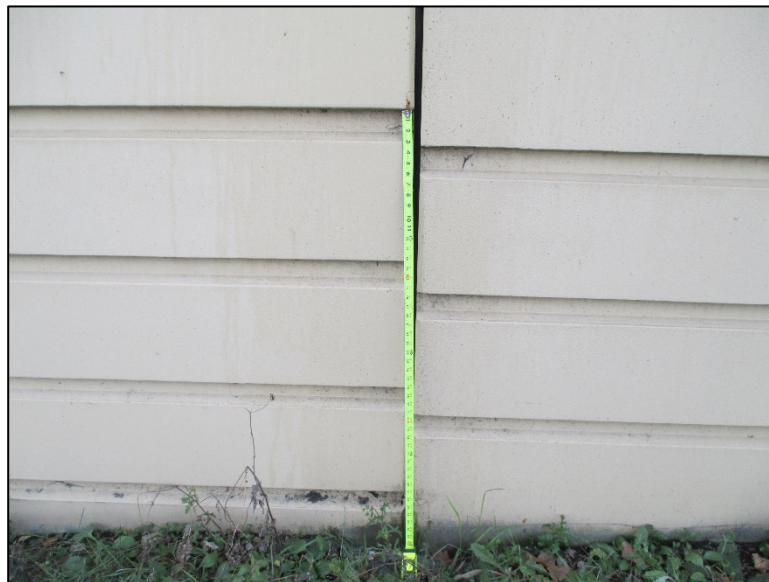
Figure 4.4.2-8: View of Differential Settlement between Precast Concrete Panels. Note Misalignment in Rustication.

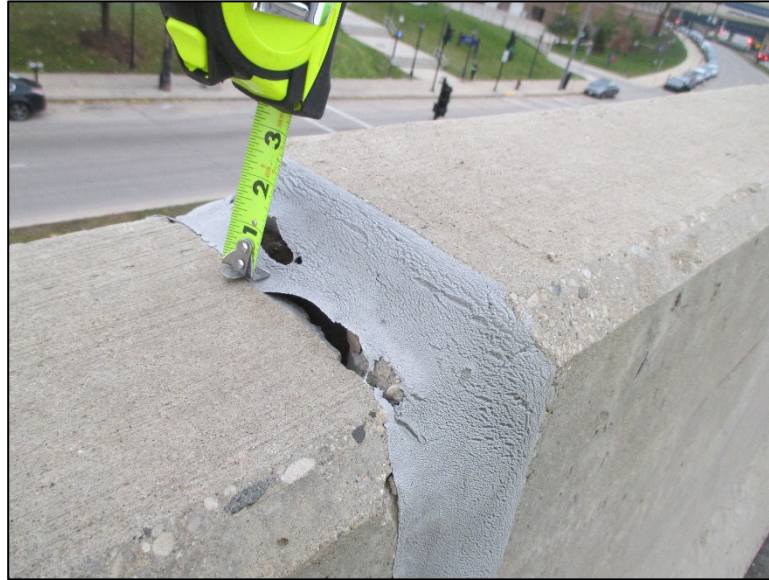
Figure 4.4.2-9: Settlement as Seen from Bridge Rail at Top of Wall.
Note, Settlement was Reflected in Adjacent HMA Pavement.

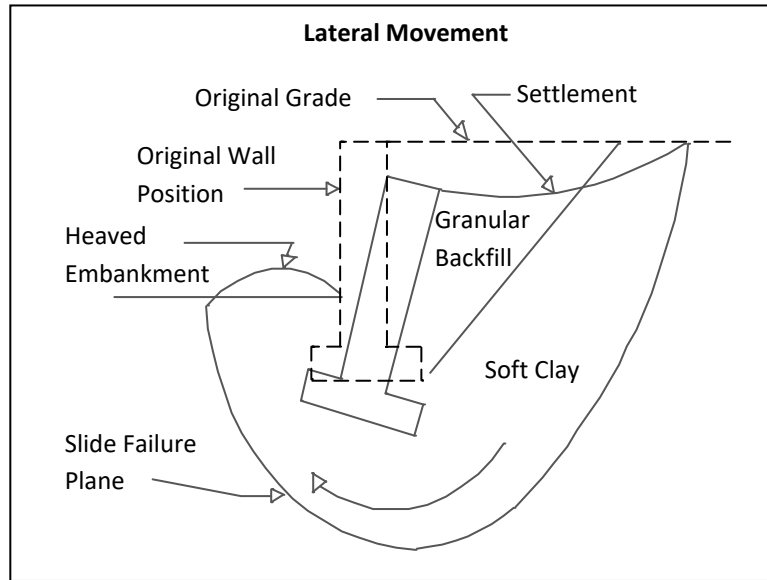
Figure 4.4.2-10: Lateral Movement and Rotation of a Retaining Wall Due to Slope Failure.

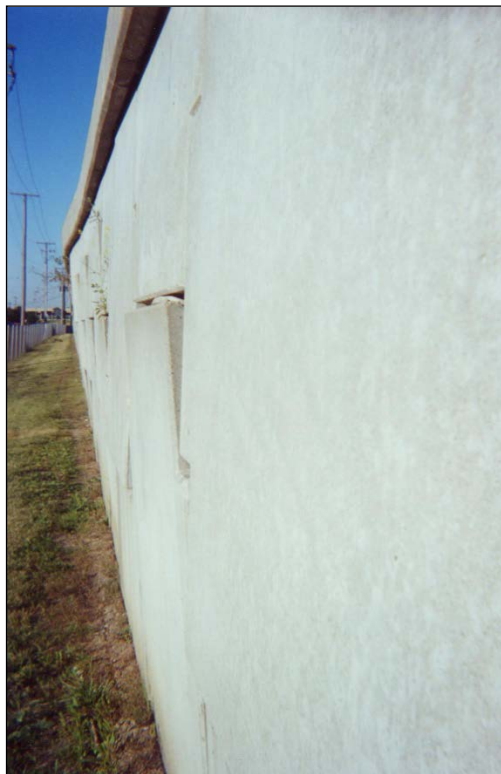
Figure 4.4.2-11: Lateral Movement of an Individual Panel of a MSE Wall.

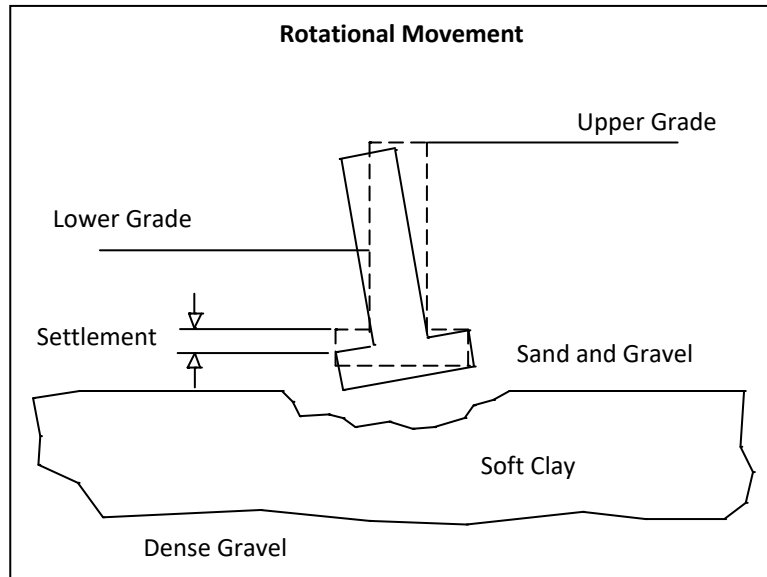
Figure 4.4.2-12: Rotational Movement of a Retaining Wall.

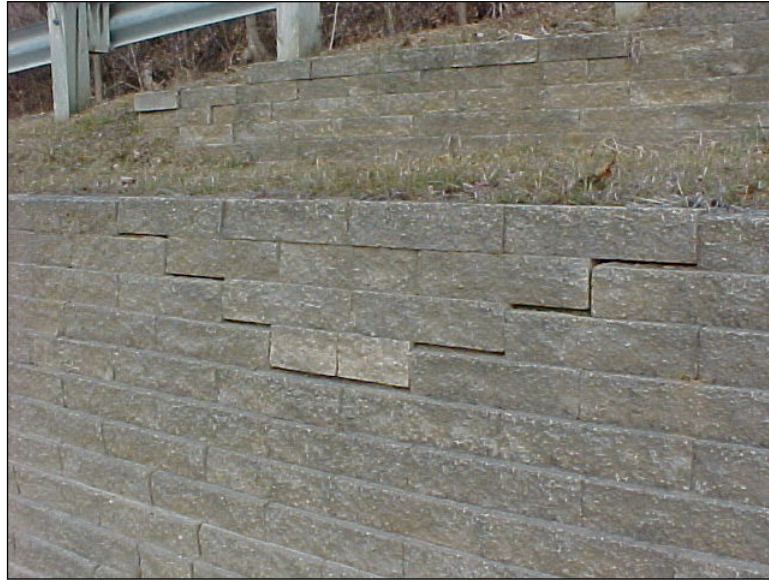
Figure 4.4.2-13: Poor Construction Methods Resulting in Block Separation.

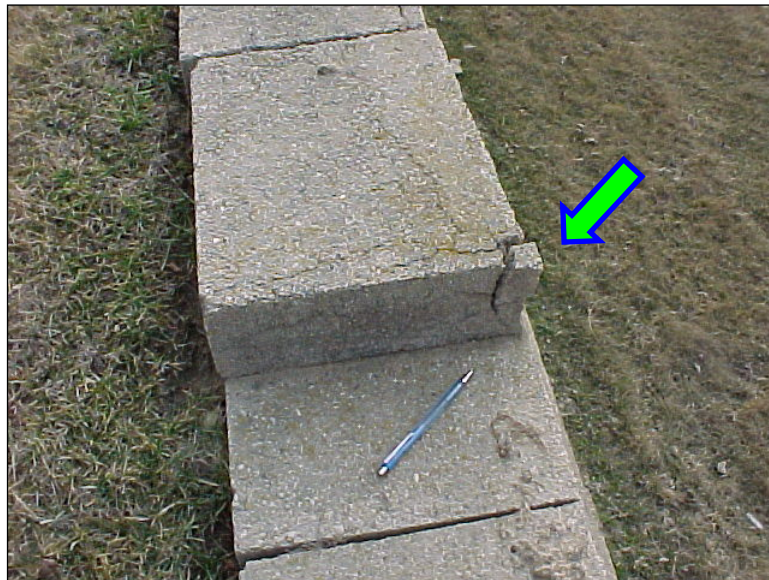
Figure 4.4.2-14: Corner Break with Cracking on the Top Face.

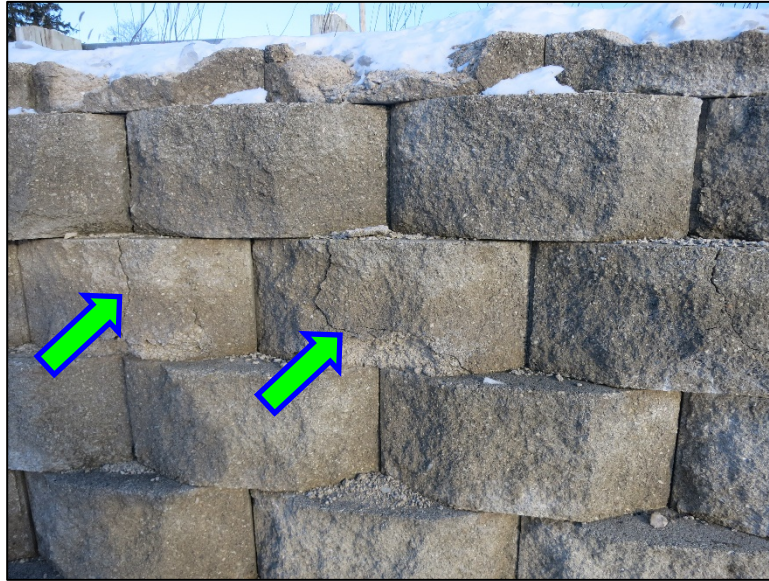
Figure 4.4.2-15: Vertical Cracking through the Front Face of a Block Unit.

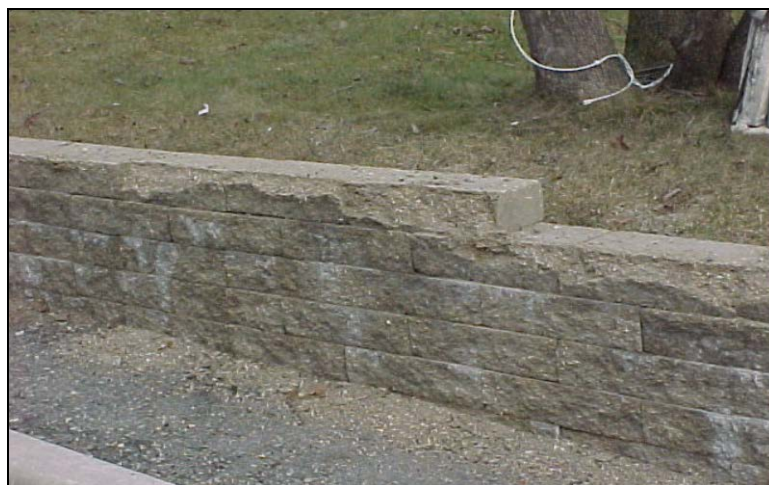
Figure 4.4.2-16: White Precipitate Formed due to Efflorescence.

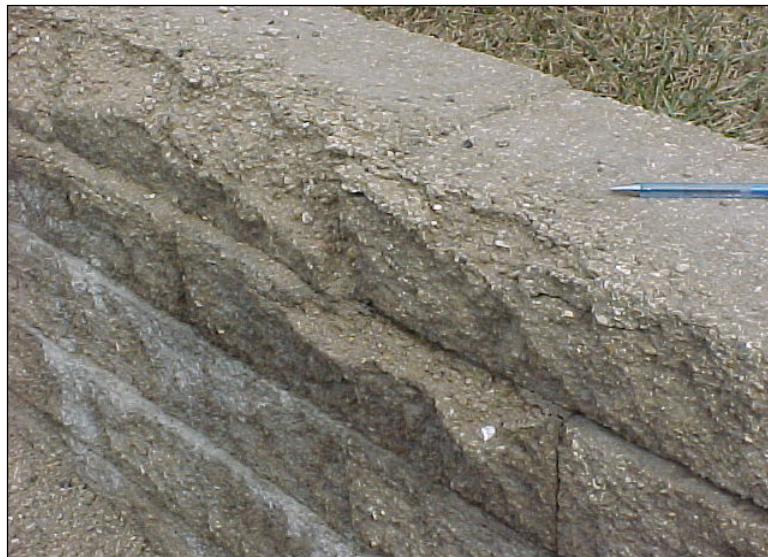
Figure 4.4.2-17: Spalling and Fraying on the Top Edge of the Block.

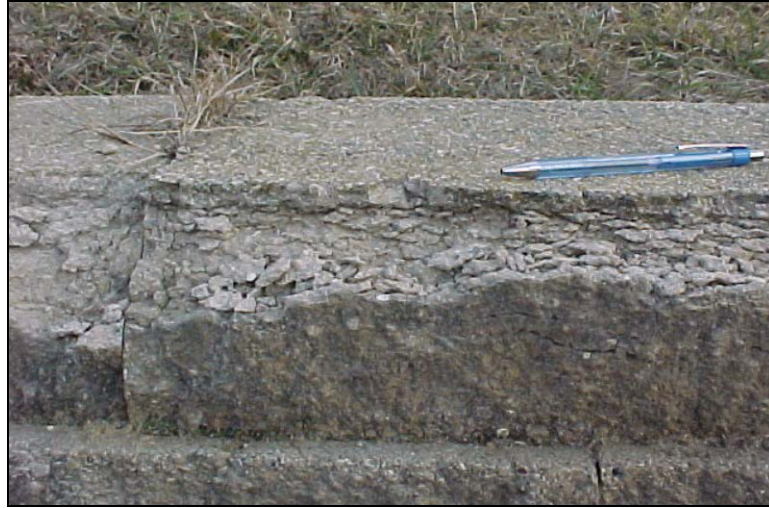
Figure 4.4.2-18: Freeze-Thaw Damage at a Corner.

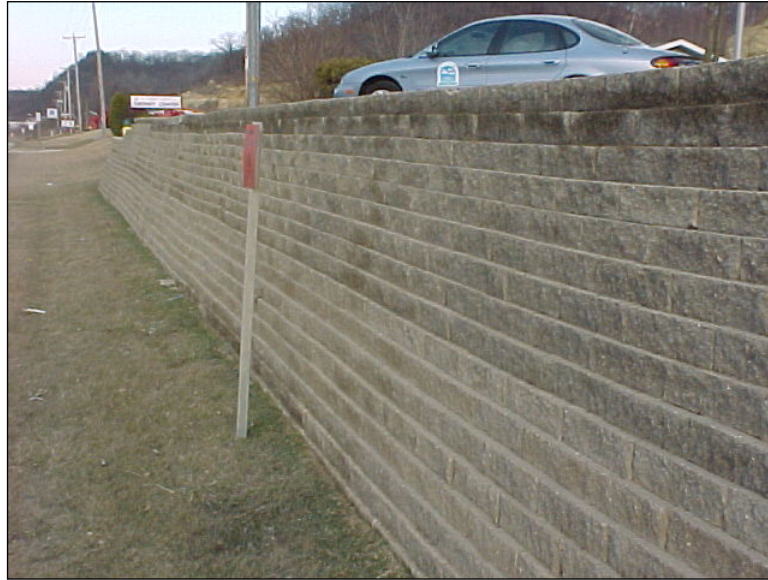
Figure 4.4.2-19: Typical Staining Evidenced by the Brown Discoloration of the Blocks.

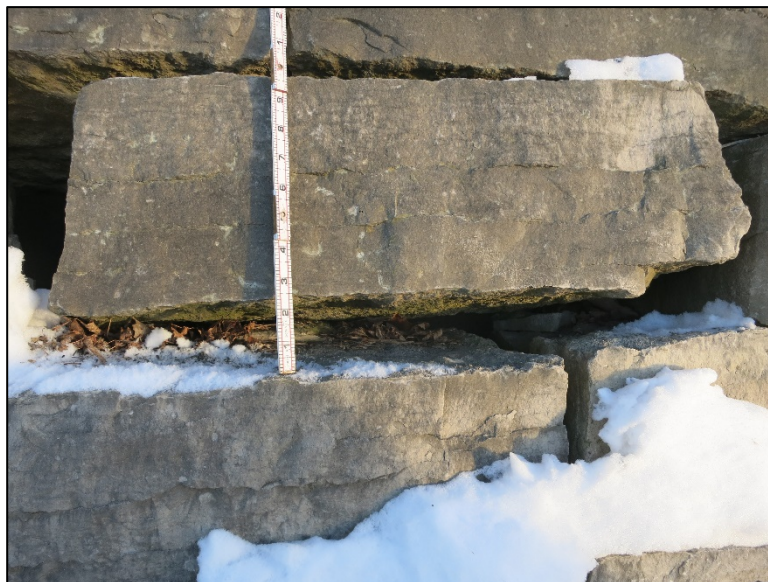
Figure 4.4.2-20: Excessive Gap Forming At Base of Stone Block.

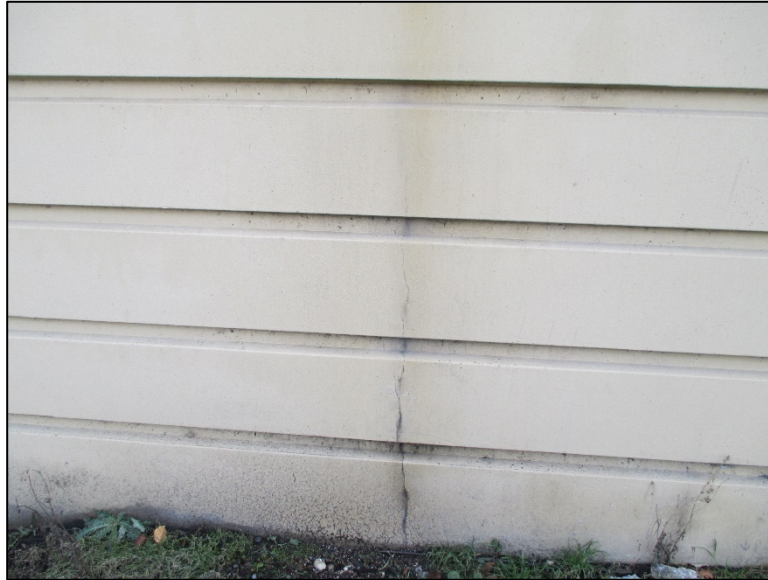
Figure 4.4.2-21: Vertical Crack Through Precast Concrete Panel.

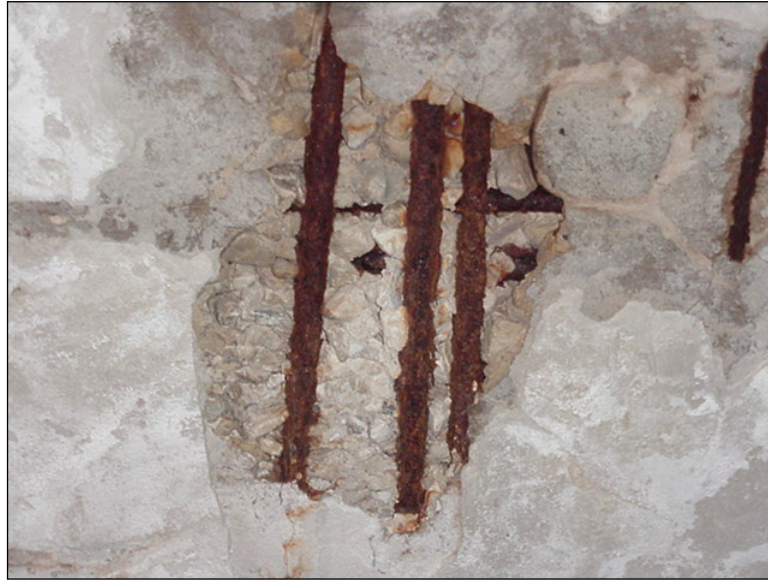
Figure 4.4.2-22: Concrete Spalling with Exposed Reinforcing Steel.

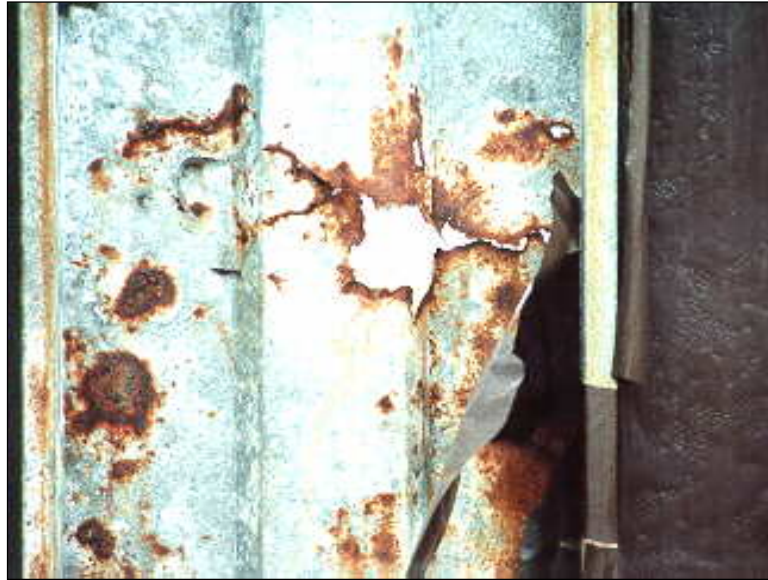
Figure 4.4.2-23: Severely Corroded Steel Sheeting Cantilever Wall.

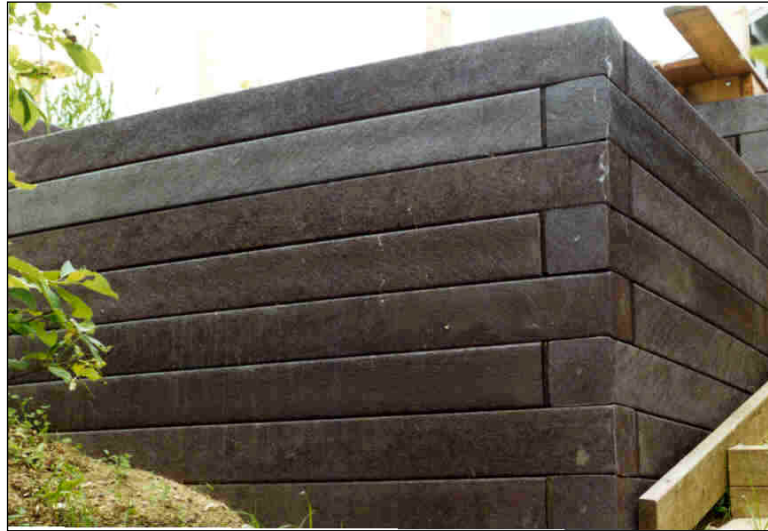
Figure 4.4.2-24: Plastic Lumber Retaining Wall.

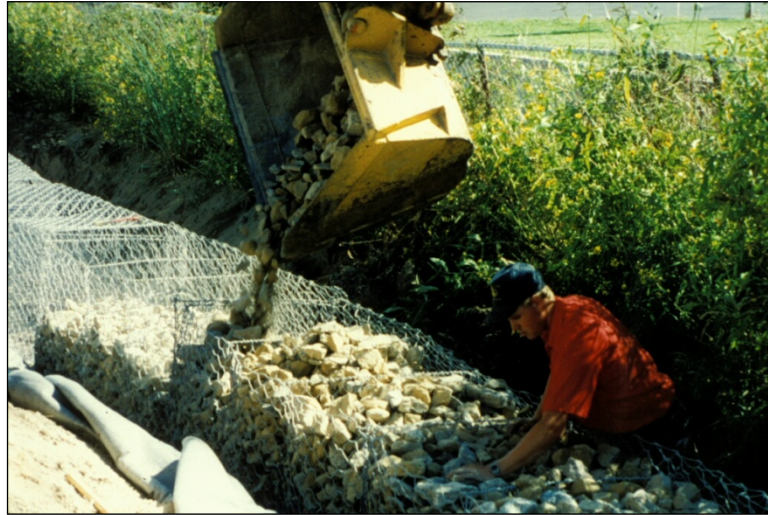
Figure 4.4.4-3: Gabion Gravity Crib Wall Under Construction.

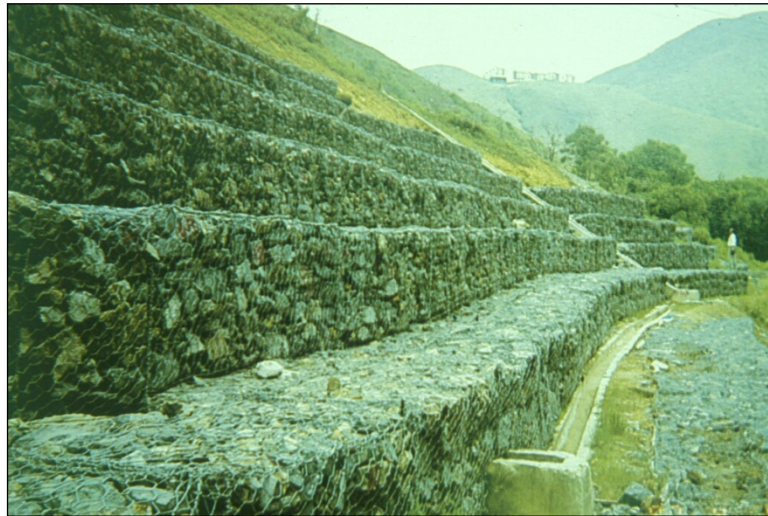
Figure 4.4.4-4: Tiered Gabion Gravity Crib Wall.

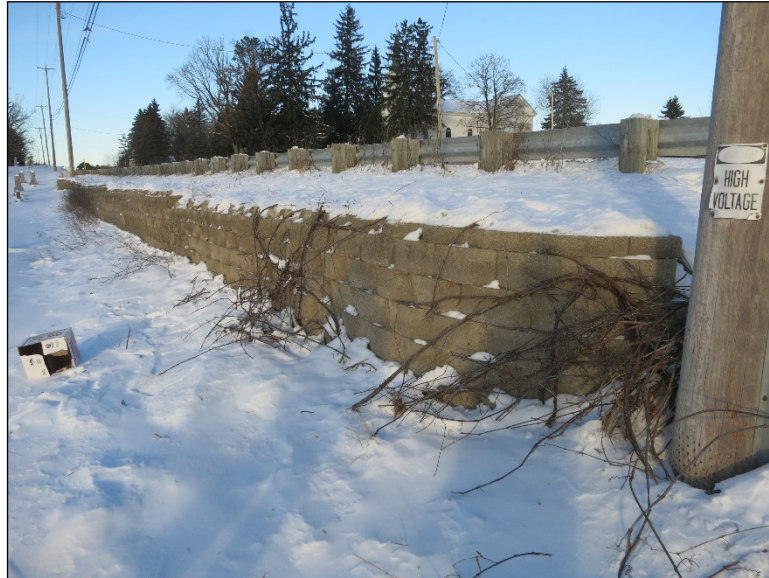
Figure 4.4.4-5: Segmented Modular Block Gravity Wall.

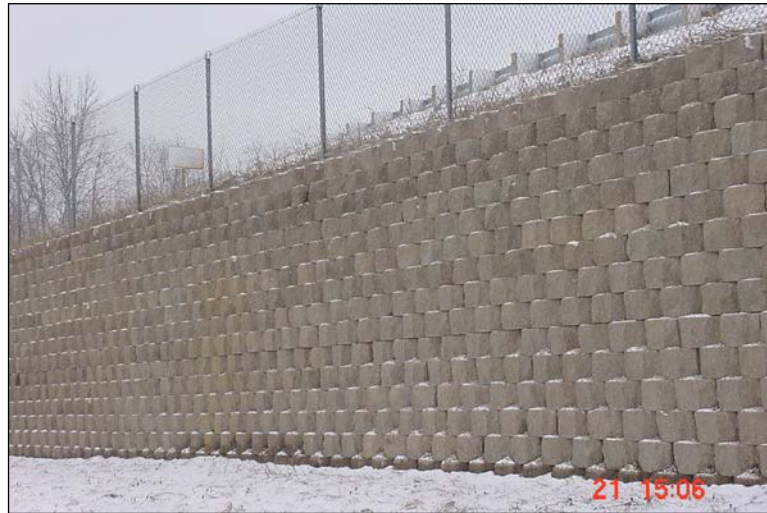
Figure 4.4.4-7: Segmented Modular Block MSE Wall.

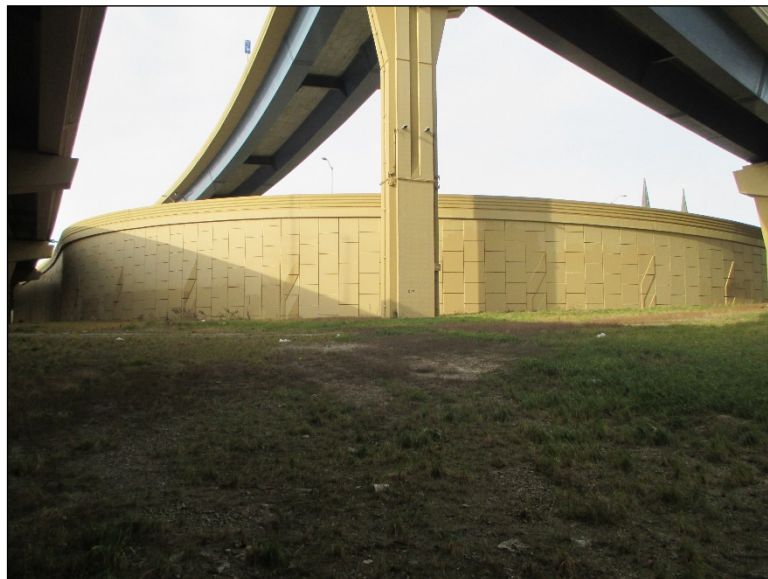
Figure 4.4.4-8: MSE Precast Concrete Panel Facing Wall.

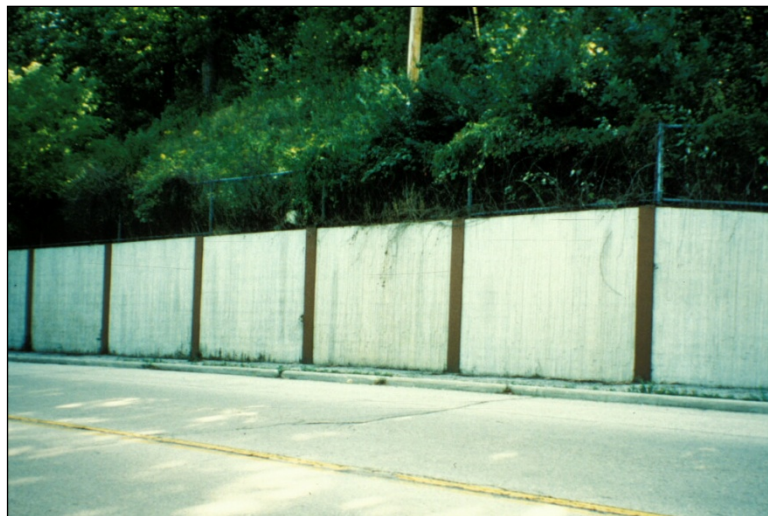
Figure 4.4.4-9: Post and Panel Cantilever Wall with Precast Panels and Steel "H" Piles.

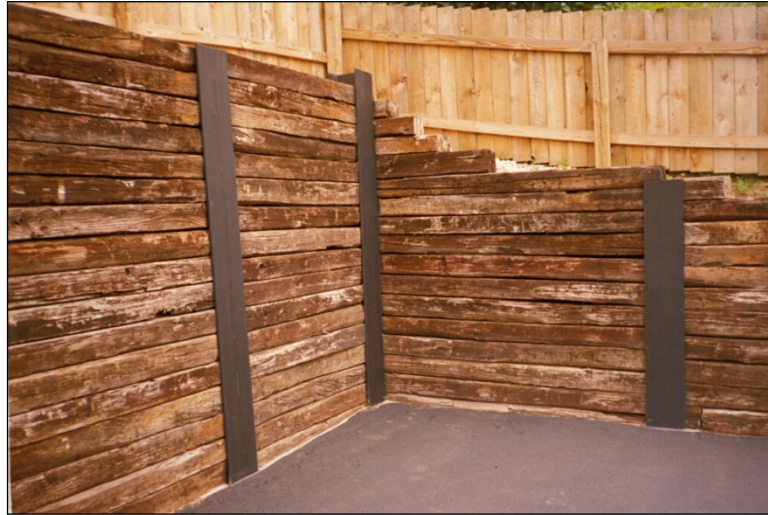
Figure 4.4.4-10: Post and Panel Cantilever Wall with Timber Planks and Steel "H" Piles.

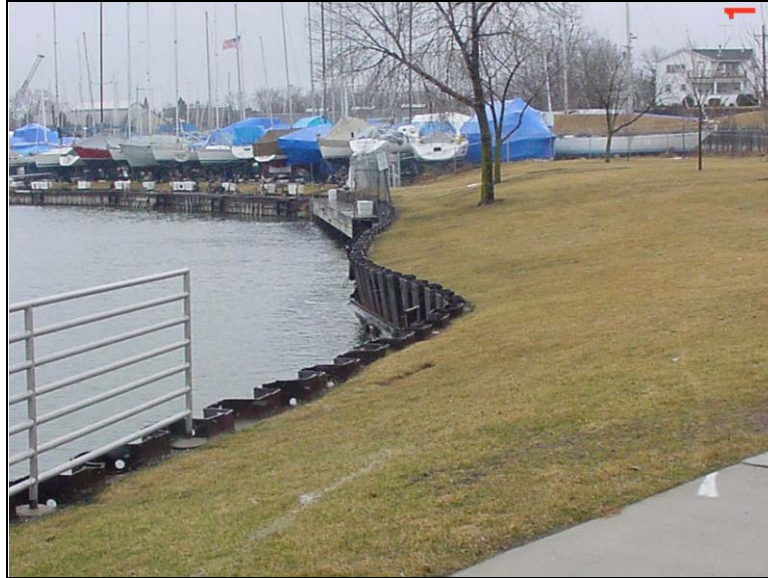
Figure 4.4.4-11: Tilted and Deformed Sheet pile Dockwall.

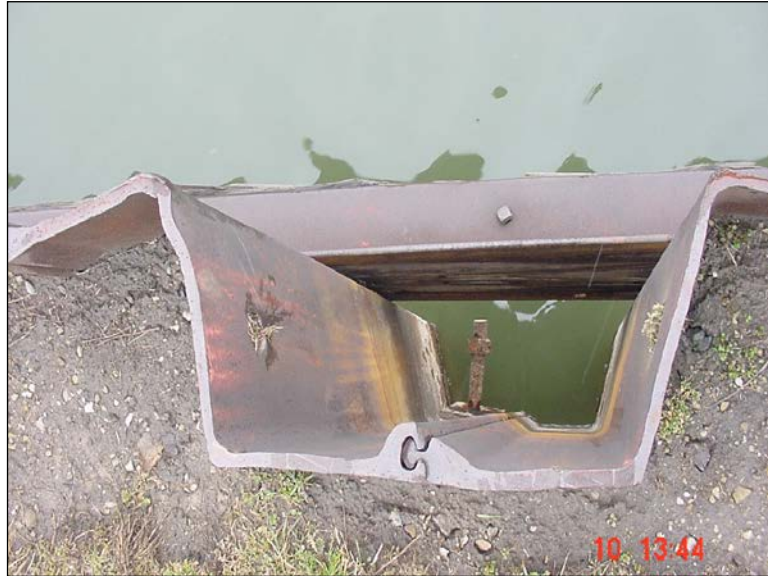
Figure 4.4.4-12: Failed Tie-rod Along a Sheet Pile Dockwall.

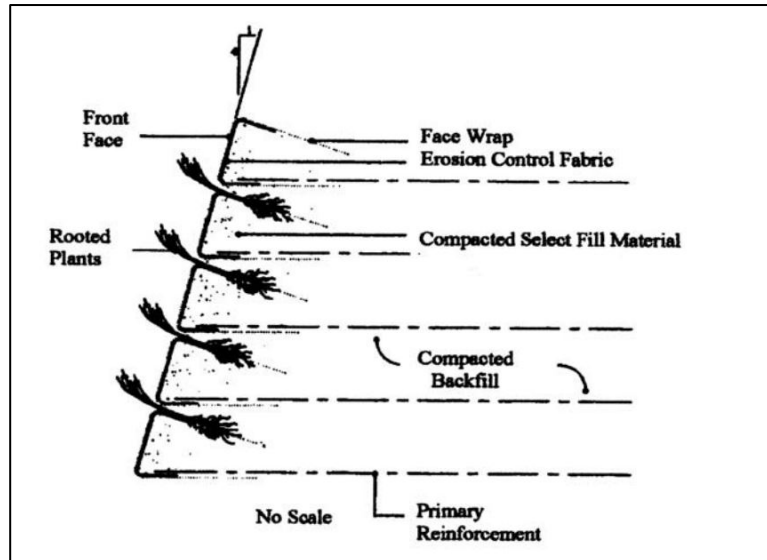
Figure 4.4.4-13: Schematic of a Reinforced Soil Slope with Vegetation Facing.

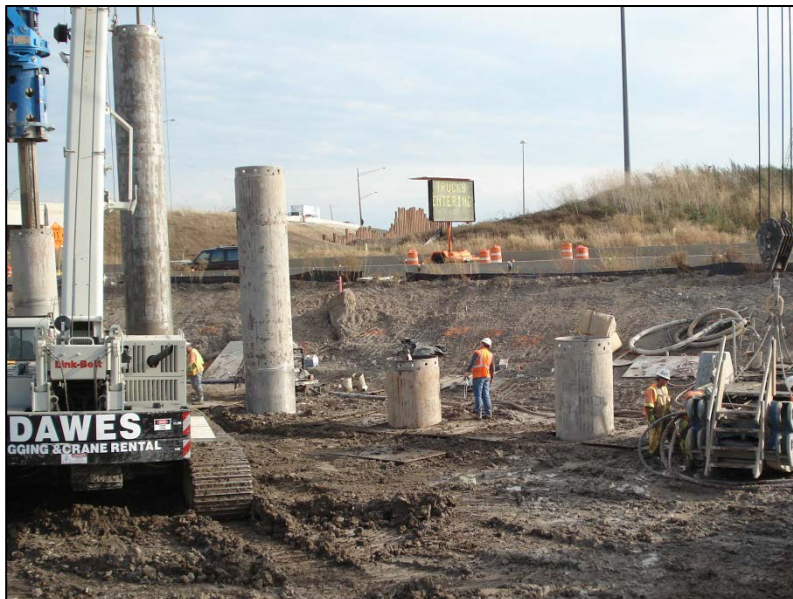
Figure 4.4.4-14: Secant Wall Construction.

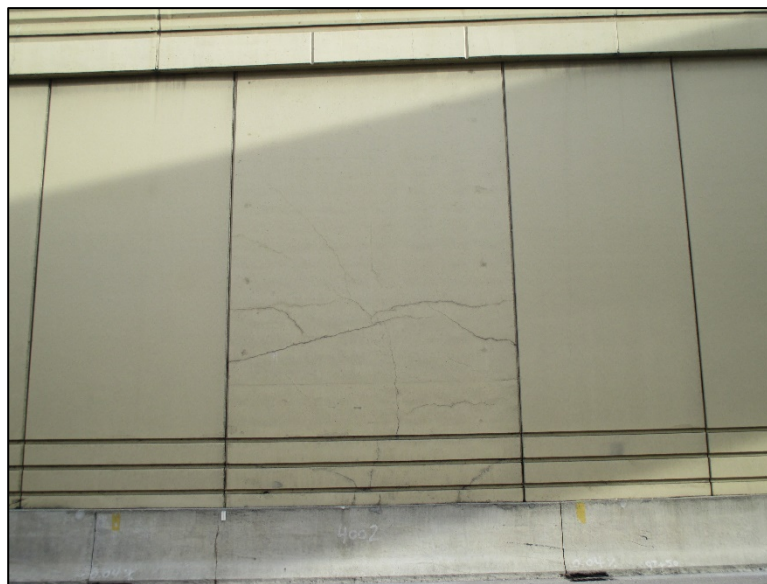
Figure 4.4.4-16: Excessive Cracking within Secant Wall Facade Concrete Panel.

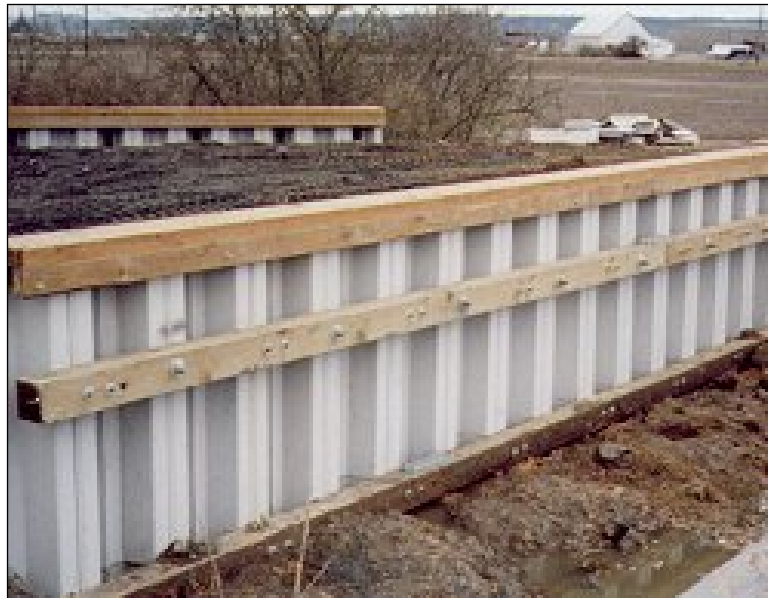
Figure 4.4.4-17: Vinyl Sheet Piling Retaining Wall.

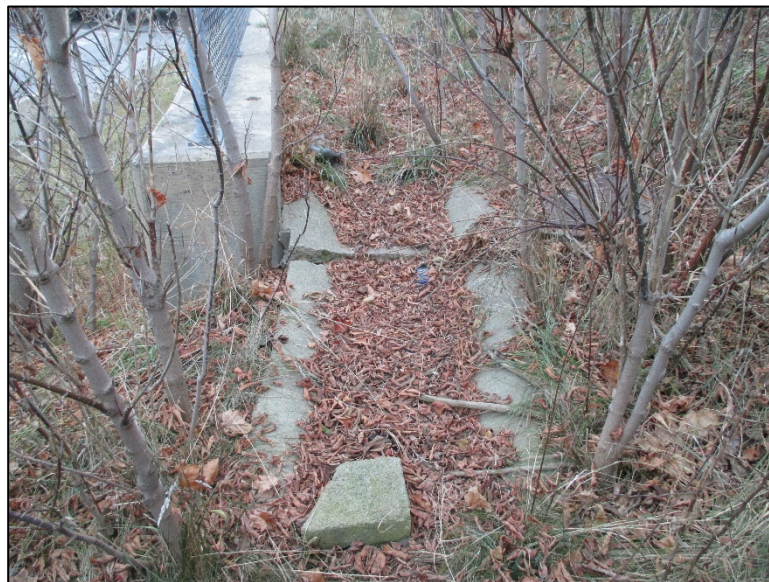
Figure 4.4.5-1: Concrete Flume at End of Wall. Condition State 2 (Fair) – No Erosion Evident, with wide crack.

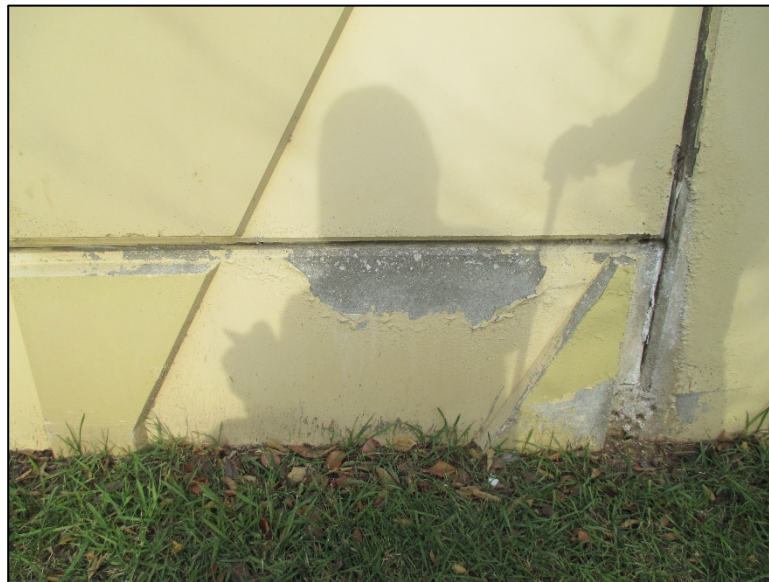
Figure 4.4.5-2: Failed Concrete Stain.

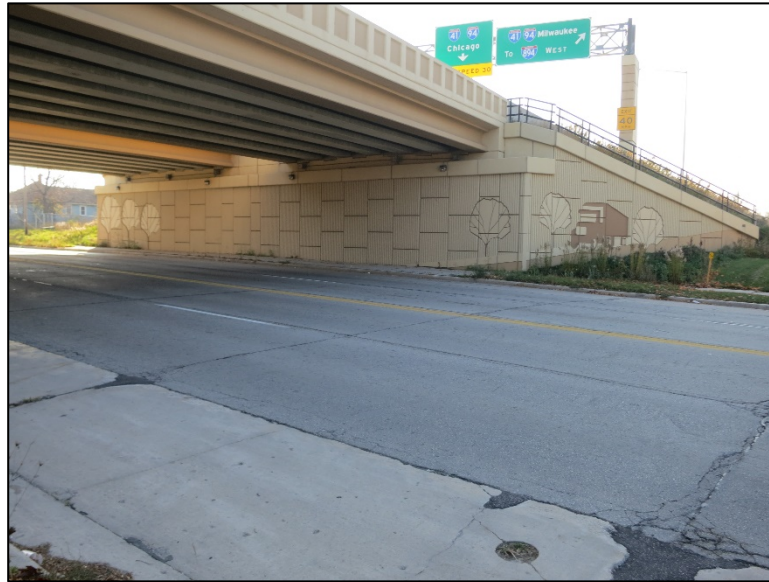
Figure 4.4.5-3: Aesthetic Treatment Form-Lined Precast Concrete Panels.

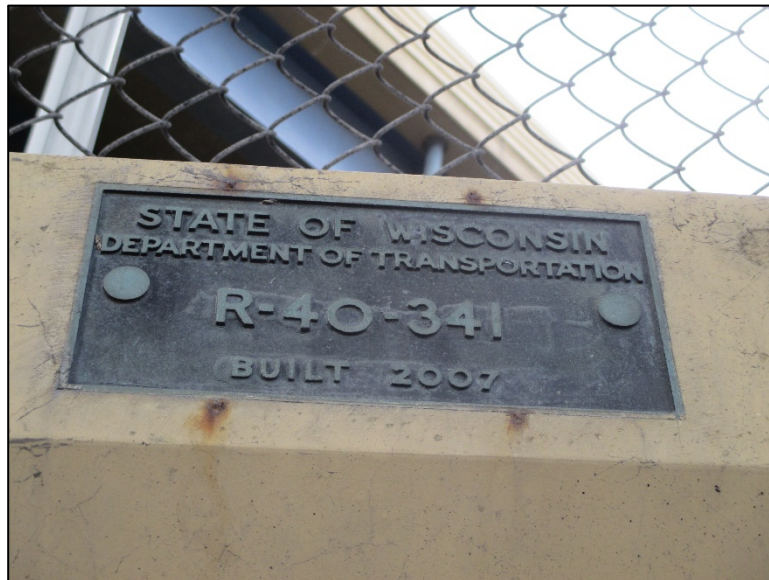
Figure 4.4.5-4: Retaining Wall Name ID Plaque.

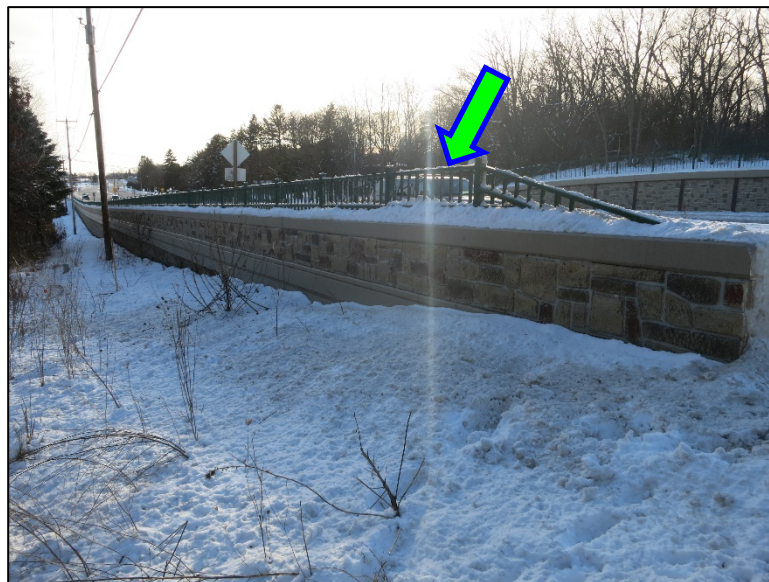
Figure 4.4.5-6: Decorative Rail atop a Bridge Rail Element.

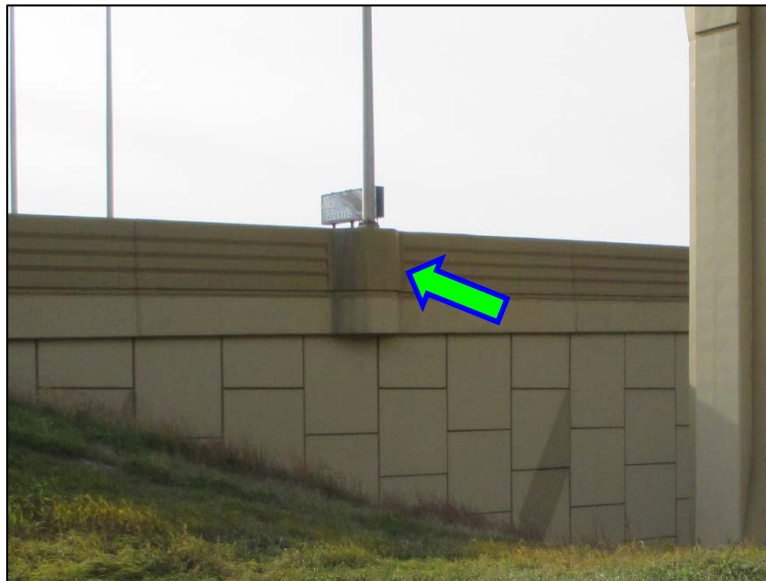
Figure 4.4.5-7: Luminaire Base Placed in Coping and Barrier Wall.

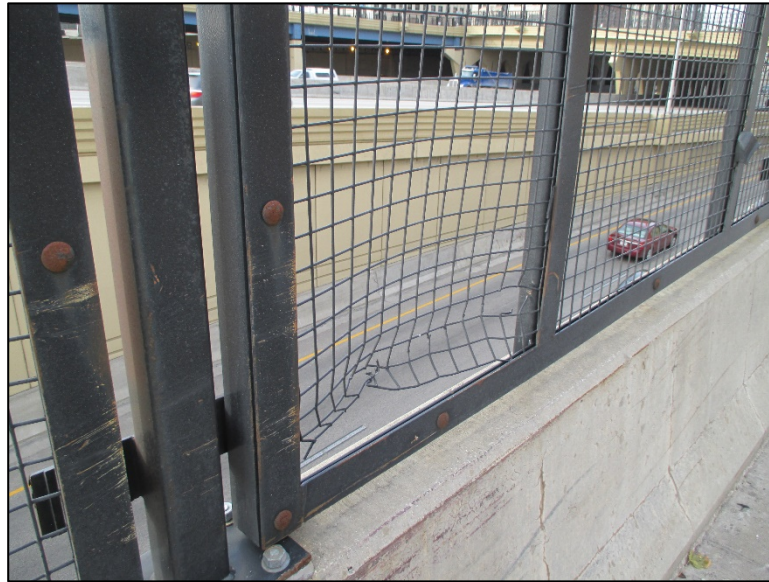
Figure 4.4.5-9: Assessment State 3 Protective Screening atop Bridge Rail. Note Chain-link Fence Deformation but Function Remains.

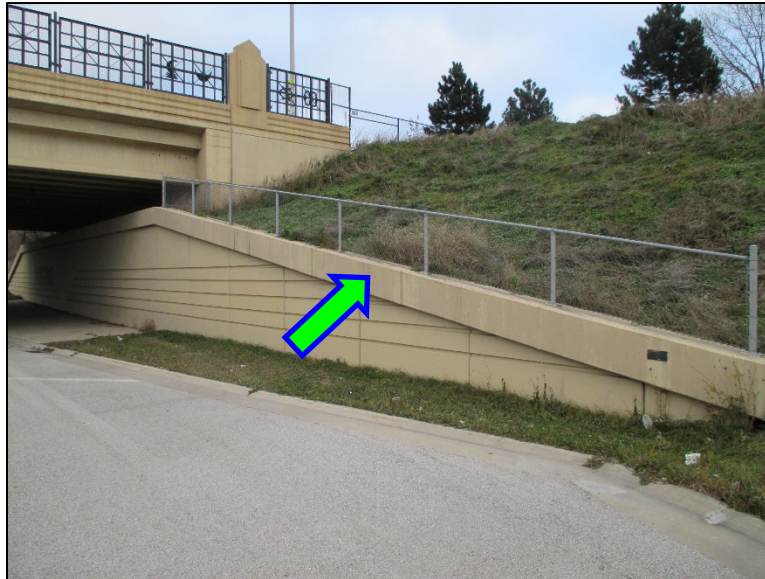
Figure 4.4.5-10: Cast-In-Place Horizontal Coping

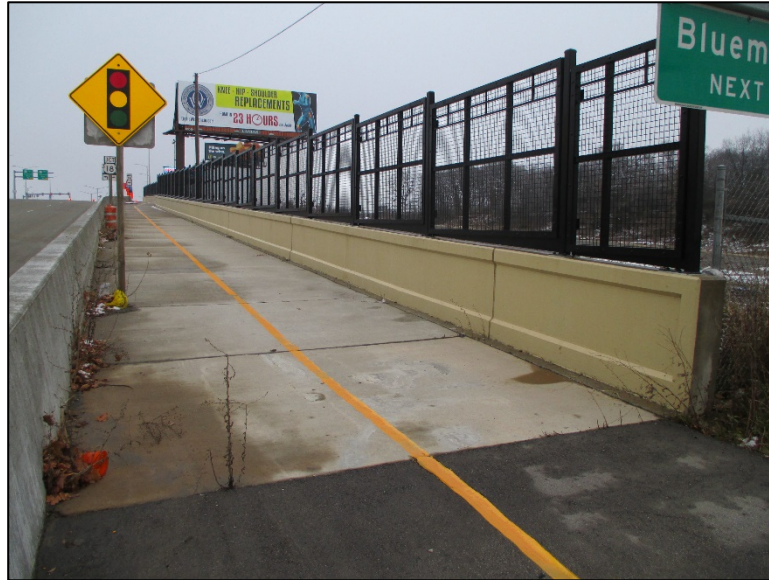
Figure 4.4.5-11: Concrete Sidewalk Along Top of Retaining Wall.

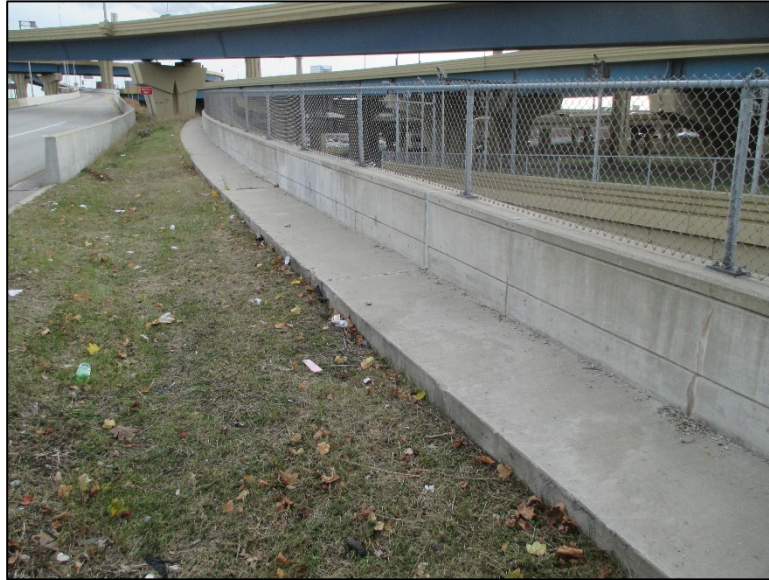
Figure 4.4.5-13: Drainage System Along Top of Retaining Wall. Note Vegetation Exhibits No Signs of Erosion or Settlement.
