Supplement to Joint Sawing Practices And Effects on Durability

Appendix D – Implementation Activities

WisDOT ID no. 0092-16-01

2.0 OBSERVATIONS DURING PAVEMENT CONSTRUCTION

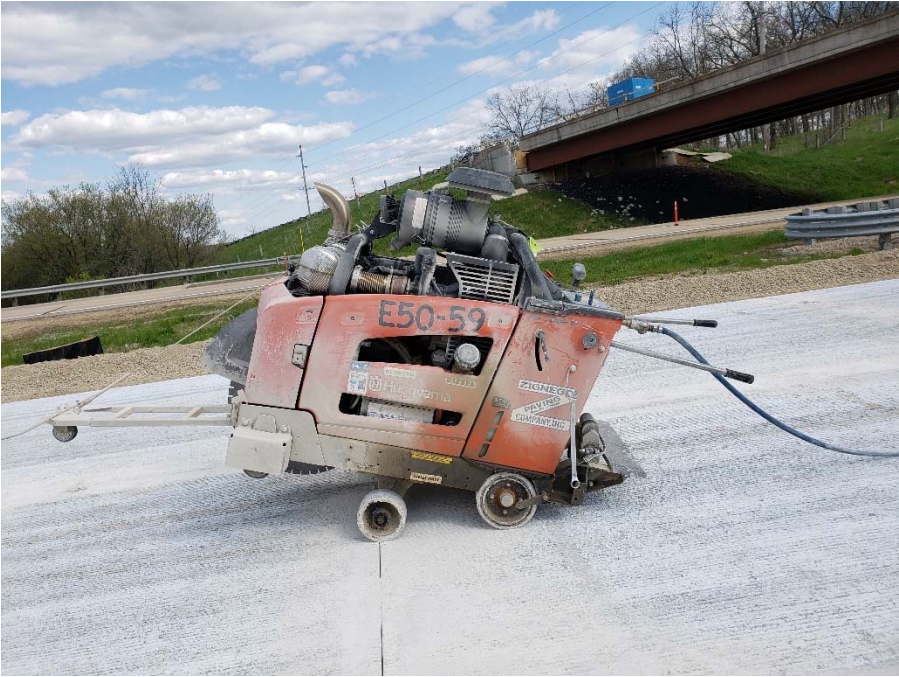
The sawing questionnaire returned by the Zignego Company indicated conventional Husqvarna FS 7000D and FS 6600D walk behind saws would be used with Esch JSWU-414 blades. Discussions with the sawing personnel indicated a Jaguar JSWU-414 blade was generally used on the FS 7000D saw while the FS 6600D saw used the Husqvarna 14140 1DP blade. It was further indicated that saw blades generally lasted 1.5 to 2 nights of sawing.

Figure 2.2.5: Husqvarna FS 7000D Conventional Saw

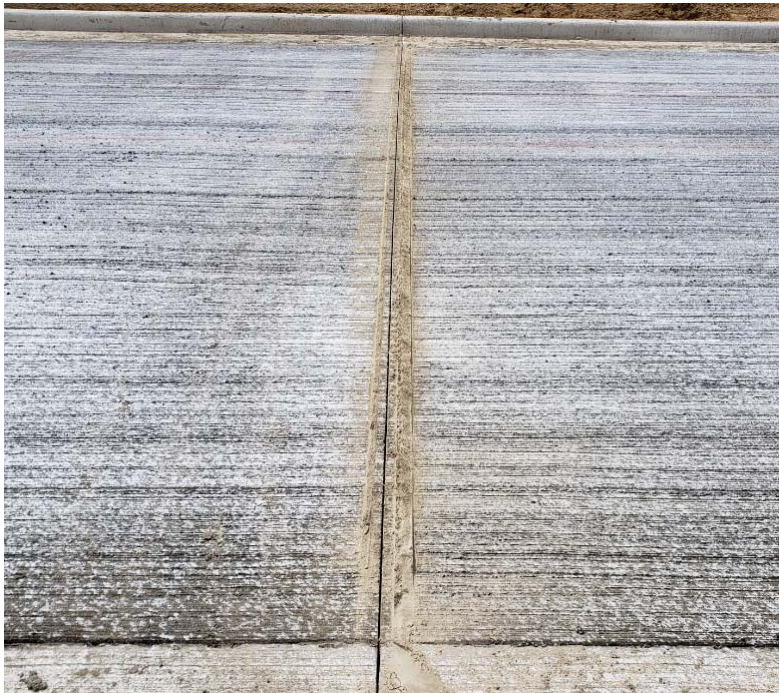
Figures 2.3.5 – 2.3.7 provide representative photos taken before and during the joint sawing operations. Figure 2.3.8 provides a plot of data obtained with the Giatec Smartbox for the period from paving to joint sawing. Using a Baseline reading of 39 Ohms, the “maturity” between paving and joint sawing, as represented by the shaded triangular region, is calculated as 660 Ohm-minutes. After sawing was completed in the vicinity of the monitoring joint, visual observations of the joint surfaces indicated that no spalling or breakout had occurred other than that noted during longitudinal joint sawing. Probe depths in the monitored joint indicated an average sawing depth of 2.43 inches.

Figure 2.3.7: Finished Transverse Joint Saw Cut

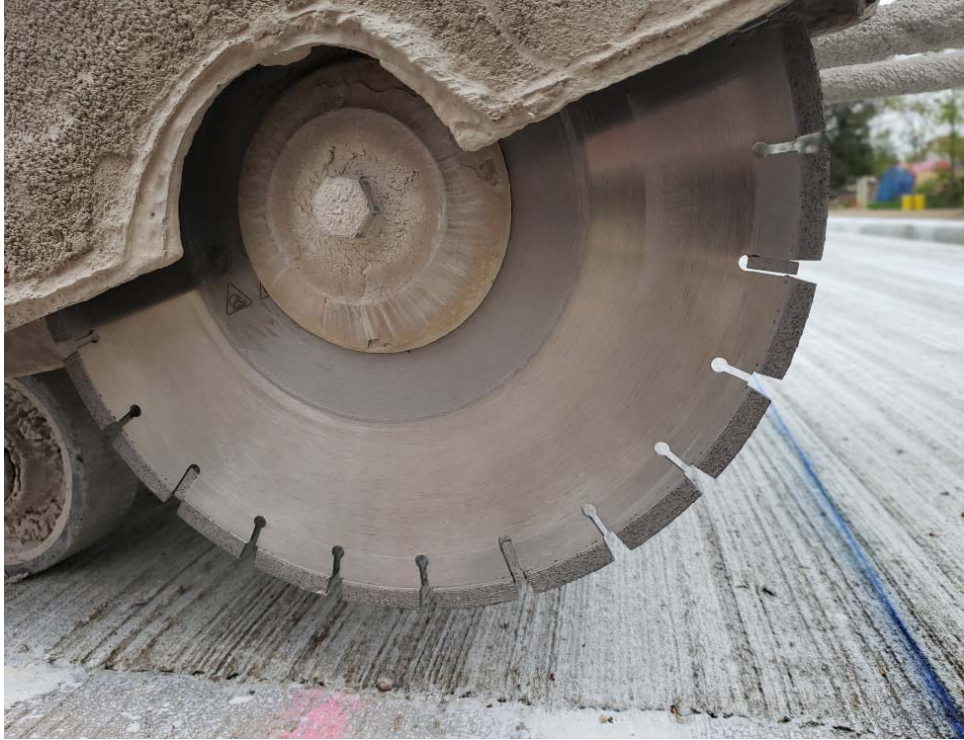
The sawing questionnaire returned by Vinton Construction indicated a Husqvarna FS 4800 conventional saw would be used with Husqvarna 14x155 blades. Discussions with the sawing personnel indicated the Husqvarna high performance green blades are operated at 2,100 RPM and generally provide around 50,000 inch-feet of cutting per blade.

Figure 2.4.5: Husqvarna HI PERF Green Blade

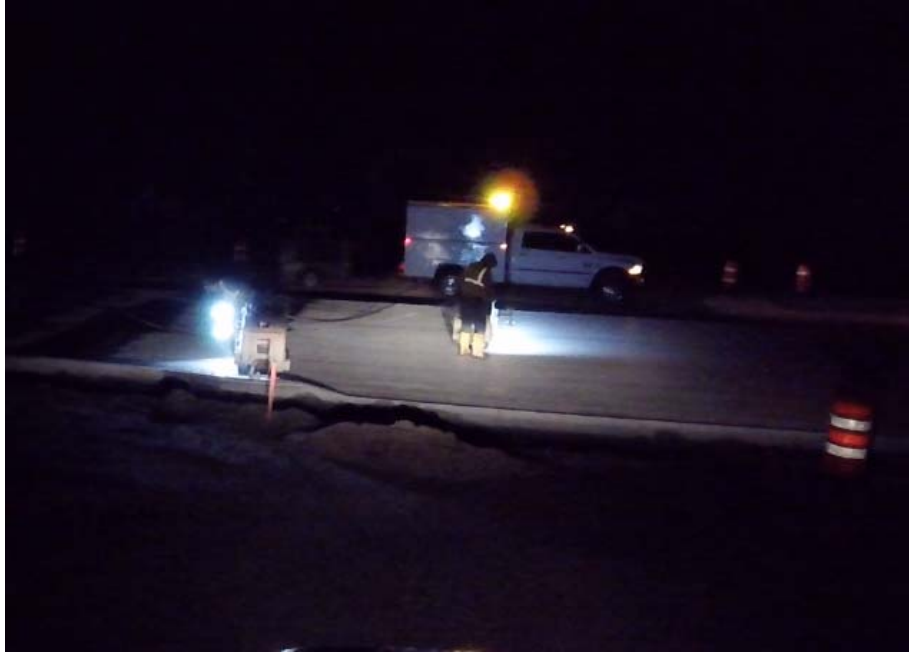
Joint sawing operations began at 8:55 PM with each Husqvarna FS 4800D saw working in tandem to cut each transverse joint, with one saw traveling in one direction and the other in the opposite direction. Transverse joint sawing continued for approximately 150 feet (10 joints), at which time sawing operations were suspended to allow time for blowing out the joints with compressed air for subsequent joint sealing operations. Transverse sawing reached the monitoring joint at 10:30 PM.

Figure 2.4.7: Tandem Transverse Joint Saw Cutting

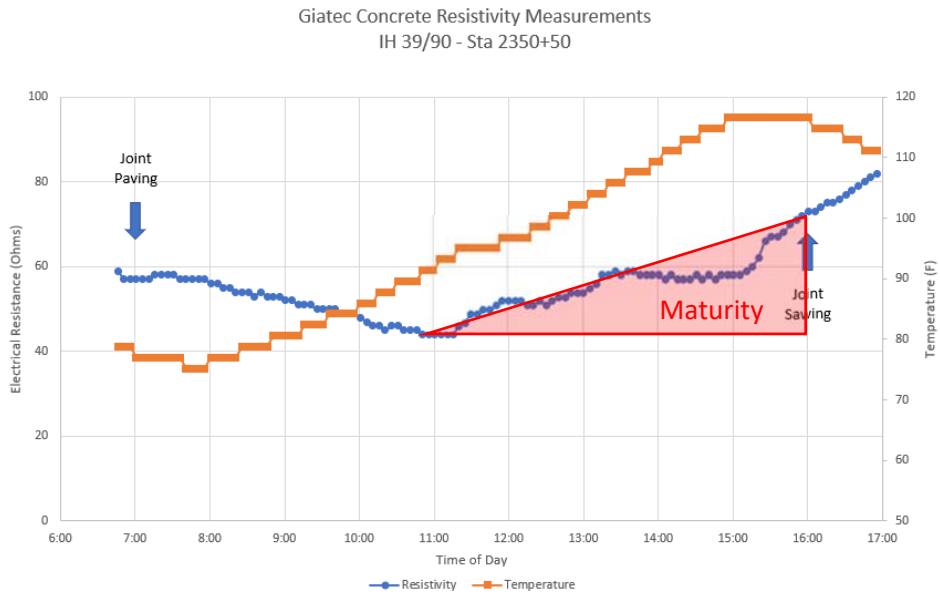
Figure 2.5.8: Giatec Smartbox Data from Concrete Cylinder

Figures 2.5.5 – 2.5.7 provide representative photos taken before and during the joint sawing operations. Figure 2.5.8 provides a plot of data obtained with the Giatec Smartbox for the period from paving to joint sawing. Using a Baseline reading of 44.8 Ohms, the “maturity” between paving and joint sawing, as represented by the shaded triangular region, is calculated as 4,235 Ohm-minutes. After sawing was completed in the vicinity of the monitoring joint, visual observations of the joint surfaces indicated that no spalling or breakout had occurred along the

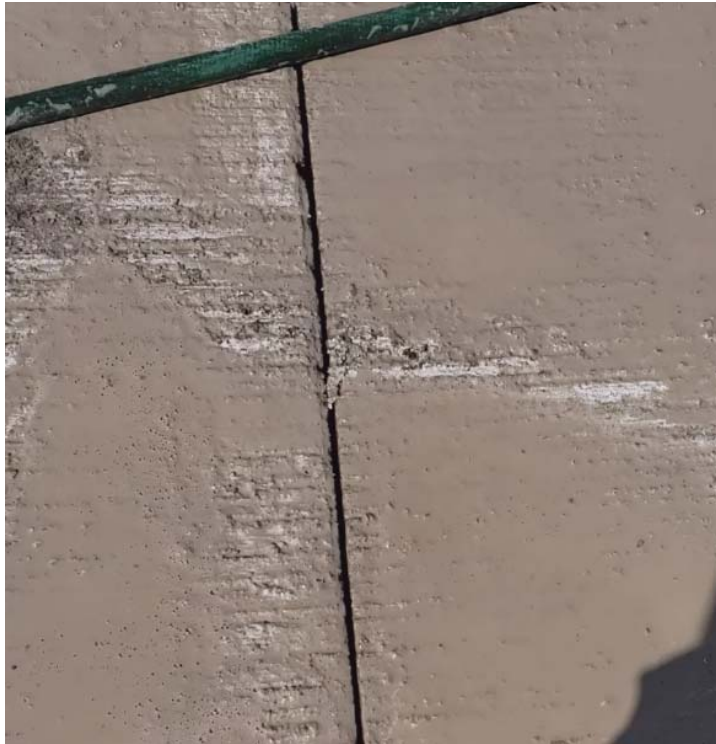
transverse joints during the actual saw cutting operation; however, there were some areas where the steering wheel had caused slight cracking as it crossed the sawn joint, as shown in Figure 2.5.9. Probe depths in the monitored joint indicated an average sawing depth of 4.08 inches. It is also noted that observations from a few of the transverse joints from the previous day of paving indicated some aggregate dislodgement along the joint and cracking in areas where the steering wheel of the riding saw has crossed the joint, as shown in Figures 2.5.10 and 2.5.11.

Figure 2.5.9: Joint Crack Due to Wheel Movement

- **Timing of Sawing:** The initiation of joint sawing operations remains a decision of the sawing personnel based on their experience. Observations of joint cracking during sawing during the field visits, including cracking of the transverse joint during longitudinal joint sawing with early entry equipment and cracking of the transverse joint during movements of the conventional riding saws, indicate that joint sawing operations may still be starting too soon. A data driven method is recommended to aid in the development of appropriate saw timing windows. Resistivity measurements, similar in concept to concrete maturity readings taken to predict concrete strength for opening to traffic, provide data related to the

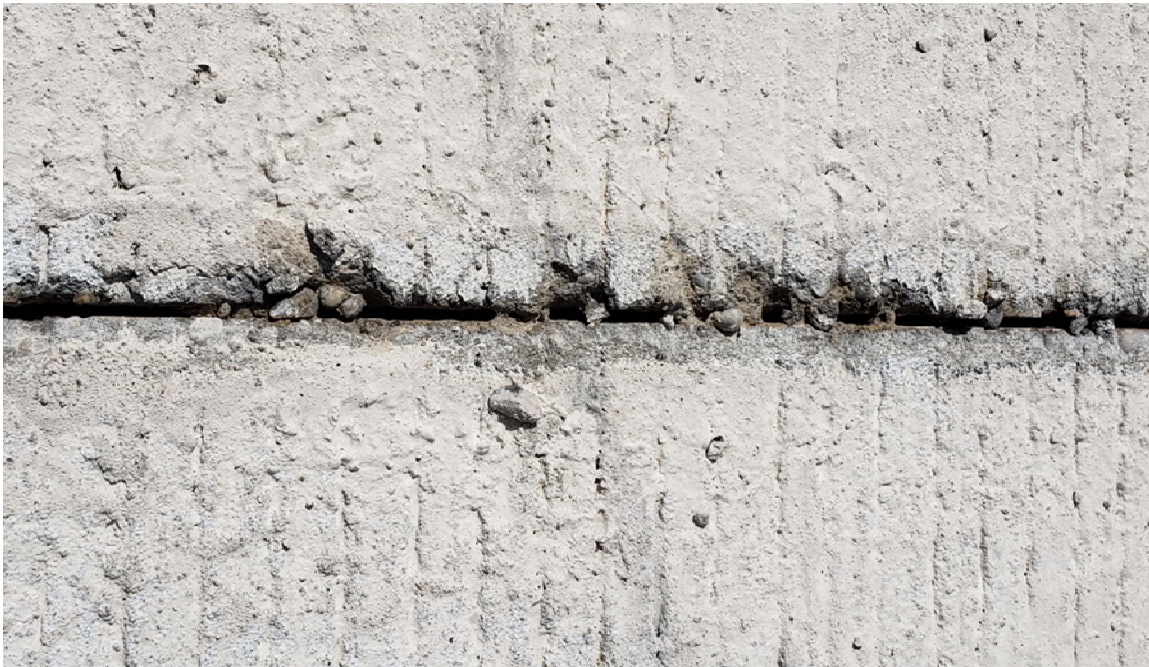
Figure 2.5.10: Aggregate Dislodgement Noted on Sawing from Previous Day

- **Joint Inspections:** Joint sawing is often completed during nighttime hours when only the sawing crew is present. This in itself does not constitute a problem, but inspection of the sawn joints during and after operations is recommended, including measurements of saw cut depth and joint surface cracking/spalling. A review of the daily diaries and inspector notes from the day of, and the day after field project visits, found no observations/measurement of the sawn joints. As the cost of joint sawing is considered incidental to the cost of the concrete pavement construction, there may be no specific remedies for anything other than replacing slabs with random cracking. Having joint sawing as a specific bid item, with potential pay reductions if the work is not completed properly, is recommended to provide a mechanism for better control.
