Evaluation of H-pile Corrosion Rates for WI Bridges Located in Aggressive Subsurface Environments

Glenn Department of Civil Engineering,
Clemson University

WisDOT ID no. 0092-16-03

May 2019

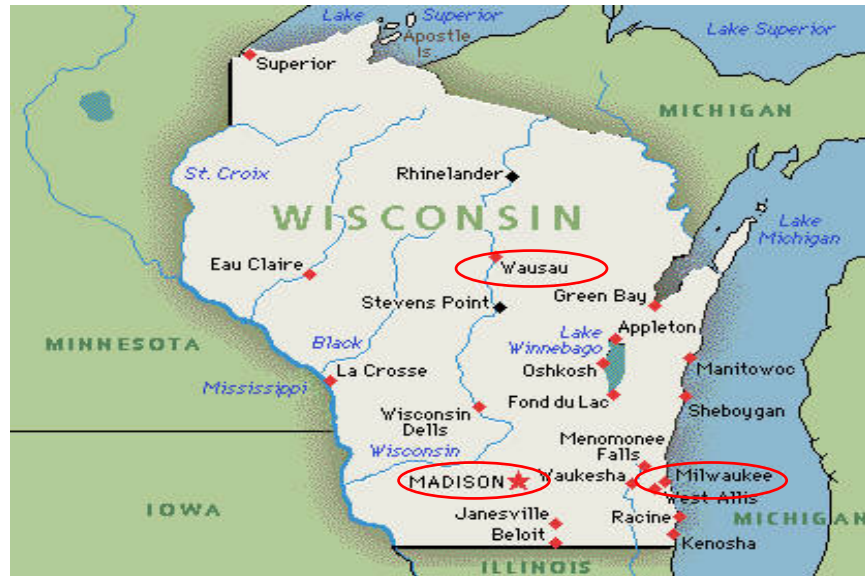
Figure 3.2. Locations of the collected soils

Soil samples were collected from different locations in the state of Wisconsin, as shown in Figure 3.2. Figure 3.3 shows the pictures of the locations. The physicochemical parameters of the collected soil samples were measured as followings: moisture content according to ASTM D2974-87 [125], pH by using EPA 9054 [126], soil resistivity according to EPA 120.1 [127], chloride and sulfate contents following EPA 300.0 [128], and the total organic carbon using EPA 9060 [129]. Table 3.2 shows the physicochemical parameters of 9 soil samples in group one. Two group of the soils were used in this study. The measurement cells in group one was prepared with the as-received soils, while the chloride was added and its content in the soils was adjusted to 3% by weight of the soil in group two.

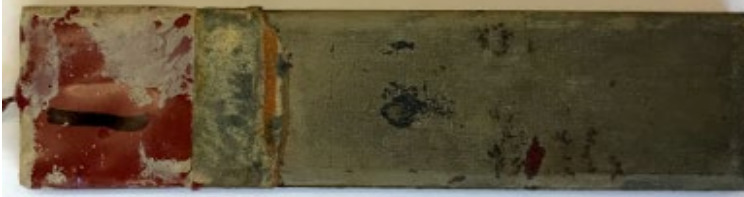
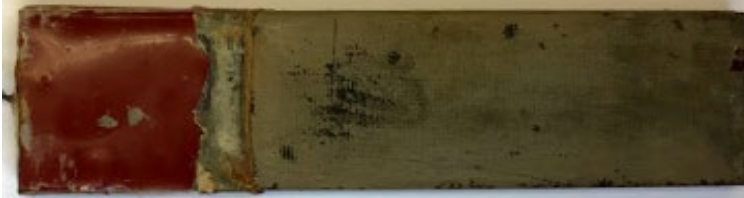
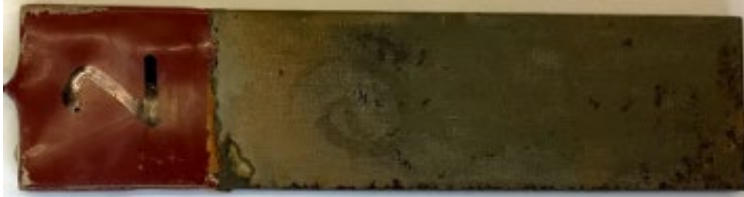
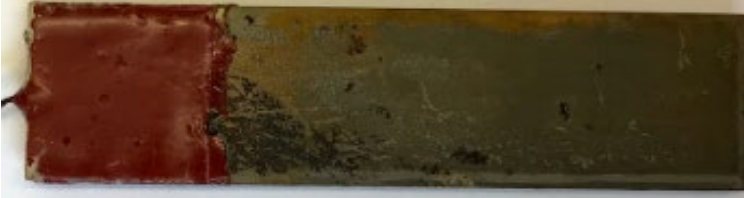
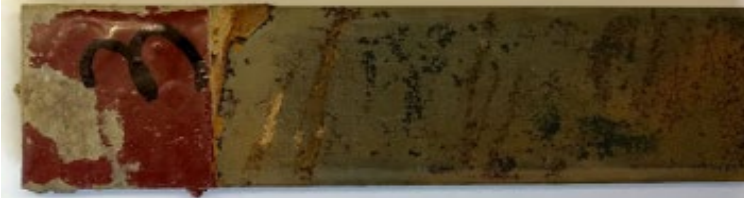
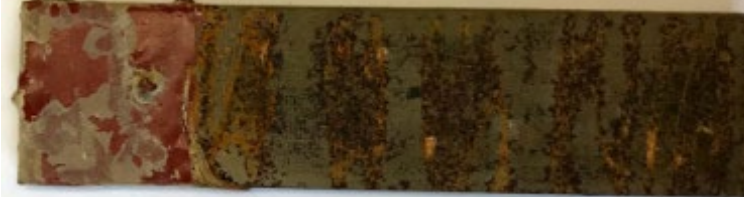
Soil 2

At the end of the experiments, the specimens (both as-received and steel-mortar) were removed from the soils. Then, pictures were taken from both sides of each specimen (Appendix A) and image analysis was carried out with the aid of ImageJ [131] and the corroded surface area on each specimen was measured. Table 4.2 shows the average corroded area for each specimen in different soils.
