Textured Epoxy Coated and Galvanized Reinforcement to Reduce Cracking in Concrete Bridge Decks and Components

WisDOT ID no. 0092-19-01

August 2021

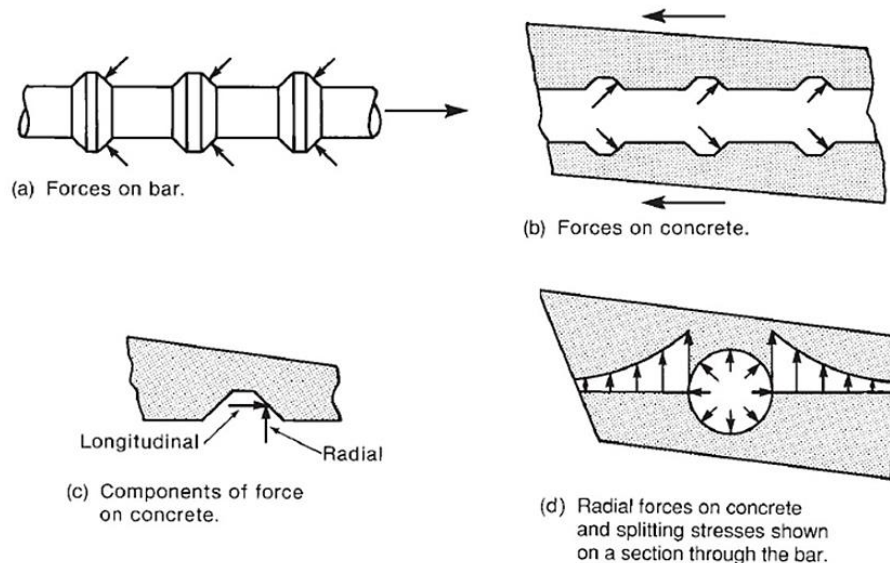
Figure 5- Bond transfer mechanism (Figure from [38]).

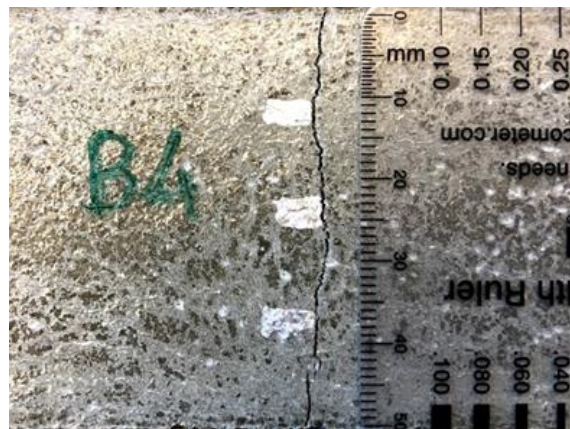
Figure 10 - Shrinkage cracking in an example test specimen.

Cracks were observed in all specimens, and crack data were collected 24 hours after casting the mortar. Digital images of the cracks were collected, and crack width was also measured at three locations using a handheld microscope. An example crack is shown in Figure 10. Eight series of shrinkage tests were conducted, and one specimen of each coating type was included in each series.

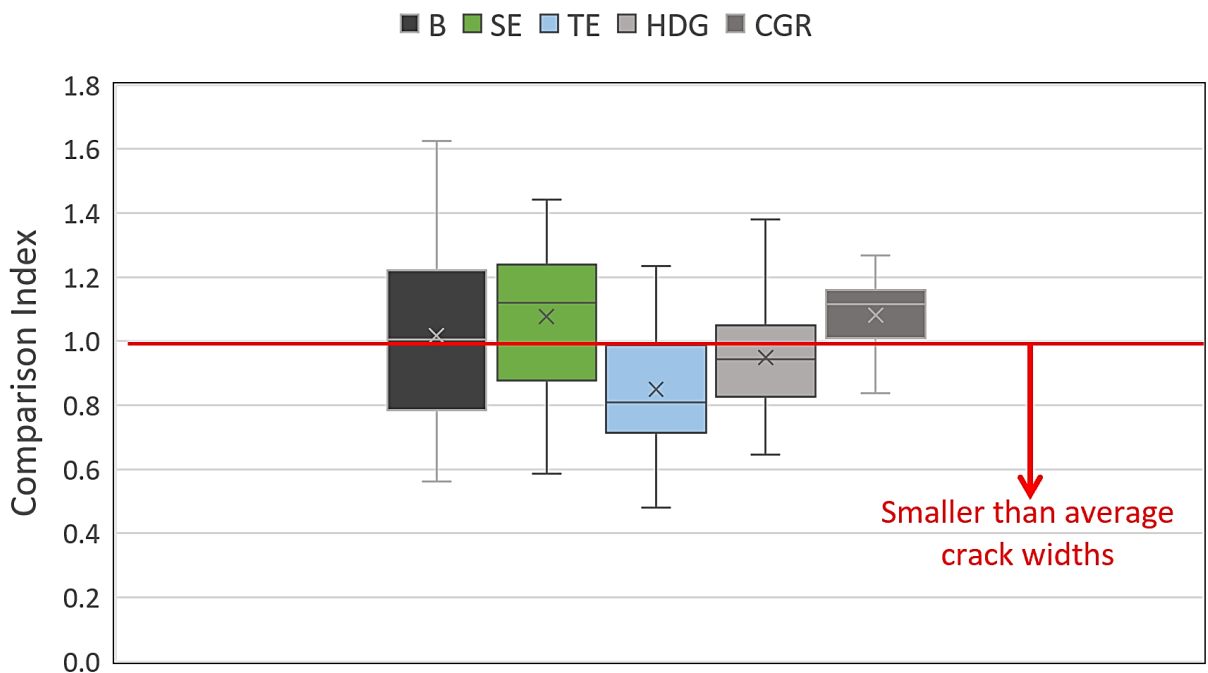
Figure 11 - Comparison index of the average crack width, prepared using the data from image analysis.

Comparison Index results are shown in Figure 11 to provide a graphical means of evaluating and interpreting the shrinkage crack data. The “box” portion of the data indicates the upper and lower quartiles of the data. The “whisker” portion shows the range of the data points, excluding any outliers. Data in the figure come from ImageJ and microscope measurements, and only three outliers were recorded in the dataset out of 128 comparison index values. The “x” in the figure indicates the mean value, and the horizontal line in the box indicates the median value.

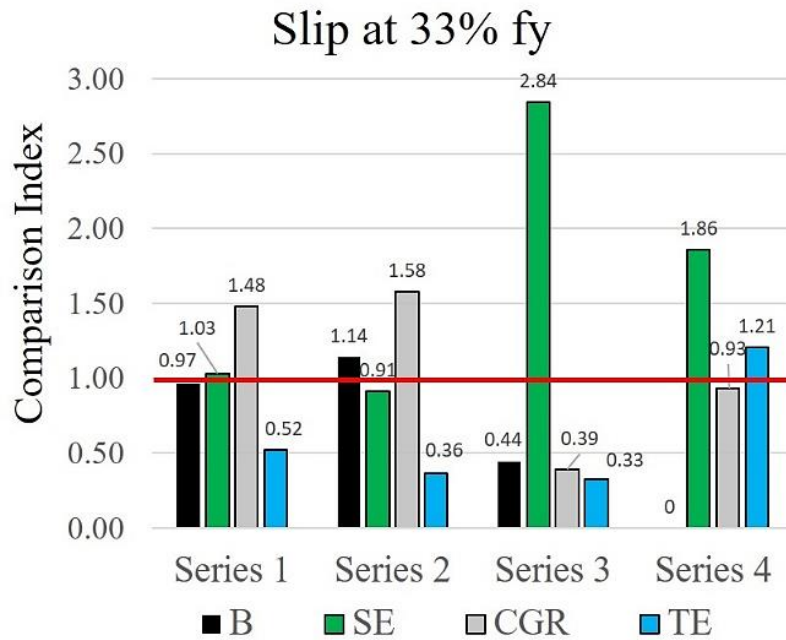
Figure 17 - Comparison index of bar slip at 33% of yield stress

trends indicate that the textured-epoxy bars have superior bond capacity than the smooth epoxy-coated bars. Furthermore, textured-epoxy bars should not be treated the same as smooth epoxy-coated bars when calculating development length. Additional testing is recommended to confirm this observation and determine the range of roughness properties and concrete strengths for which it is valid.

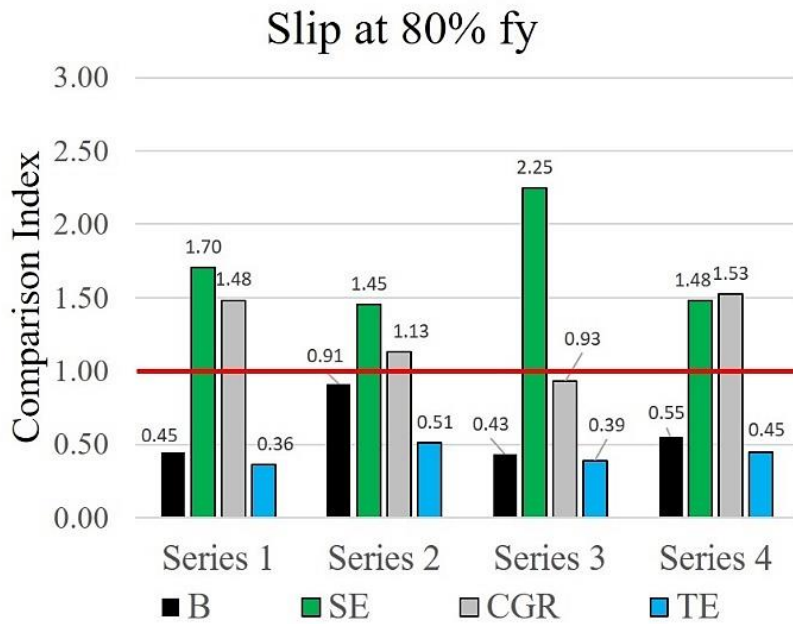
Figure 18 - Comparison index of bar slip at 80% of yield stress

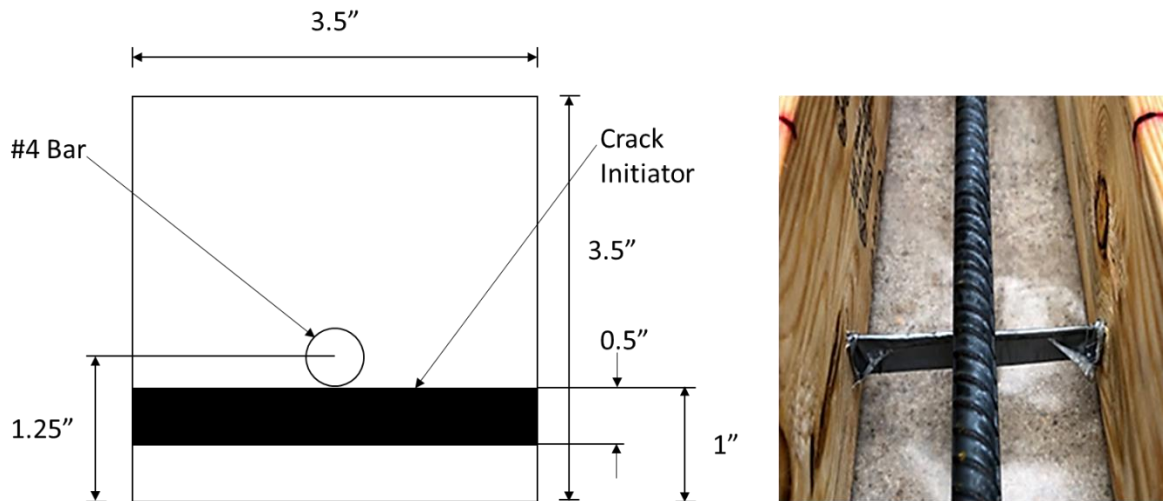
Figure 22 – Section and details of short beam specimens.

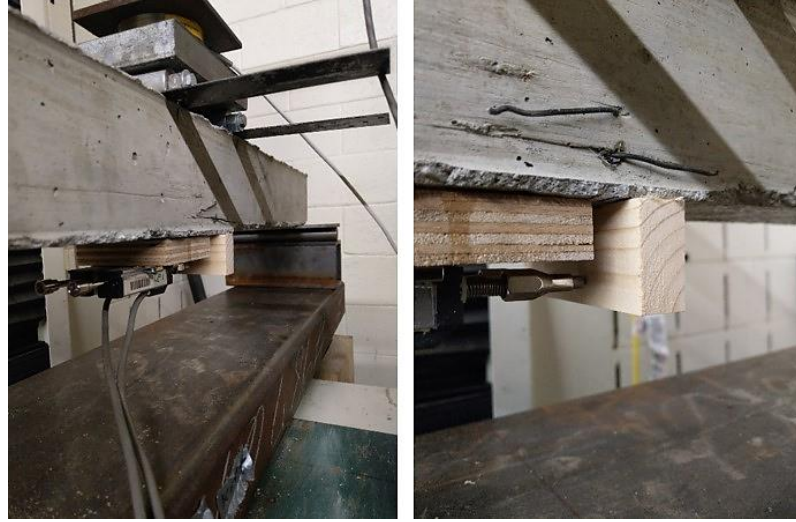
Figure 25 - Linear potentiometer set-up using woodblocks.

Figure 23 shows the free-body diagram of the test setup. Linear potentiometers (LP) were used at the center of the beam to measure crack displacement. The woodblocks used to mount the LP had consistent dimensions for each test specimen. This ensured comparable crack opening data across tests. The overall setup for the test is shown in Figure 24. The setup of the linear potentiometers is shown in Figure 25.

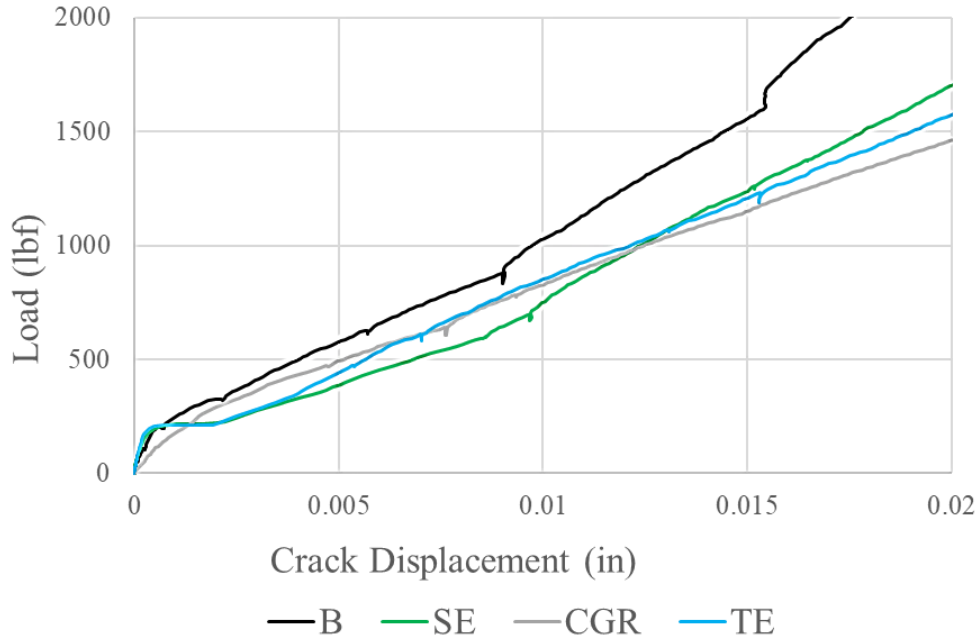
Figure 26 - Load vs displacement from series 2.

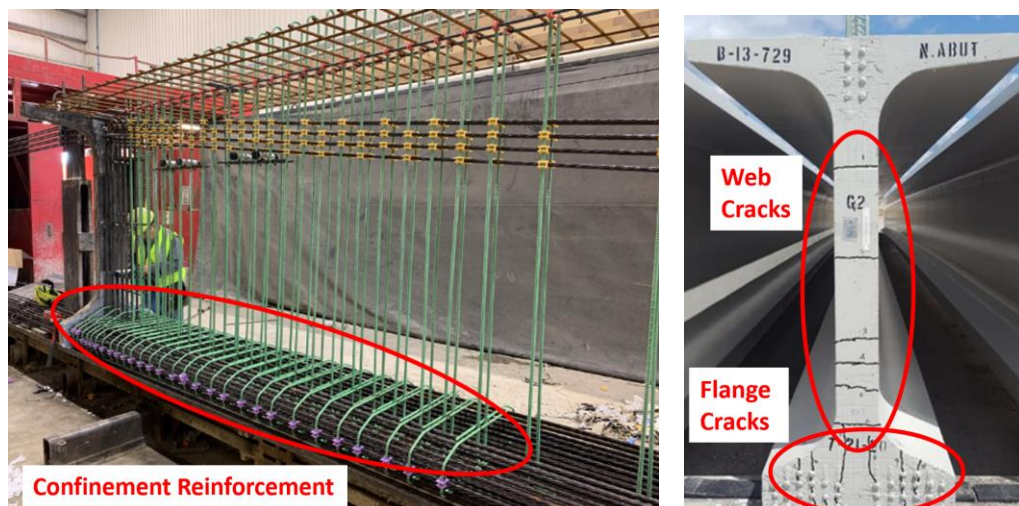
Figure 36 - Girder reinforcement prior to casting concrete (left) and representative end cracking (right).

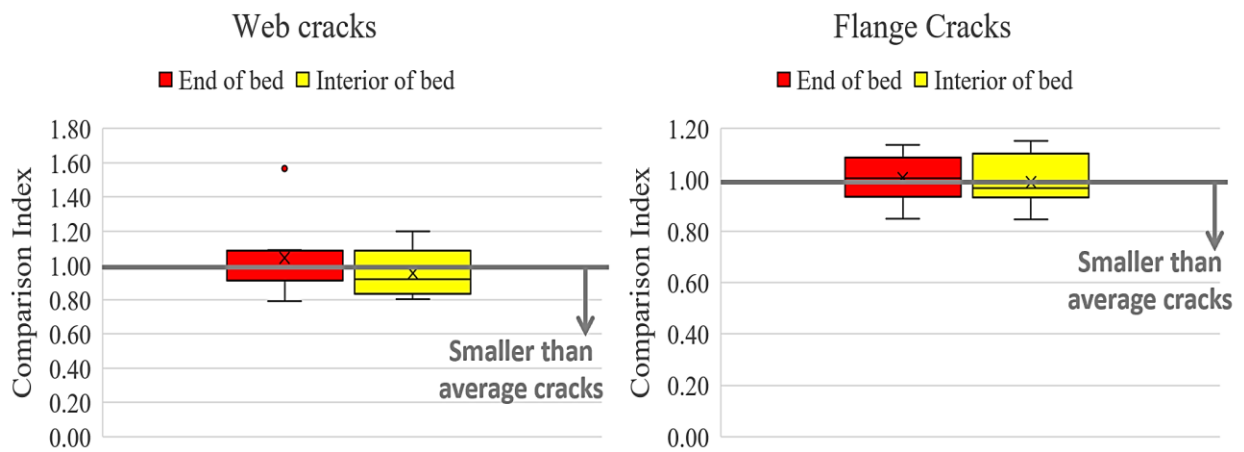
Figure 39 - Crack widths at girder ends based on stressing bed position.
