Pretensioned Concrete Girder End Crack Control

This brief summarizes Project 0092-15-01,
“Implementation and Field Evaluation of Pretensioned Concrete Girder End Crack Control”
Wisconsin Highway Research Program

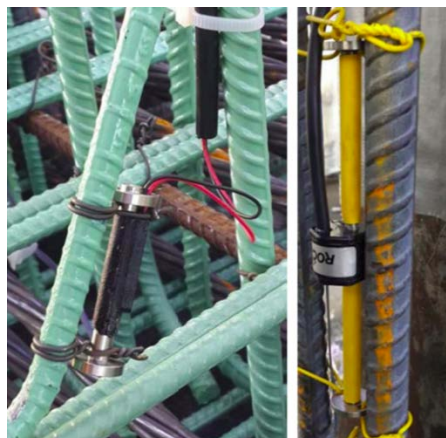
Vibrating wire (VW) gauges were placed on reinforcing bars to measure concrete strain.

Prestressed girders, 54 and 72 inches deep, were designed and built using three different debonded designs along with two standard designs to evaluate and prove the effectiveness of debonding. The girders were instrumented with various gauges to record internal strains and detect cracking during the prestressing or detensioning process.
