Evaluation of Concrete Pavement Buckling in Wisconsin

Applied Research Associates, Inc.

WisDOT ID No. 0092-20-02

February 2022

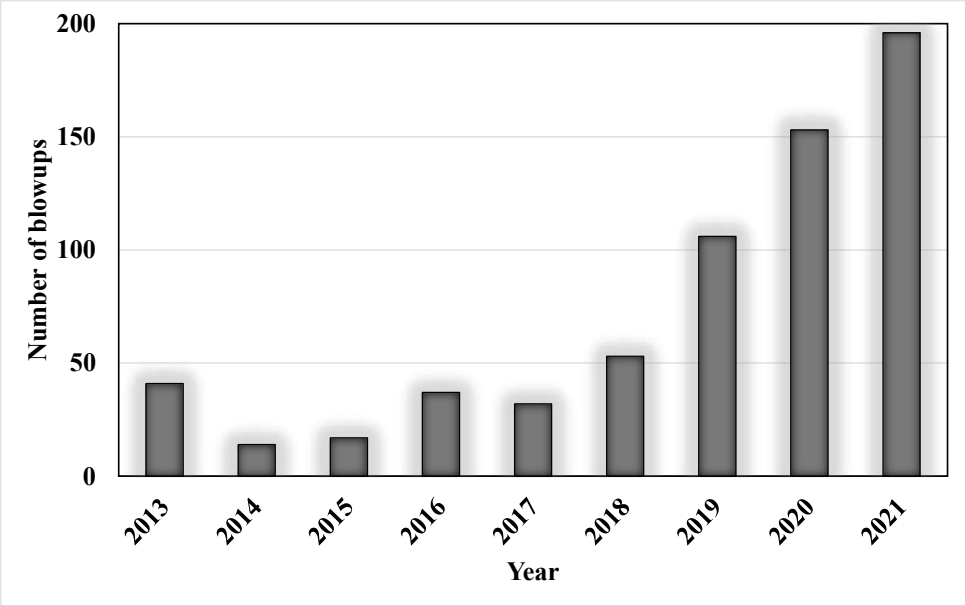
Figure 7. Number of blowups in Wisconsin between 2013 and 2021.

The number of blowups in each year between 2013 and 2021 are shown in Figure 7 and the geographic distribution of the blowups from 2013 to 2019 is shown in Figure 8. The rate of buckling generally increased every year with the highest number of blowups in 2021. A significant number of blowups have occurred between 2019 and 2021, which is considerably higher than the number of blowups between 2013 and 2018. Most of these blowups occurred on JPCP with a joint spacing of 15 and 18 ft. The different markers in Figure 8 correspond to different years with the green with white center markers representing blowups in 2019. The occurrences of pavement blowups can be summarized as follow:

- 83 percent of blowups occurred when the surface temperature estimated at the time of blowup was equal to or greater than 90 °F.
- 40 percent of blowups occurred in the month of June, 30 percent in the month of July, and 25 percent in the month of May.
- 82 percent of blowups occurred between 2:00 and 7:30 pm.
- Buckling is distributed throughout Wisconsin and corresponds primarily to the density of the concrete pavement roadway network.

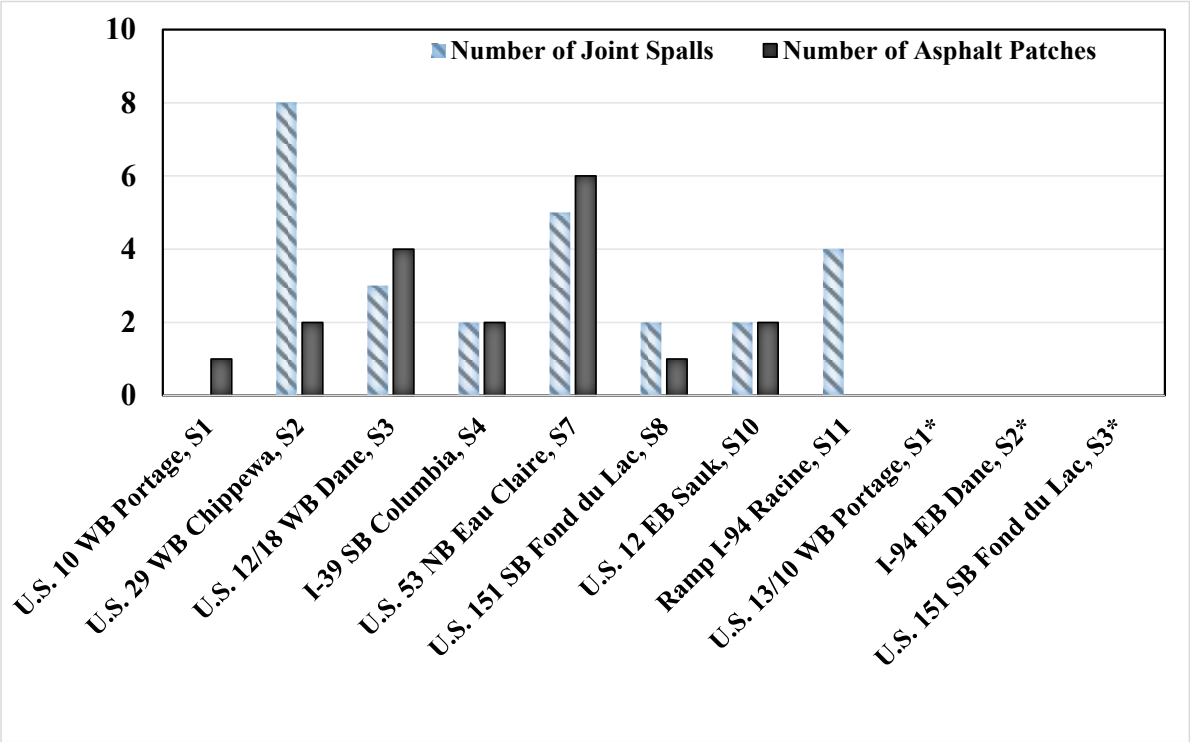
The conditions of transverse joints were evaluated through visual inspection and coring for buckling and control sites. The number of joint spalls and asphalt patches were recorded as shown in Figure 11.

Figure 11. Number of transverse joint spalls (width of spall ≥ 1.0 inch) and asphalt patches over a 1,000-ft section for buckling and control sites.

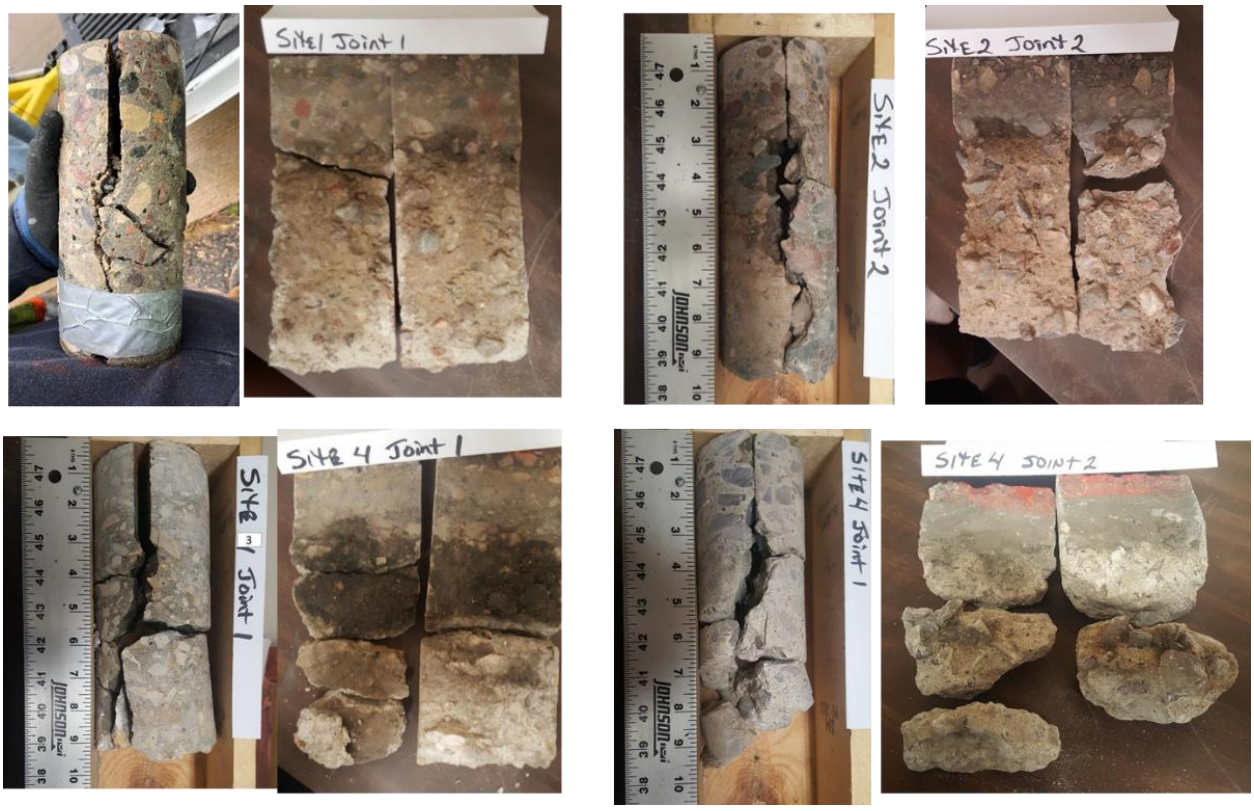
site # 4 site # 10 site # 7

Figure 15. Cores from buckling sites taken from transverse joints and core holes showing spalls in the lower portion of the joint.

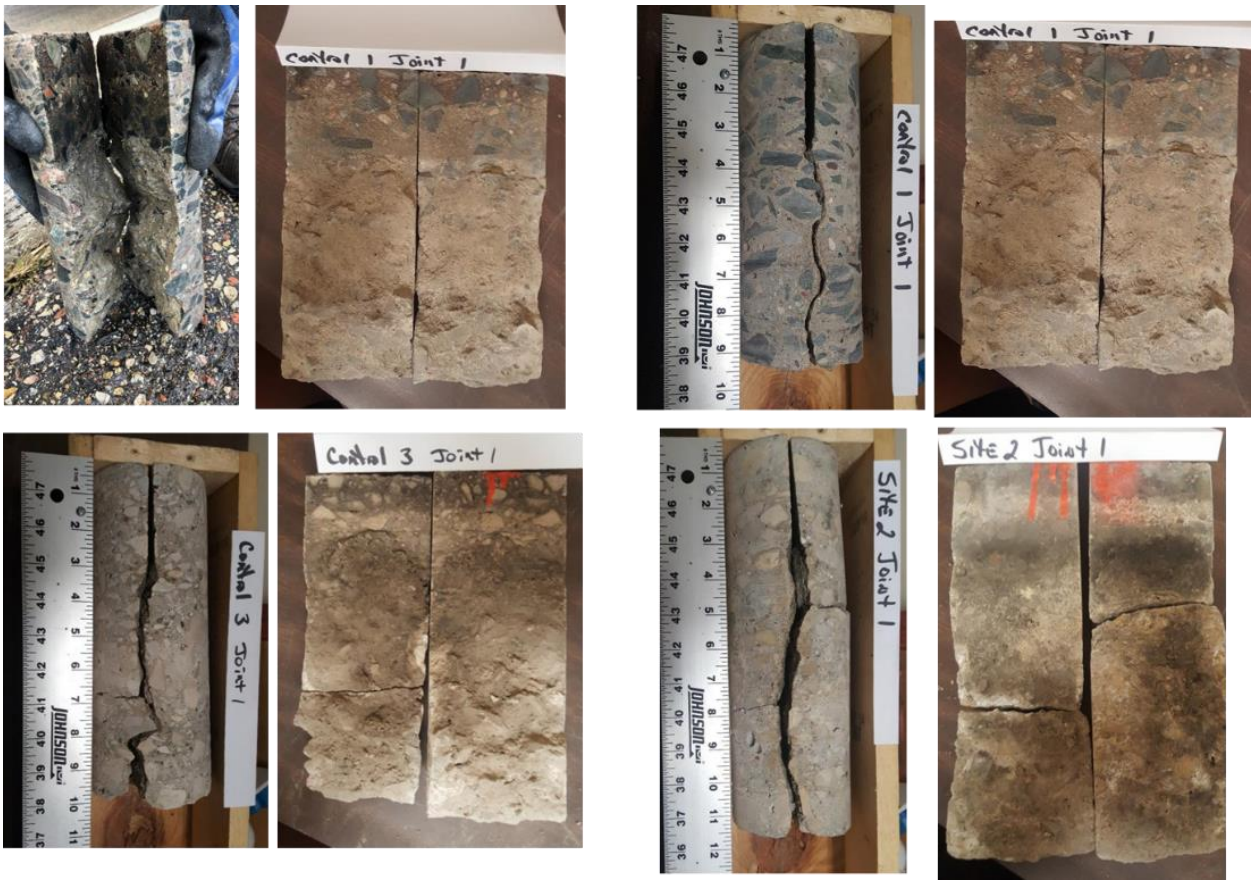
Site # 1* Site # 2* Site # 3*

Figure 16. Cores from control sites taken from transverse joints and core holes showing no spalls in the lower portion of the joint.

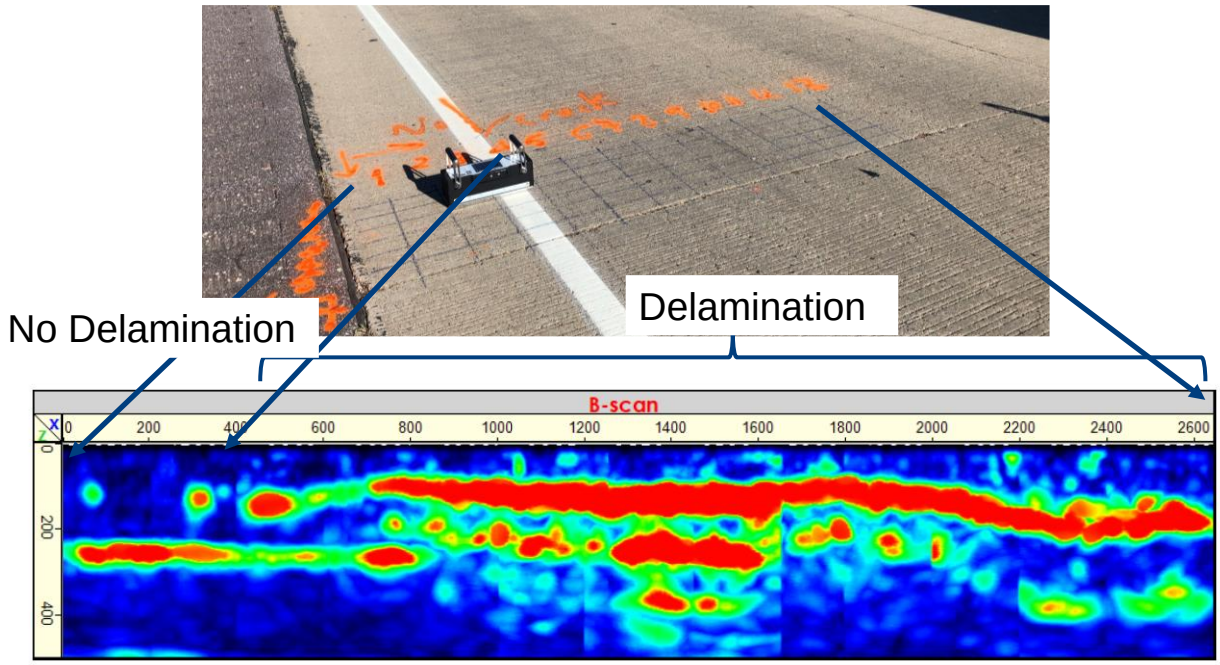
As part of a separate project, the research team performed ultrasonic scanning of some joints near buckling site # 4 on I-39. The result of one of the scans is shown in Figure 17, which shows these cracks extending almost the full transverse width of the lane beneath the surface at approximately the depth of the dowel bar. The top red large ultrasonic echo is the delamination cracking, the two circle echoes on the top left are from two dowel bars, and the lower sporadically red and green echoes are from the boundary between the concrete and the granular base. Note that surface of the concrete is still intact. These horizontal “delamination” cracks did not always progress to the top of the pavement but when then did, they manifested themselves as large spalls at the joints. It is unclear if or how this delamination cracking is related to buckling of the pavement – i.e., if they are related, what is the mechanism, what is the cause, and what is the effect.

Figure 17. Delamination cracking beneath the surface of the concrete near Site # 4 on I-39.

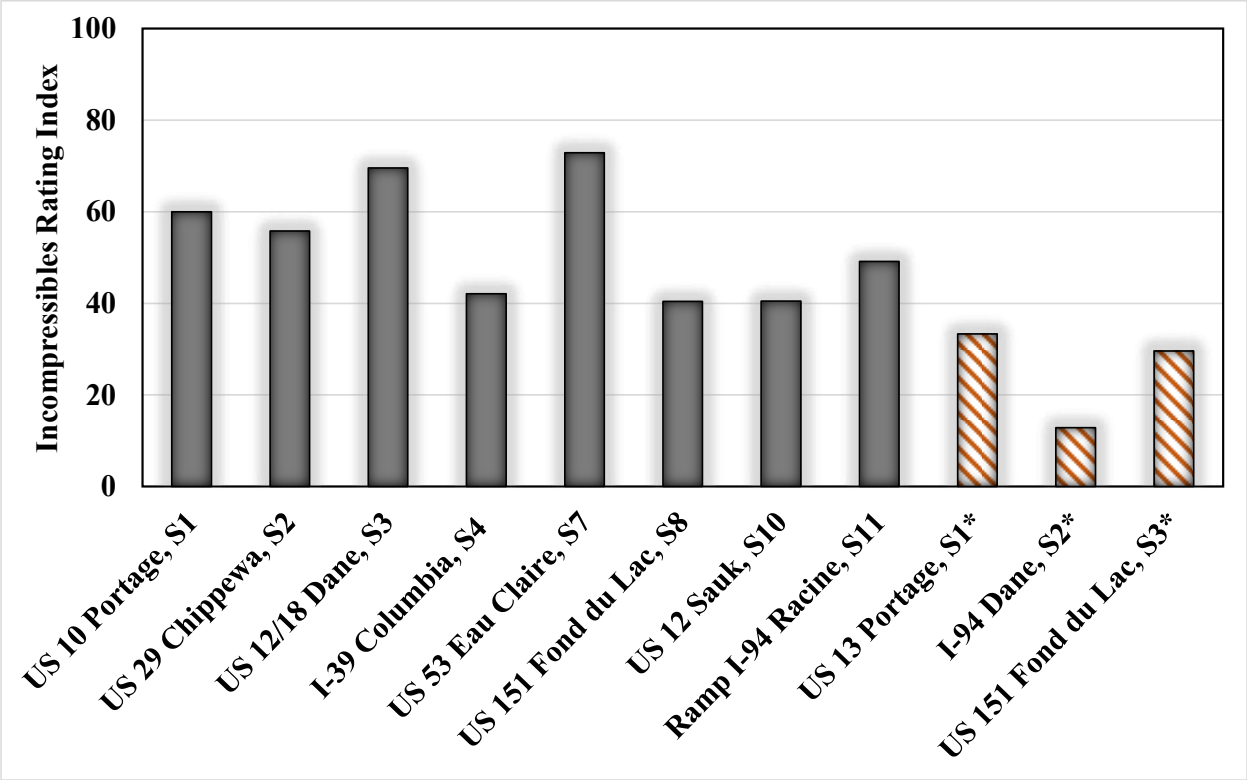
- A side-by-side comparison was performed between buckling and control sites located in the same county and relatively close to each other. This comparison depicting the amount of incompressibles in both sites are shown in Figure 19. The buckling sites had high amount of incompressibles and were rated as high/medium compared to the control sites.
- Incompressibles near the buckling location (red line indicating buckling location in Figure 19) are high and decreased (relatively speaking) with distance from buckling location.

Figure 18. Incompressible rating index for buckling and control sites.

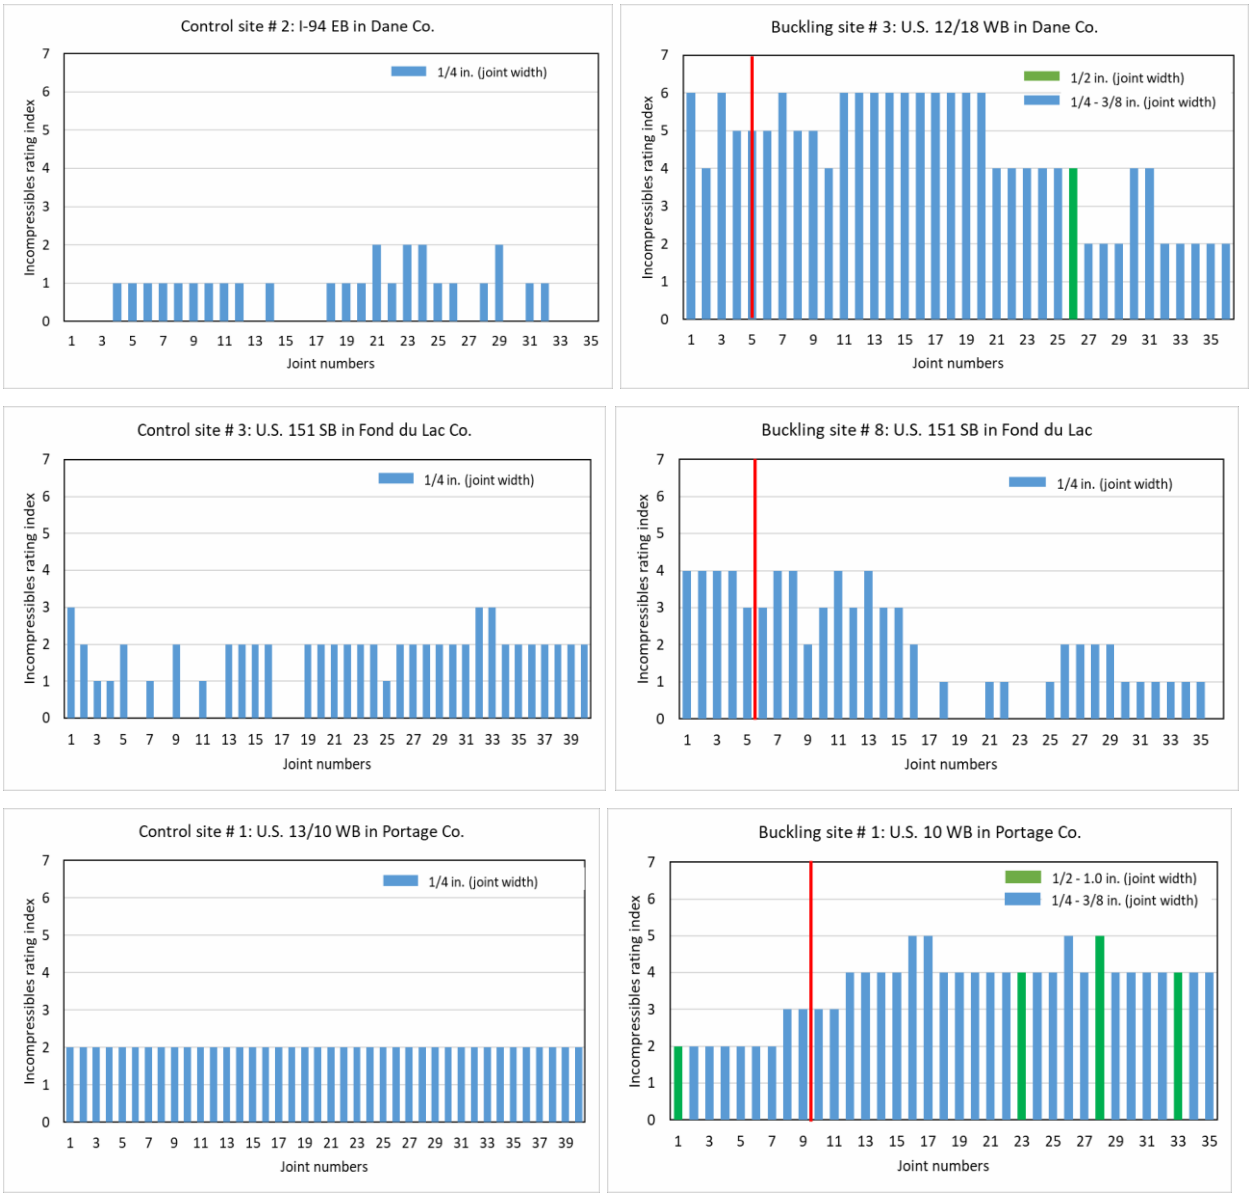
Figure 19. Comparison of individual joint incompressible rating indices between nearby control (left) and buckling (right) sites.

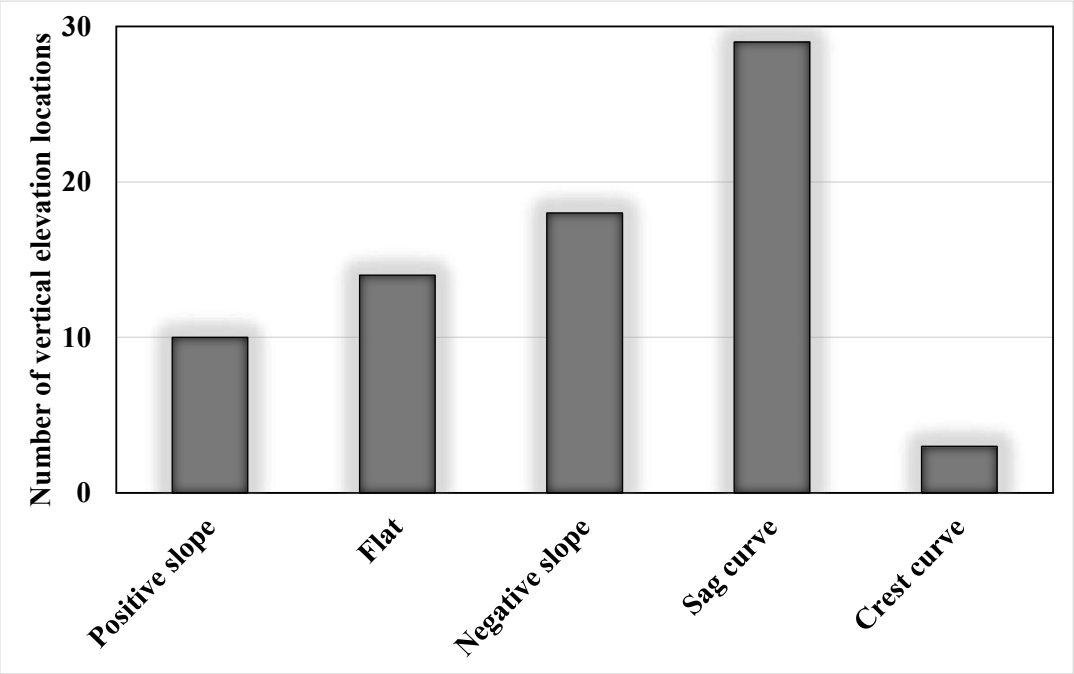
Figure 23. Number of vertical elevation locations representing 74 buckling locations.

The number of blowups were categorized based on positive slope, negative slope, zero slope, sag curve, and crest curve as shown in Table 4 and Figure 23. This data provides an overview estimate of geometry of buckling locations that either occurred on downhill, uphill, or flat terrain. Seventy-four blowups were selected and analyzed from nine roadways located in different counties. These roadways correspond to the full construction projects of the 1,000-feet sites selected for the field survey. The summary of vertical elevation of buckling locations is as follows:

- 24.0 percent of blowups occurred on negative slope,
- 19.0 percent of blowups occurred on zero slope/flat,
- 14.0 percent of blowups occurred on positive slope,
- 4.0 percent of blowups occurred on crest curve.

Most of the blowups occurred on sag curves and negative slopes. This could potentially be attributed to the fact that the transverse joints at the sag curves and negative slopes deteriorate at higher rate at the surface of the joint or in the lower portion of the joint likely due to higher rates of moisture- or durability damage. It could also reflect the impact of gravity or vehicle tire-pavement interactions on the displacement (slipping) of the slabs over the base, and thus the opening and closing of joints and cracks.

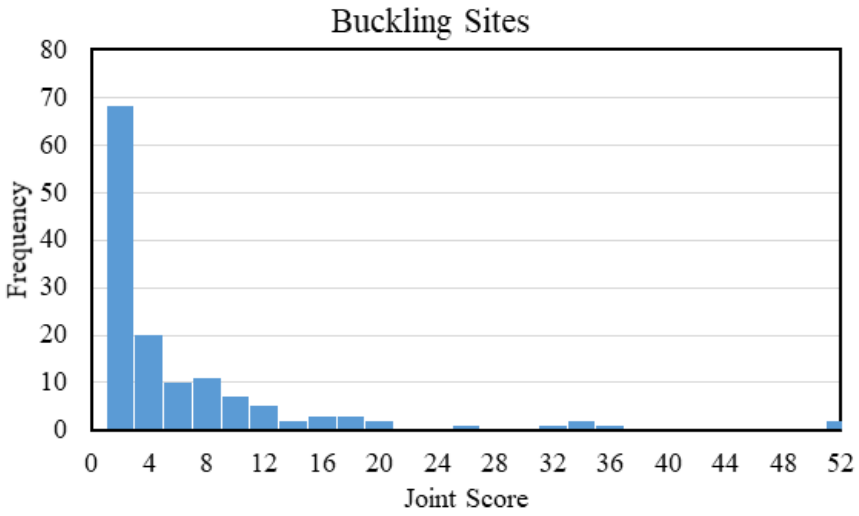
Figure 25. Joint scores of buckling sites.

Pulse induction technology scanning was performed on buckling and control sites by WisDOT to evaluate the impact of dowel bar alignment on the occurrence of blowups. Joint scores were calculated for buckling and control sites as shown in Figure 25 and Figure 26. Over 95 percent of the dowels at both buckling sites and control sites had joint score less than 10 and only a few joints had joint score greater than 30. The results indicated that dowel bar alignment in Wisconsin (within the typical ranges of misalignment) had no impact on joint locking or buckling.

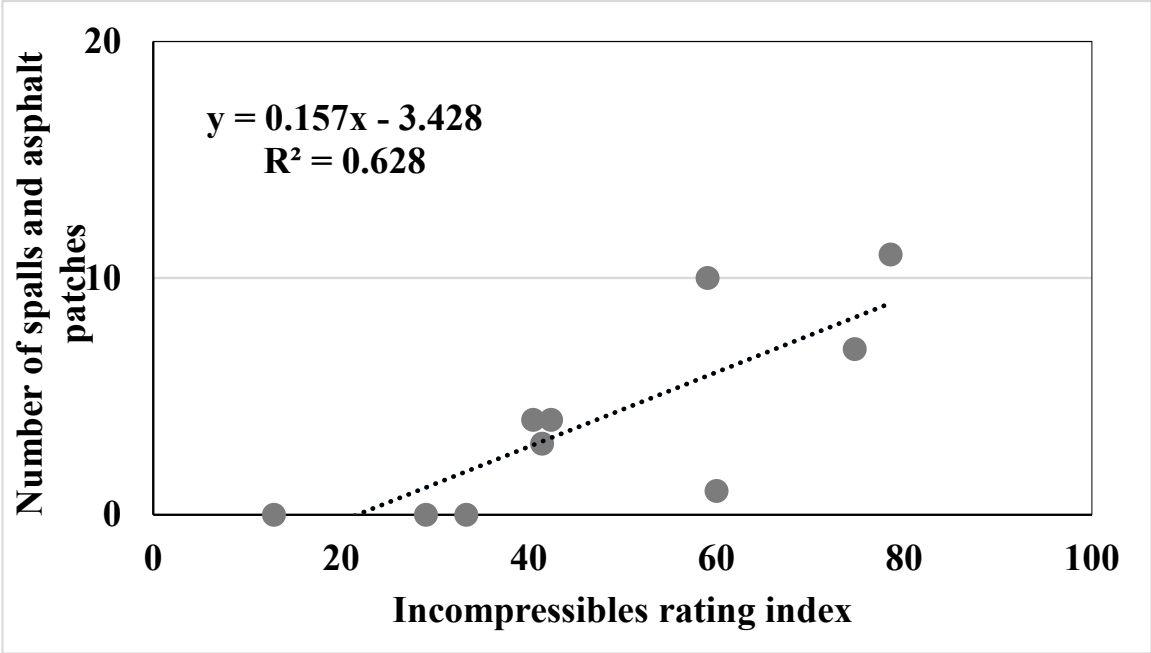
Figure 27. Number of spalls and asphalt patches vs. incompressibles rating index.

A simple linear regression model was developed to correlate the number of spalls and asphalt patches with the amount of incompressibles in the transverse joints (Figure 27). A strong correlation between the incompressibles rating index (i.e., independent variable) and the number of spalls and asphalt patches (i.e., dependent variable) was observed. The results of the regression model indicated that the model has a coefficient of determination (R^2) of 0.63, which means that 63 percent of the variance in the number of spalls and asphalt patches can be related to the change in the incompressibles rating index. Moreover, the model was significant at p-value of 0.0063 at 95 percent confidence level.

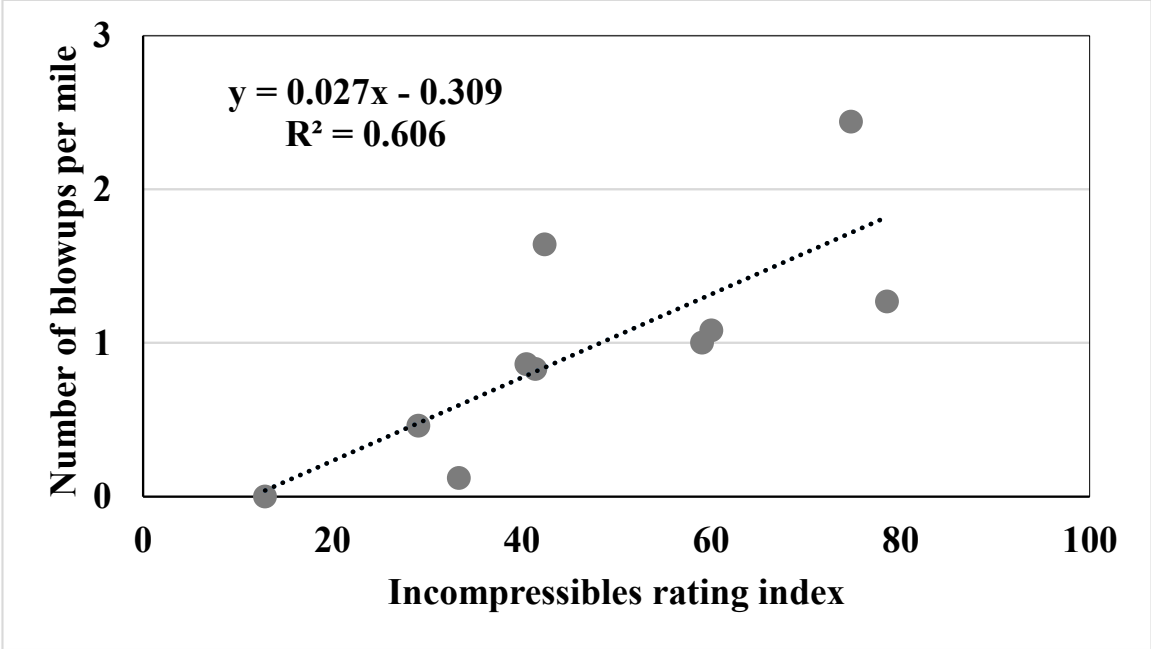
Figure 28. Number of blowups per mile vs. incompressibles rating index.

A simple linear regression model was developed to correlate the number of blowups per mile with the amount of incompressibles in the transverse joints (Figure 28). A strong correlation between the incompressibles rating index (i.e., independent variable) and the number of blowups per mile (i.e., dependent variable) was observed. The results of the regression model indicated that the model has a coefficient of determination (R^2) of 0.61, which means that 61 percent of the

variance in the number of blowups per mile can be related to the change in the incompressibles rating index. Moreover, the model was significant at p-value of 0.0080 at 95 percent confidence level.

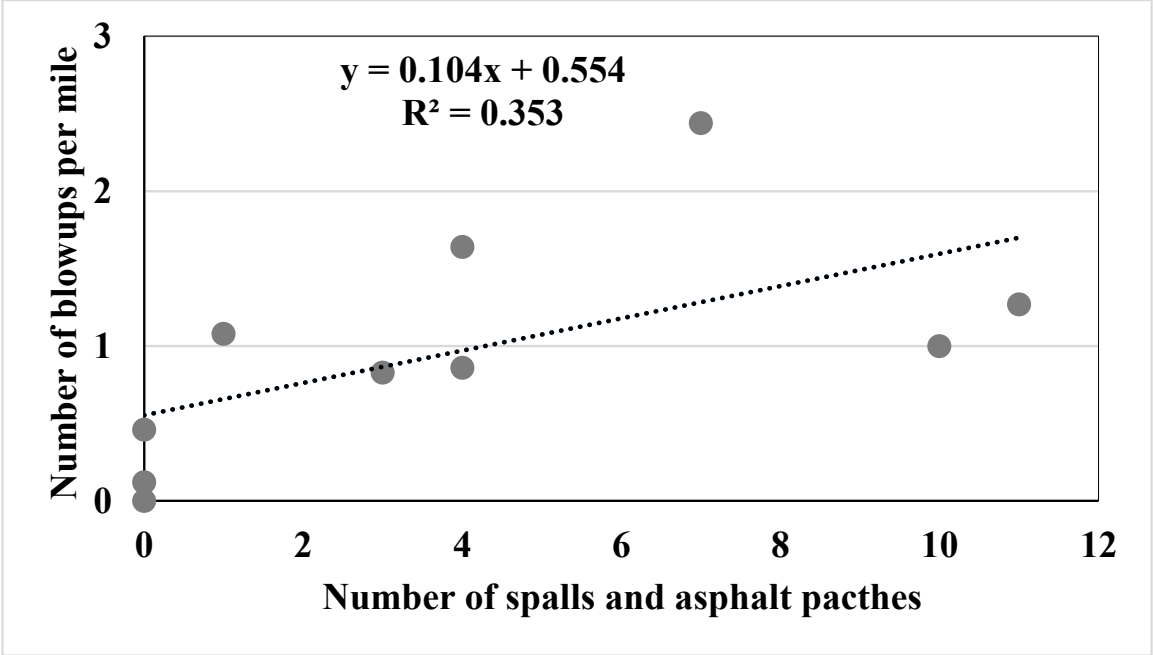
Figure 29. Number of blowups per mile vs. number of spalls and asphalt patches.

A simple linear regression model was developed to correlate the number of blowups per mile with the number of spalls and asphalt patches. This model shows that the impact of the number of spalls and asphalt patches was less than of incompressibles on the occurrence of blowups. The model has an R^2 of 0.35 and is less significant as compared to incompressibles, with a p-value of 0.07 at 95 percent confidence level. Other independent variables (joint spacing and PCC thickness) did not show strong correlation with the number of blowups per mile. This may be attributed due to the relatively small ranges of these variables (15 to 18 feet for joint spacing and 9.5 to 11.5 inches for PCC thickness) and the limited data set.

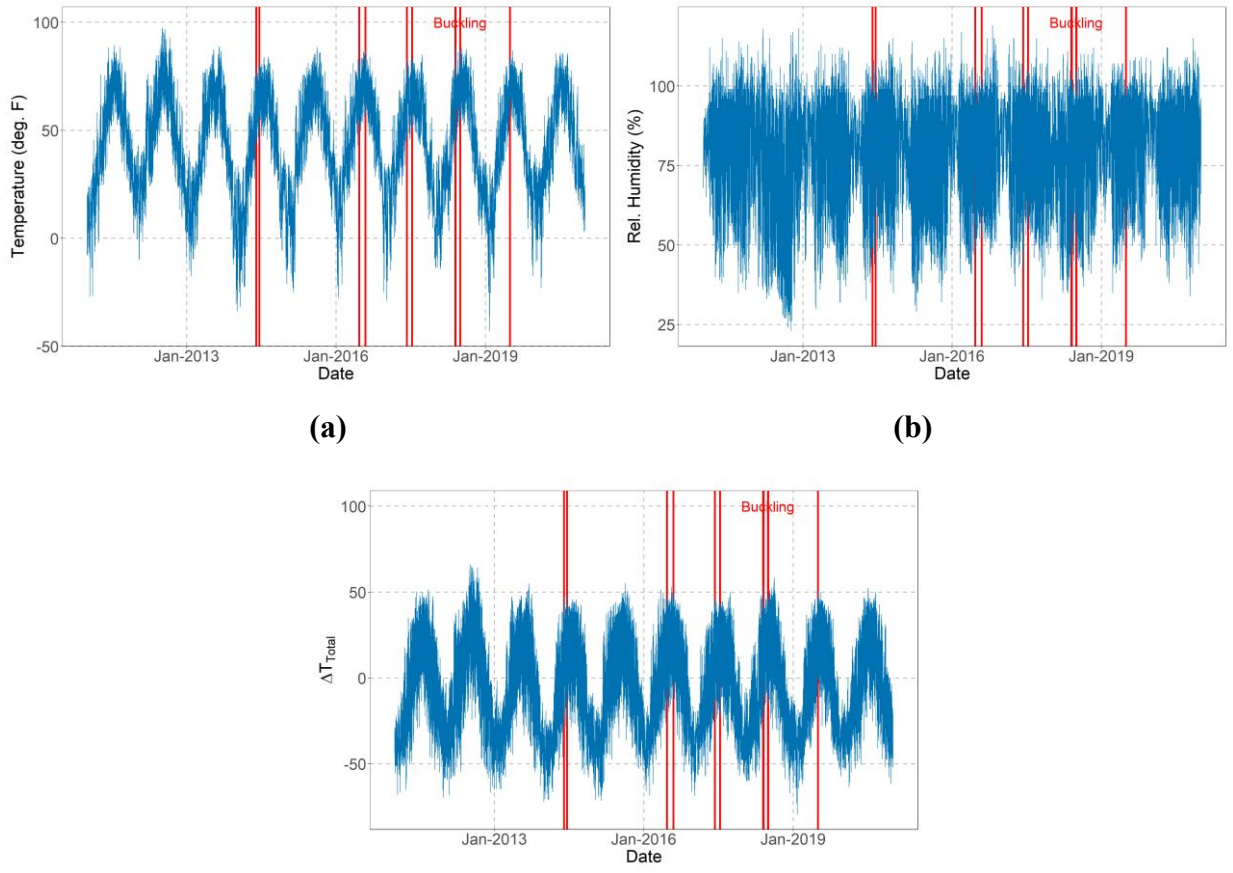
Figure 33. Control site # 1 (a) temperature, (b) relative humidity, and (c) mean ΔT_{Total}.

As an example, Figure 33 shows the temperature, humidity, as well as the calculated ΔT_{Total} value for control site # 1, where the joints were relatively free of incompressible materials and no buckling was observed. The figure also shows the blowups that occurred along the same roadway within ± 5.0 miles from control site # 1, which correspond closely to the ΔT_{Total} peaks as expected.

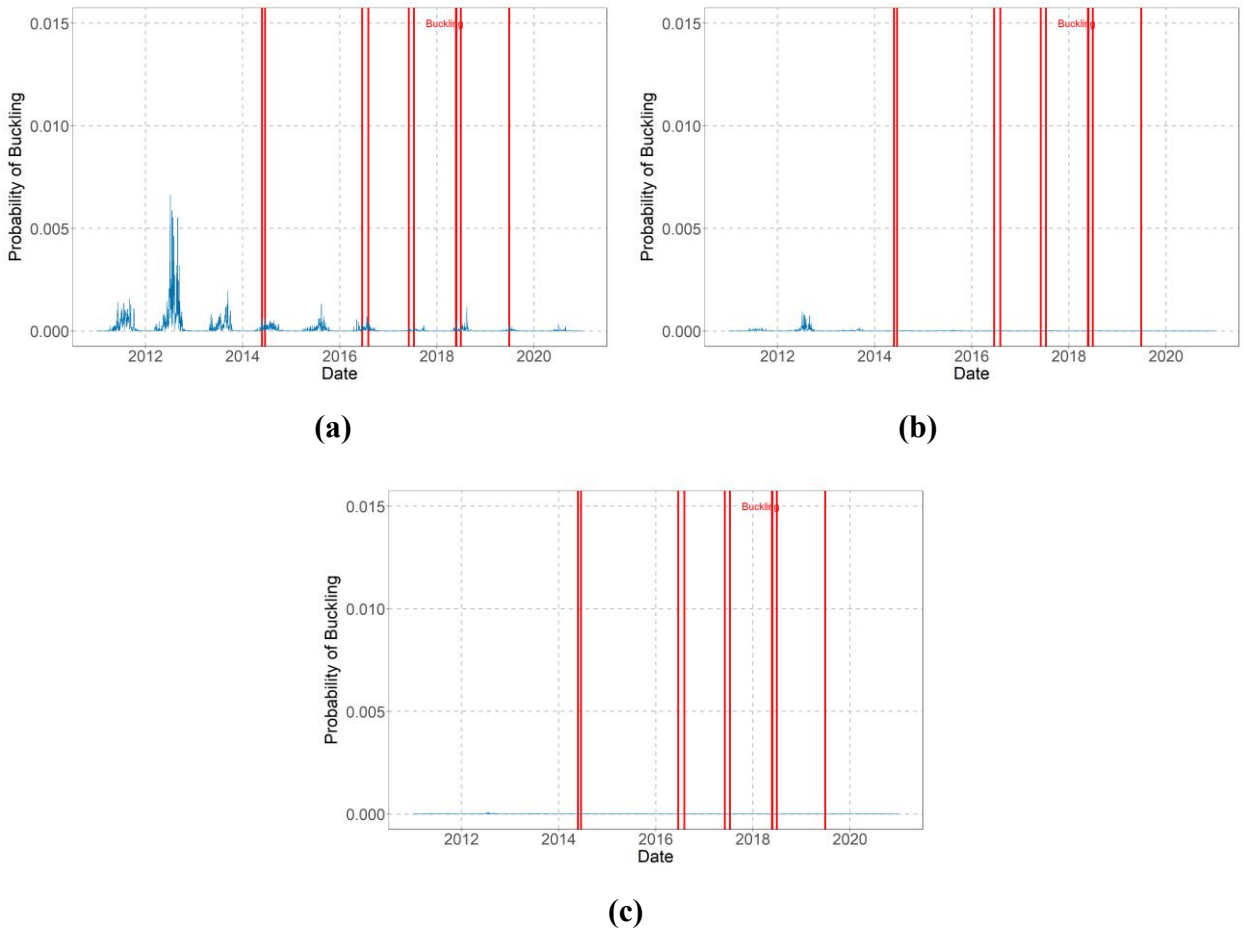
Figure 34. Probability of buckling for control site #1 for neutral temperatures of (a) 50 ºF, (b) 70 ºF, and (c) 90 ºF.

Figure 34 shows the probability of buckling for different neutral temperatures of PCC pavement. Similarly, Figure 35 shows the expected number of joints to buckle per mile (assuming 352 total joints per mile, with 15 feet joint spacing). These figures generally show minimal probability of buckling, especially for PCC neutral temperature above 70 ºF. Figure 34 and Figure 35 suggest a high probability of buckling in the summer of 2012 for the control site # 1, which corresponds to the peaks of ΔT_{Total} in Figure 33(c), but only if the neutral temperature was not high (50 ºF). However, this control site exhibited no buckling in 2012, which suggests high neutral temperatures or not enough incompressibles in the joints in 2012.

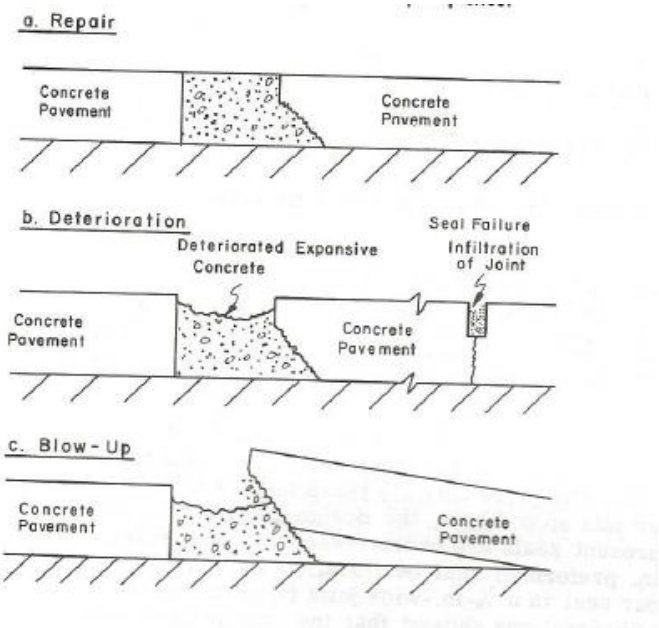
During the summer of 1972, Utah experienced its first blowups on pavements that were 9 years of age. The initial investigation at these sites indicated that the blowups had occurred at two locations where the contractor had left transverse wooden bulkheads in-place that were laid at the end of a day's paving (McBride and Decker 1975). These locations were later noticed and repaired as shown in Figure 41. However, the repairs were performed such that the conditions were conducive for a blowup to occur – note in Figure 41 the repair material acts as a ramp for the existing concrete pavement. About 9 years later, blowups occurred at these locations thus demonstrating how deficient construction and repair procedures can lead to buckling.

Figure 41. Utah repair, deterioration, and buckling sequence (McBride and Decker 1975).
