AESTHETIC COATINGS FOR STEEL BRIDGE COMPONENTS

WisDOT ID no. 0092-11-07

November 2013

FINAL REPORT

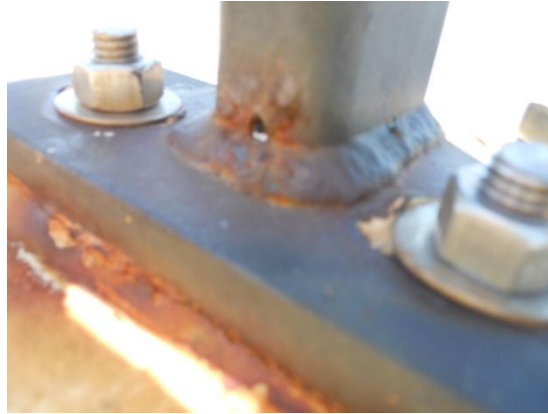
Figure 8: Sauk City Bridge Railing Drainage Hole

Connection and expansion joints constructed in the railings of the bridge are shown in Figure 6. At both connection types, poor construction details were used and there were easy access points where water could penetrate and accumulate inside the tubular members of the railings. Due to insufficient drainage, accumulated water froze and expanded during the winter months that lead to excessive expansion and failure of both the tubular railing members and the coating system in the local areas, see Figure 7. It appeared that the WisDOT maintenance personnel or others attempted to remedy the water accumulation problem inside the railing members for this bridge after the initial construction by drilling small holes in some areas of the railings, see Figure 8. However, it was found that additional drainage were needed and most of the drilled holes were plugged with debris since they were small and located close to the base of the railing where debris tend to accumulate more frequently.

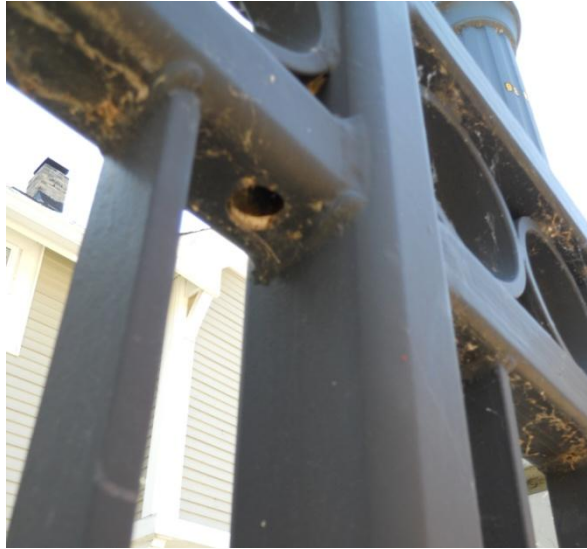
Figure 11: Jefferson Bridge Railing Galvanization Holes

Prior to the galvanization process of steel railings, holes are drilled in strategic locations of the railing to allow entrapped air or moisture to exit and to prevent bursting of the members due to expanding gases, see Figure 11. During the galvanization process the steel is submerged in a molten zinc bath at approximately 830°F. At these high temperatures, entrapped air and moisture will expand and form very high pressure if there is not adequate drainage or ventilation in the railing members. Drilling appropriate vent holes in the railing members is not only beneficial during the galvanization process, but also allows future water or moisture to drain from the inside of the railings. Because of adequate vent/drainage holes in the railing

members, there was no damage in the railing of this bridge due to water entrapment and freezing.

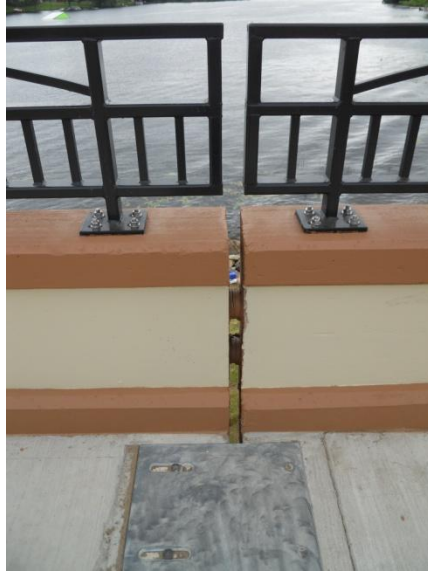
Figure 12: Tomahawk Bridge Railing Expansion Joint

The Tomahawk Bridge (B-35-154) is located in Lincoln County, Wisconsin, on North 4th Street crossing the Wisconsin River. This bridge was constructed in 2011. The bridge received galvanized decorative railings with a black two-coat coating system applied over the galvanized steel. An enhanced structural detail used for the railing was based on eliminating the connecting members at the expansion joints, see Figure 12. In both galvanized and conventional railings these areas experience coating failures and corrosion more frequently due to the presence of moving members and sharp edges or discontinuities.

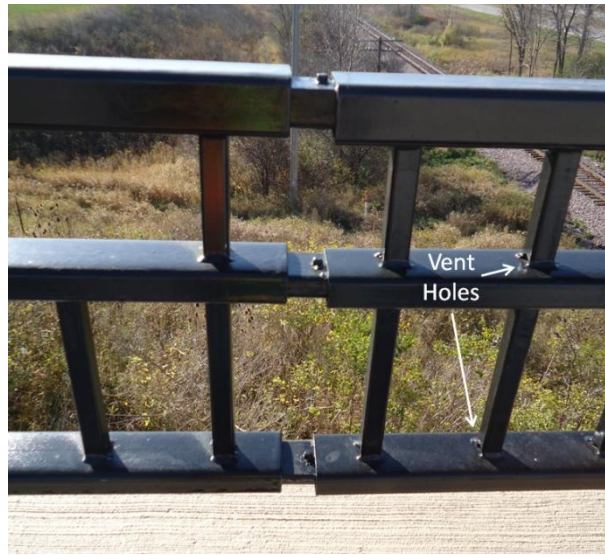
Figure 13: Highland Ave and I-43 Bridge Railing Vent Holes

The Highland Ave and I-43 Bridge (B-45-21) is located in Ozaukee County, Wisconsin, on Highland Ave crossing Interstate 43. This bridge was constructed in 2011. The bridge received galvanized decorative railings with a black two-coat coating system applied over the galvanized steel. The bridge railing contains vent holes cut at the base of each vertical member as shown in Figure 13. These vent holes were made to facilitate the galvanization process and prevent water or moisture from being trapped in the railings. It was observed that there are signs of corrosion particles in the vicinity of the vent holes, see Figure 14.

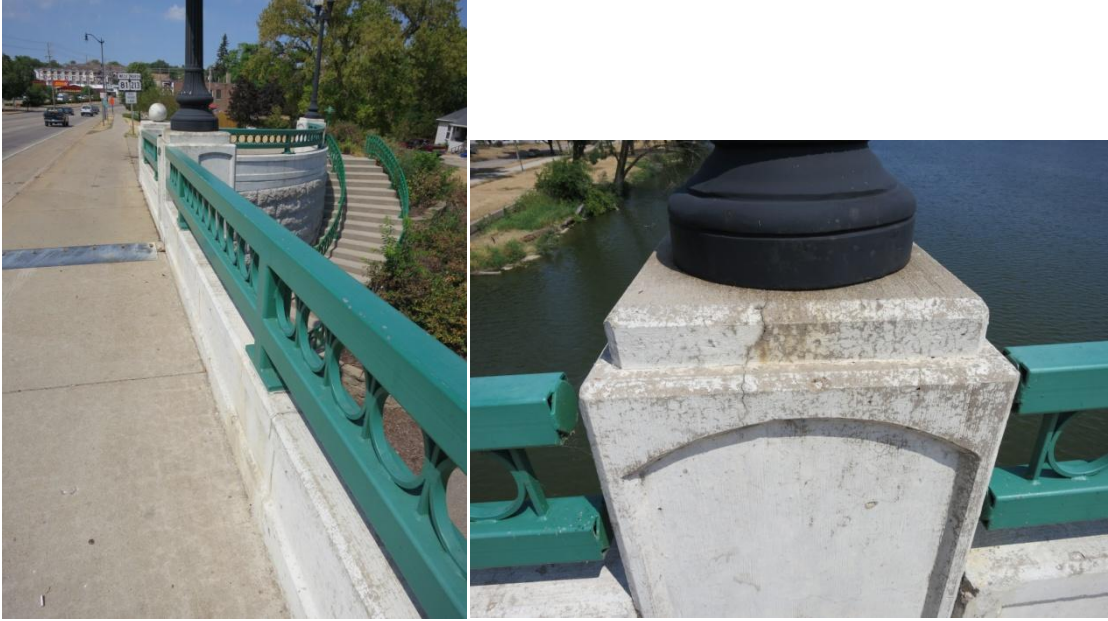
Figure 17: Beloit Bridge Railing Connections

of aggressive exposure as the darker color coatings. Again, it was observed that the galvanization of the steel railing was effective in preventing occurrence of corrosion even though the coating system has shown signs of failure at different areas of the railing at this bridge site. No mechanical connections or expansion joints are used in the railings of this bridge as adjacent sections of the railing are interrupted by short concrete pedestals rising from the top of the parapet supporting the railings, see figure 17. Also, there was no evidence of peeling of the coating from the galvanized steel in the railing of this bridge. Overall, it was concluded that the choice of appropriate structural details, coating system, and application has largely contributed to the relatively successful performance of the railings in this bridge for more than 15 years.
