Optimizing Bridge Abutment Slope Protection at Stream Crossings

WisDOT ID no. 0092-21-02

December, 2022

WISCONSIN HIGHWAY RESEARCH PROGRAM

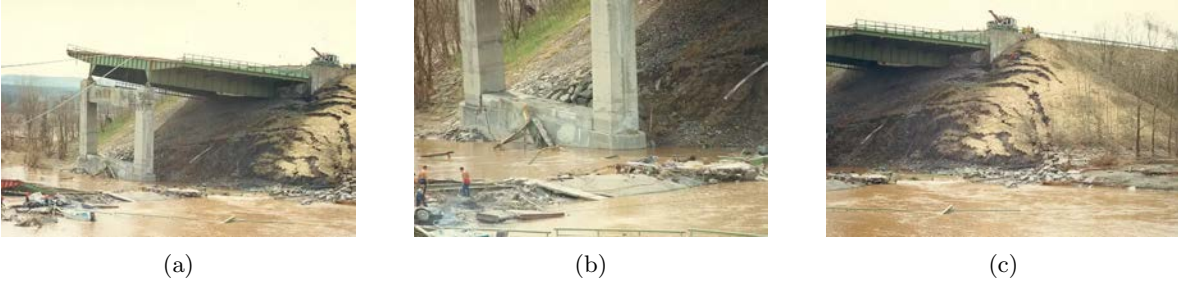
- Custer Creek train wreck as the worst rail disaster in Montana history, occurred on June 19, 1938, when the foundation of the bridge AA-438 washed away by a flash flood. Consequently, the bridge structure collapsed beneath the Milwaukee Road’s Olympian as it crossed the Custer Creek river near Saugus, Montana, killing about 47 people.
- Schohaire Creek Bridge’s failure over the Schohaire Creek near Fort Hunter and the Mohawk River in New York State on April 5, 1987, due to the foundations’ scour-induced failure after record rainfall. Unfortunately, the collapse caused nine casualties and one missing but served as the motivation for improving bridge design and inspection procedures with the New York State and beyond. Figure 1 presents some aftermath photos of this tragedy.

Figure 1: Photos from a Utica resident document the aftermath of the collapse of the New York State Thruway bridge over the Schoharie Creek in 1987 [29]

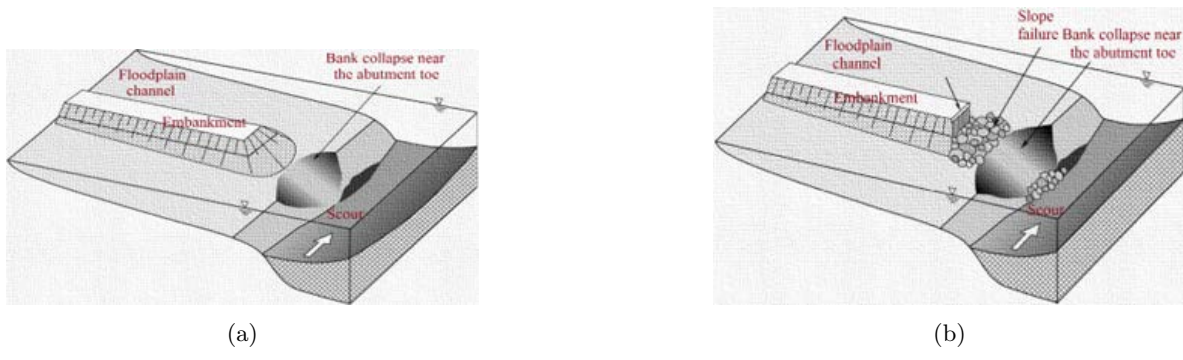
Condition I: Scour destabilization of the main channel banks near the abutment placed close to the bank. It is recognized that compared to the bed of the main channel, the floodplain is relatively resistant to erosion. Figure 4a illustrates a multi-stage failure process for a spill-through abutment due to scour leading to the geotechnical failure of the main channel banks and the abutment adjoining embankment. In this case, the hydraulically induced failure of the main-channel bed triggers the channel bank's geotechnical instability and collapse. As the bank becomes unstable, it undercuts the abutment embankment and its local collapse, and as a result, embankment and bank soil and possibly their attached protective riprap layer start to collapse into the scour hole, as shown in Figure 4b. For the wing-wall abutments, which are located within the bank of the main-channel, in addition to flow contraction, several other erosion processes can lead to the failure of the bank of the main-stream channel and the approach embankment. In this case, the local flow field emerged due to abutments' presence can result in local scour at the abutments' vicinity, as shown in Figure 5a. As the scour hole grows, the channel bank and the abutment embankment face collapse into the scoured area, as shown in Figure 5b. In the case of wing-wall abutments, it is also common to encounter the exposure of piles under the pile cap supporting the abutment and erosion of the riverbank and embankment soil from the beneath of the pile cap and in-between the piles, as shown in Figure 6.

Figure 4: Multi-stage collapse process of a spill-through abutment in a compound channel due to scour associated with scour condition I: (a) Hydraulic scour of the main channel bed sediment leading to riverbank instability and failure; (b) failure of the abutment embankment face. Under this condition, the floodplain is much less erodible than the main-channel sediments [adapted from NCHRP].

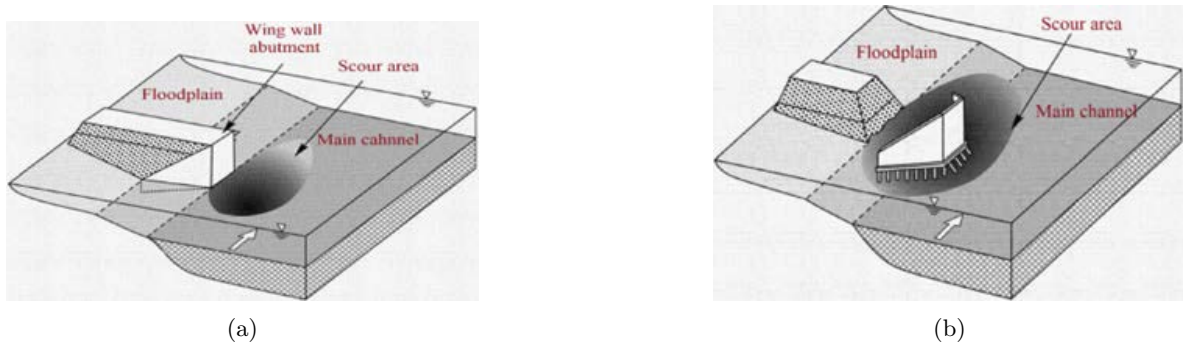
Figure 5: The two-step scour-induced collapse process of a wing-wall abutment associated with scour condition I: (a) Hydraulic scour of the main-channel bed sediment which leads to riverbank instability and failure; (b) Failure of the channel bank and the approach embankment face [adapted from NCHRP].

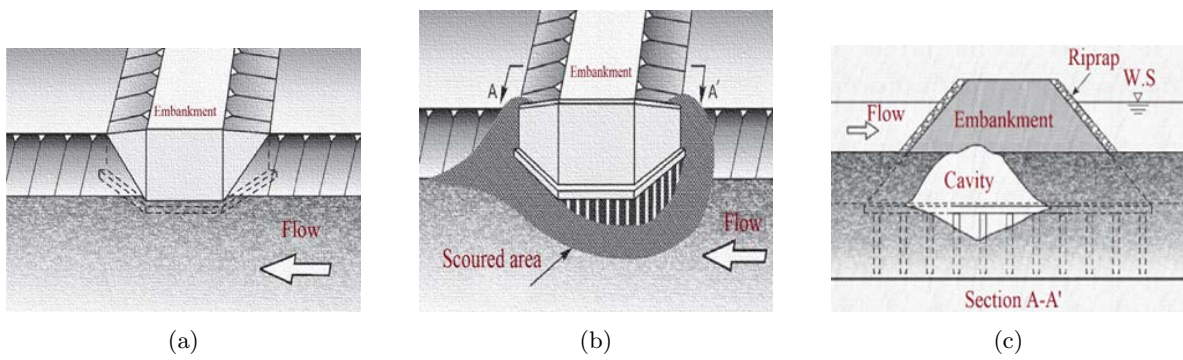
Figure 6: Collapse process of a wing-wall abutment due to the erosion of embankment soil beneath the abutment pile cap: (a) before scour; (b) scour develops under the pile cap; (c) embankment soil is sucked from the beneath of the pile cap forming a cavity in the embankment [adapted from NCHRP].

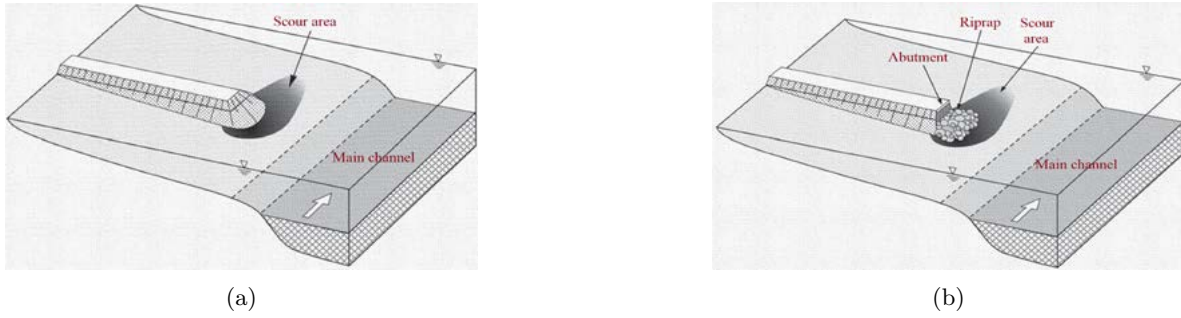
Condition II: Scour of the floodplain around an abutment wall set back from the main channel. It is recognized that the scour at the floodplain usually occurs near and slightly downstream of the abutment. Under this condition, the scour hole can locally destabilize the embankment side slope, which can cause the embankment soil and the protective riprap layer to slide into the scour hole, as shown in Figure 7.

Figure 7: The scour-induced collapse process of a spill-through abutment in a compound channel associated with scour condition II: (a) hydraulic scour of the floodplain; (b) failure of the approach embankment face. Under this condition, the floodplain is more or less erodible. Also, the collapse of the embankment soil and armor layer into the scour hole modifies the scour area [adapted from NCHRP].

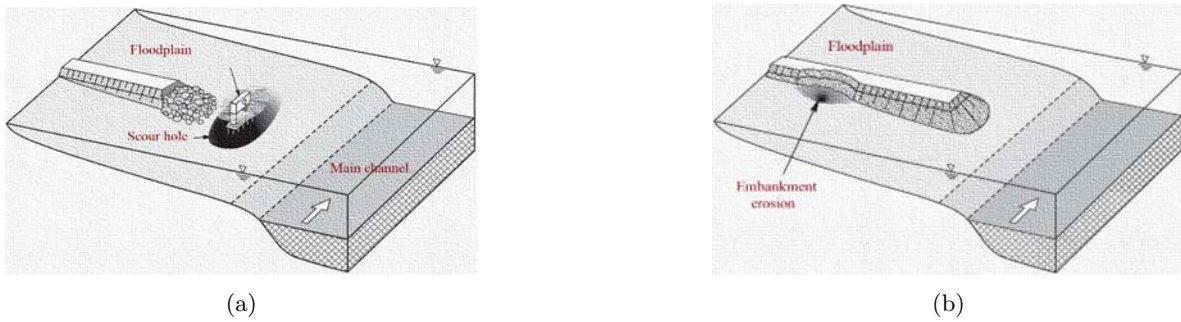
Figure 8: (a) Full washout of the approach embankment exposes the abutment foundation, which can result in the abutment structure's scour process as if the abutment were a form of a pier; (b) Impingement against a long approach embankment resulting in erosion of the embankment [adapted from NCHRP].

Condition III: Scour under conditions I and II may eventually lead to the approach embankment washout, thereby fully exposing the abutment. In this case, scour at the exposed stub or wing-wall abutment can be treated as the scour of piers, as shown in Figure 8a.

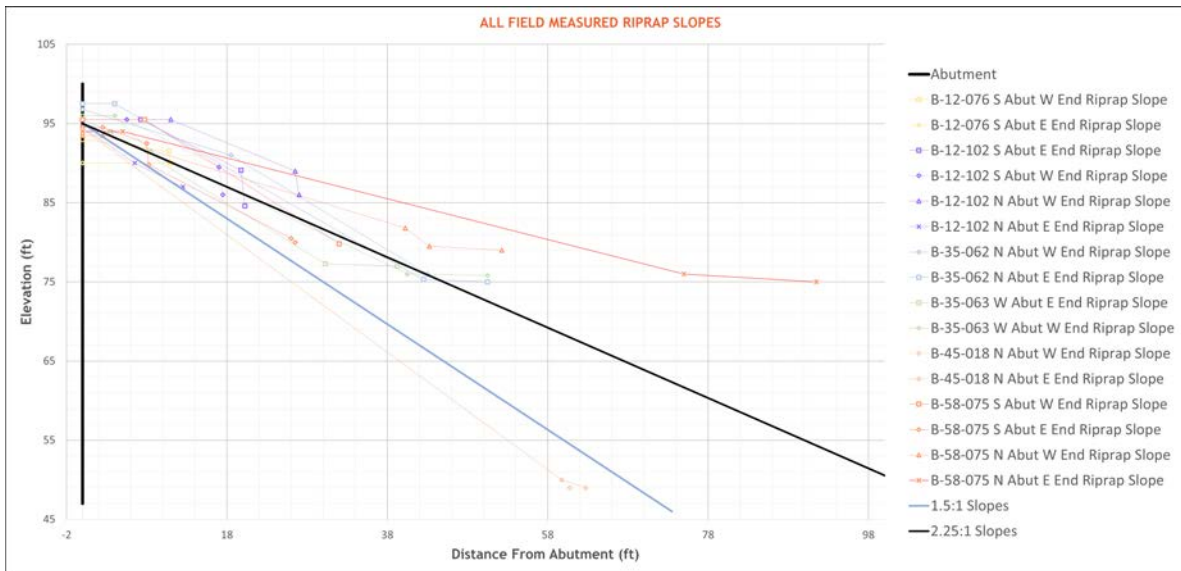
Figure 13: Observed slopes compared to a design slope of 1.5:1 (H:V), and a mean slope of 2.25:1.

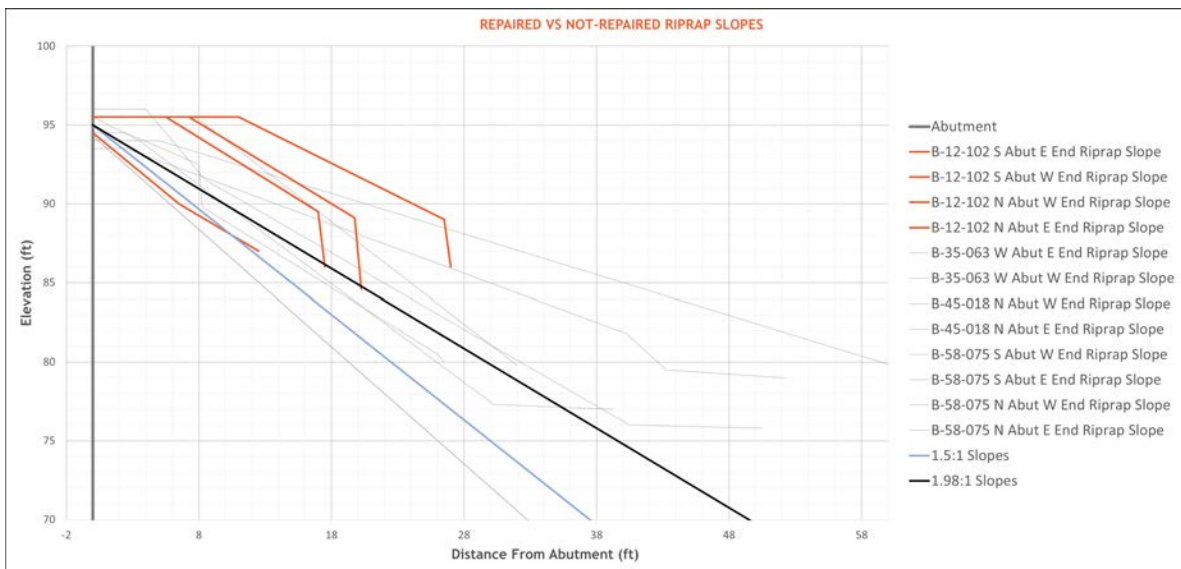
Figure 14: Observed slopes compared to a design slope of 1.5:1 (H:V), and an average current slope of 1.98:1 (not including grouted abutments, or bridges exhibiting purely scour failures). Orange slopes indicated abutments without any repair attempts.

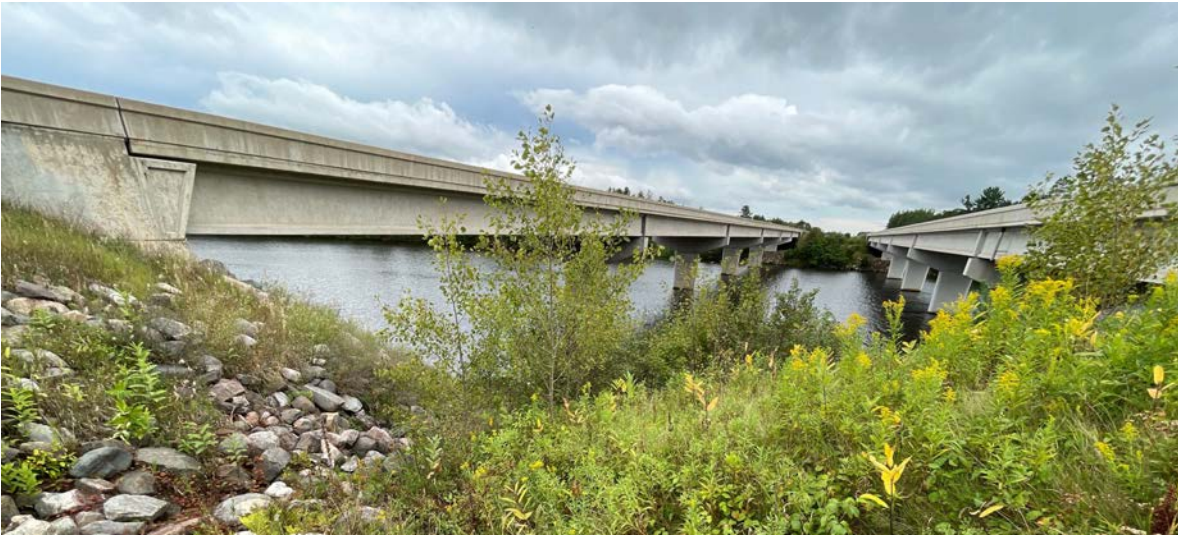
Figure 25: B-35-62 and B-35-63

The multi-span PPC I-Beam with concrete deck bridge is supported by integral/semi-integral abutments on piles with heavy riprap and hammerhead piers. The bridge is parallel to B-35-063 bridge (Figure 25) and has riprap connecting both bridges at the north abutment. The east end of the north abutment was noted with a gap between the riprap and the abutment; see Figure 26a. Per WisDOT field engineers, a concrete pour over repair was done in 2015 on the eroded riprap to cover any erosion/scour holes created by the riprap erosion; see Figure 27 for riprap existing condition overall. A severe hole near the west half of the north abutment was noted. The hole can fit a full-sized person and extends in both directions, towards the abutment (exposing abutment piles) and away from the abutment; see Figure 28. Additionally, the riprap, close to the abutment, was noted with typical cracks

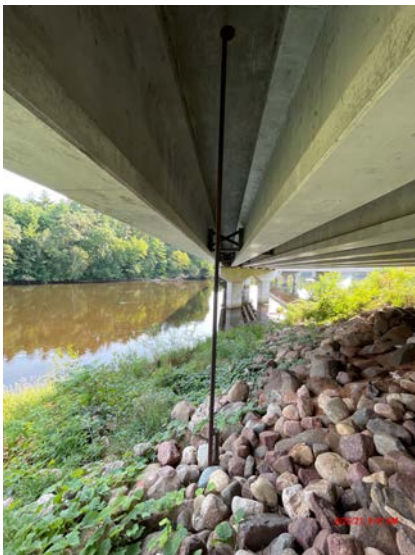
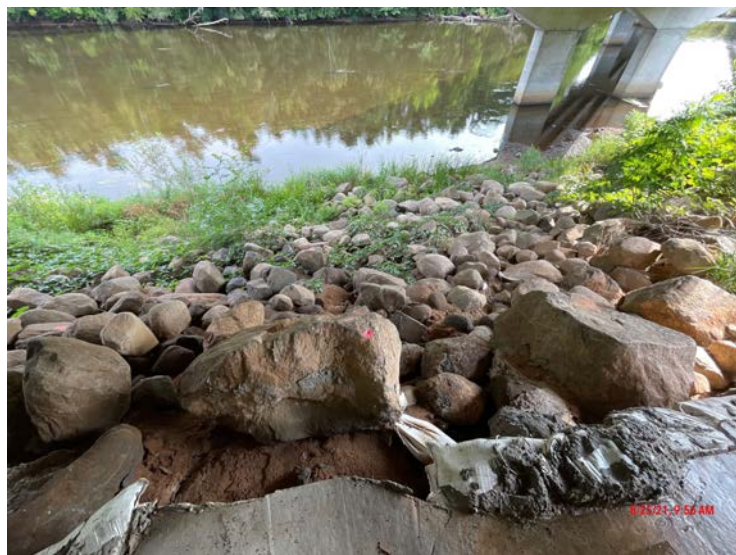
Figure 33: B-58-075 Movement monitoring

The multi-span PPC I-Beam with concrete deck bridge is supported by integral / semi-integral abutments on piles with heavy riprap and hammerhead piers; as shown in Figure 32a. The riprap on this bridge is being surveyed to evaluate the riprap movement and an inclinometer is being used to assess the soil erosion; see Figure 33. The wingwalls were noted with steep slopes as a typical condition. The concrete pour at the west abutment, north end, had sheared off. Concrete repairs in 2014, 2019, and 2020 have left sandbag attachments in place attached to the repair; thus, adding dead weight to the repair after the soil underneath has eroded (see Figure 34). The erosion at the south

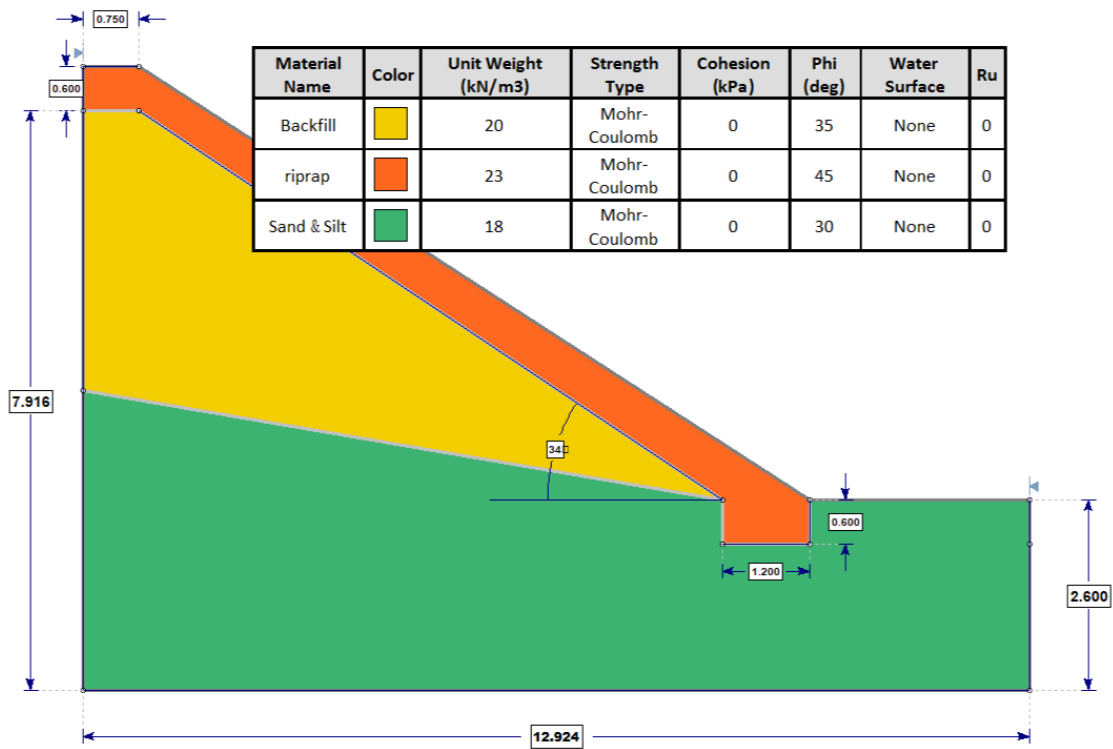
Two critical bridges visited during Task 4 had inclinometers installed in 2019; B-58-75 and B-43-18. The inclinometer data of both bridges is provided in Section A2. It can be seen that the failure surface originates roughly 8-10 feet below grade. Thus the first objective of Task 5 was to replicate this failure mode. Of the two bridges, B-58-75 exhibited more extreme soil movement, and thus was chosen to validate the outlined assessment approach.

A simplified model of the abutment is shown in Figure 35, with a designed slope of 1.5:1 (H:V), along with initial approximations of the soil properties (cohesion and friction angle). The granular backfill on the foreslope was called out as Grade 1 on the bridge plans (either sand-sized particles or sand-sized particles mixed with gravel, crushed gravel, or crushed stone). Additional discussion with WisDOT geotechnical engineers also assisted in informing the choice of soil parameters, with the understanding that in-situ properties are rarely tested. As seen in Figure 35, the abutment was modeled with three layers, indicated as riprap, backfill, and local silty soil. Results for these parameters are shown in Figure 36a, where $FS = 1.252$. A geosynthetic layer was then applied between the riprap and backfill material, which was used in B-58-75. These simulation conditions are then defined as the as-built dry case, shown in Figure 36b. It can be seen that although the geotextile fabric did add some stability ($FS = 1.277$), it might be considered negligible. Regardless of geotextile, the FS is below the allowable consideration for design in dry conditions, which is generally the less conservative case.

Figure 35: Simulation geometry and initial soil properties for B-58-75

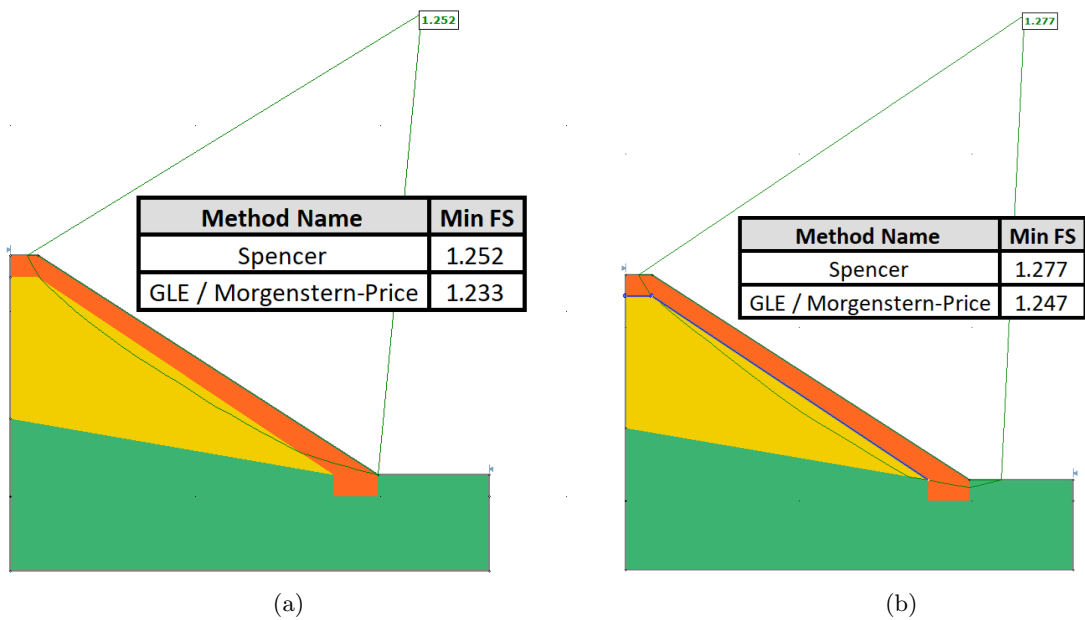
Figure 36: Benchmark analysis of B-58-75 for simulation validation. a) result of analysis of B-58-75 without geotextile fabric, b) simulated as-built dry conditions

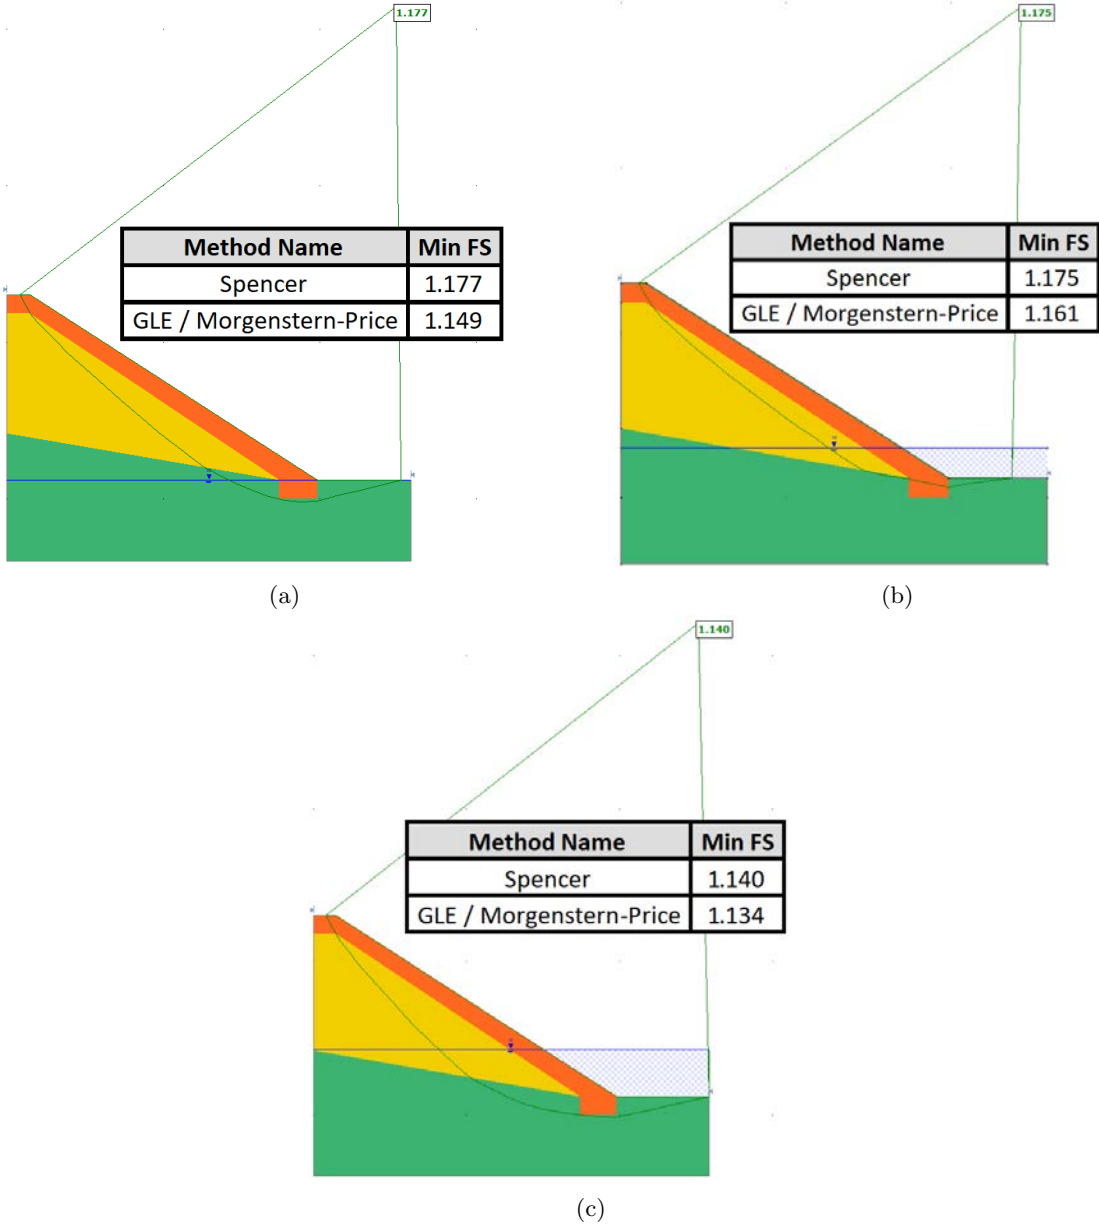
Following the dry case, a series of simulations was run with varying water table elevations to replicate low and high river levels. Analysis with the water level at base of slope, 3 ft above base, and 5 ft above base were considered as common scenarios for low, average, and high water levels. Figure 37 shows the results. The maximum associated failure surfaces are 6 ft (FS = 1.177), 5 ft (FS = 1.175), and 8 ft (FS = 1.140) below riprap, respectively. When compared to the inclinometer data (Figure 33b), which indicate a failure depth of 8-10 ft, it can be seen that the simulations provide good agreement with measured data. Though the analysis underestimates failure depth, it also is conservative with respect to water levels and soil parameters. Thus the results are sufficient to validate the modeling approach. It can also be seen in Figure 37c that the failure surface is deeper than the riprap toe, indicating that a deeper toe may help to improve conditions in high water level events.

Figure 37: Consideration of varying water table levels. a) failure with a water table 0 ft above slope base, b) failure with a water table 3 ft above slope base, c) Failure with a water table 5 ft above slope base
