## Single-Slope Slip-Formed Concrete Barrier Design and Performance

### Research Objectives

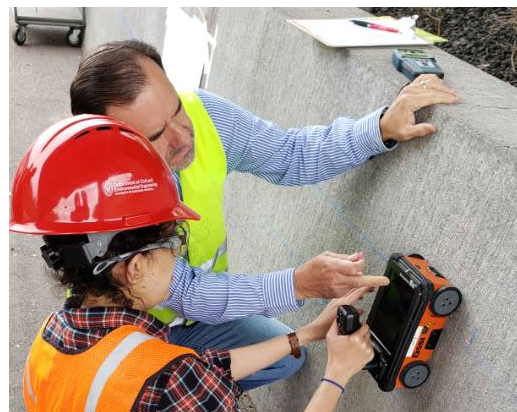
Ground penetrating radar is used to locate rebar within barriers.

The research team visited four locations across the state – one each in the northwest region (NW-1) and southwest region (SW-1) and two in the southeast region (SE-1 and SE-2) – to investigate crack spacing, length and width. Areas with visible distress were evaluated through visual inspection (VI), ultrasonic pulse velocity (UPV), half-cell potential (HCP) and ground penetrating radar (GPR).

GPR and UPV measurements of each barrier did not indicate voids or poor consolidation, suggesting there was not widespread deterioration of stiffness or strength of the concrete. Locally, however, cores extracted from barrier SE-2 showed evidence of voids and poor consolidation. This is further evidence that the concrete used in this barrier was of substandard quality. There were no signs of alkali-silica reaction in the barriers.
