# WisDOT Structure Inspection Series - Timber

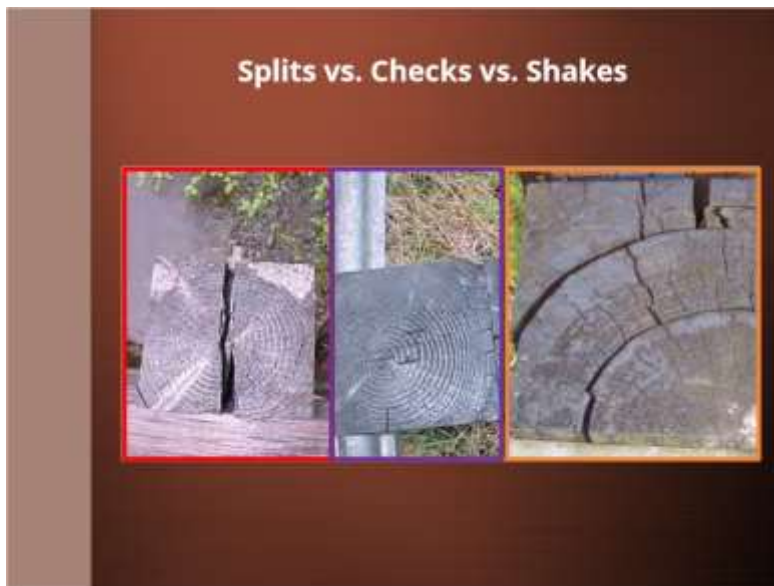
The defects shown here on bridge rail posts, from left to right, are a split, [PAUSE] checks, [PAUSE] and shakes.

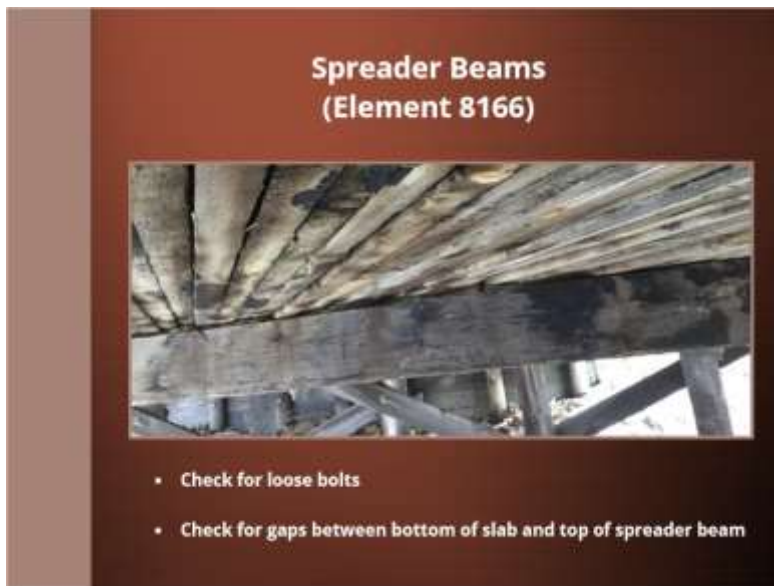
The next topic to highlight is spreader beams – Element 8166. This element label should be used instead of Timber Floorbeam.

Spreader beams, also called transverse stiffener beams, should be tight to the bottom of the slab, so that nearly all of the slab laminations are in contact with it. A recommended maintenance action and/or a structural review may need to occur if the bolts are loose, or if there are a lot of gaps between the bottom of the slab and the top of the spreader beam.

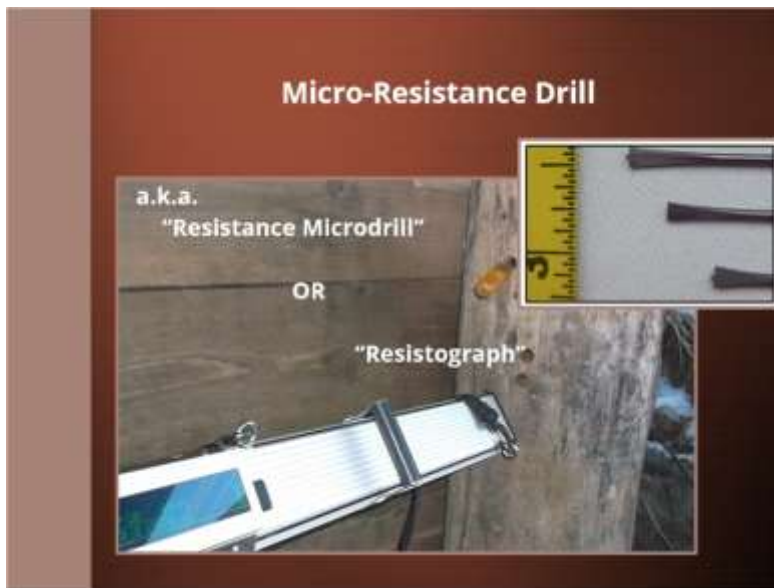
The next topic is a review of one of the most useful NDE instruments for timber bridge inspections, especially for timber piles with decay: A micro-resistance drill, also called a “resistance microdrill” or a “Resistograph.” It uses a needle smaller than 1/8-inch in diameter to identify locations of decay in timber elements. The needle travels through the member at a defined movement rate and rotational speed, and measures the relative resistance of the wood to penetration. Hard wood in good condition will have a lot of resistance. Decayed wood, splits and voids will have very little or no resistance.

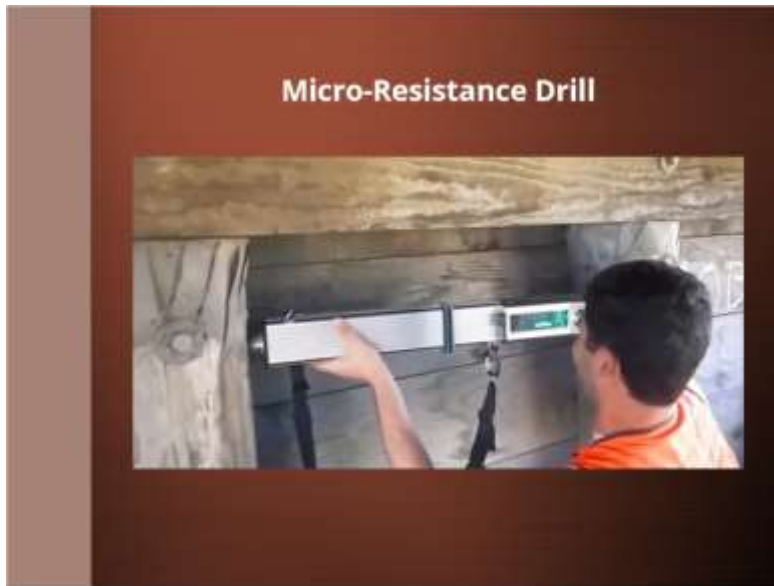
Here it is in action, showing the model WisDOT owns. It has a display screen in which the relative resistance can be observed while drilling.

The spikes up and down on the graph are the growth rings. This is the pattern you will see in good healthy timber. Then it flattens out in the middle, where decay has initiated and the wood is not as healthy, but average resistance is still not a huge drop off. Then after a couple inches the growth ring pattern picks up again. At 11.5 inches, the resistance drops to zero, where the drill has gone through the other side of the pile.
