4.5 NOISE BARRIERS

4.5.1 Introduction

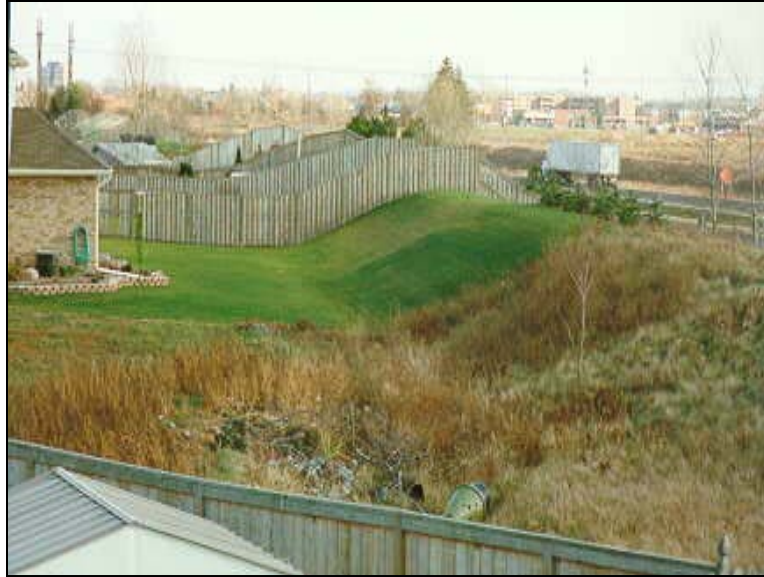
naturally stable slope. Noise barrier berms typically require more width than noise barrier walls due to the required slope of the sides, which needs to be gradual enough to maintain stability. Noise protection is typically warranted in more urban settings. Consequently, the available footprint for a structure is limited due to the higher cost associated with it. This results in the construction of a Noise Barrier Wall rather than Noise Barrier Berm in nearly all instances in Wisconsin. WisDOT does not inventory or inspect Noise Barrier Berms. Refer to Figure 4.5.1-1 for a view of a noise barrier berm.

Figure 4.5.1-1: Noise Barrier Berm between Residential Buildings (Foreground) and a Roadway (Background).

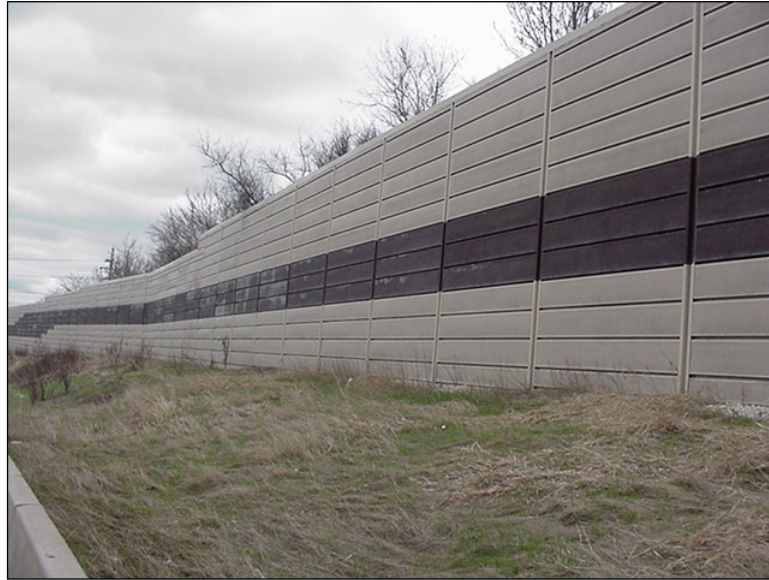
A noise barrier wall is typically a designed-cantilever structure. The components are typically prefabricated off-site and assembled on-site. A variety of noise barrier wall designs exist including: post & panel; brick & masonry block; freestanding noise walls; direct burial panels; noise walls as earth retention structures; and cast-in-place concrete walls. Refer to Figure 4.5.1-2 for a view of a noise barrier wall.

Figure 4.5.1-2: Ground Mounted Metal Panel Noise Barrier Wall.

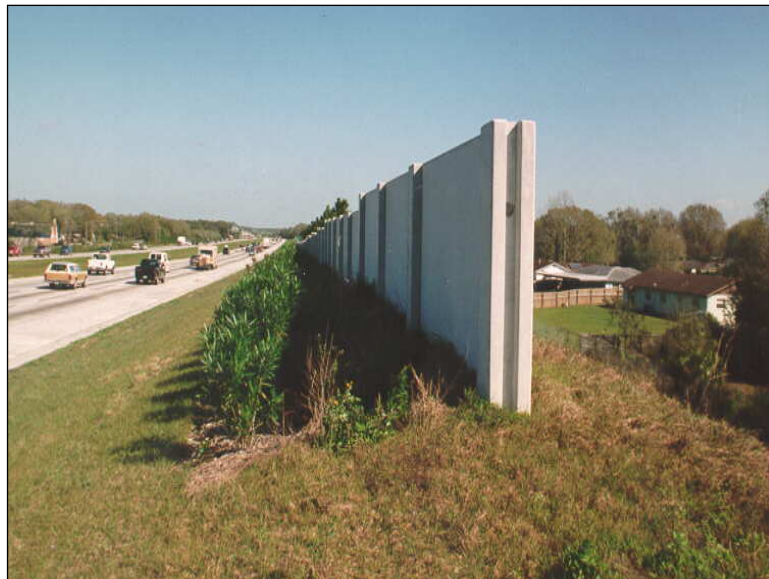
Many systems use a combination of types to obtain the required height of the noise barrier. Noise walls are frequently erected on top of a noise berm. Refer to Figure 4.5.1-3 for a view of a berm and noise barrier combination structure.

Figure 4.5.1-3: Combination Noise Barrier Berm and Wall.

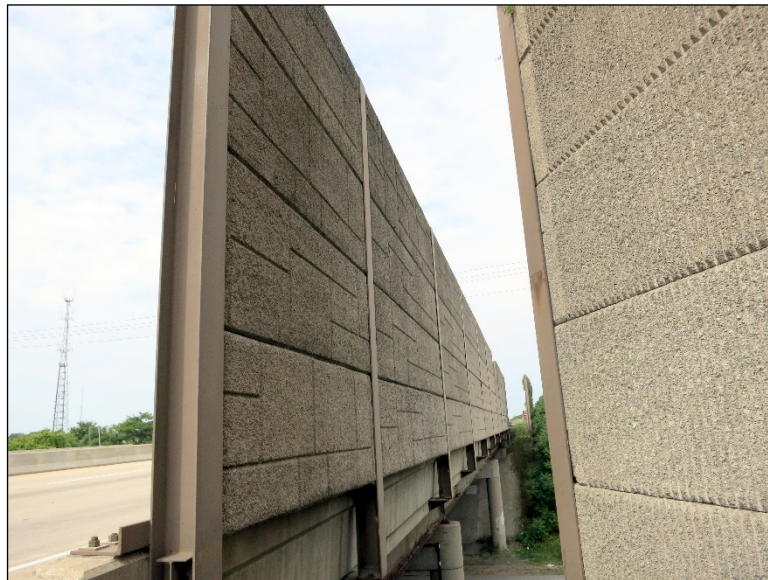
Figure 4.5.1-4: Precast Panel Noise Barrier Wall Mounted on a Bridge.

retaining walls. For bridge inspections, it is the inspector's task to identify all non-'N' numbered noise barriers, and record them as Element 8610 Noise Barrier – Structure Mounted on the bridge inspection form. Refer to Section 4.5.3 of this manual for further information on Noise Barrier Elements. If the noise barrier has an 'N' number assigned to it, then the noise barrier will not be recorded on the supporting structure inspection form, but will be properly inventoried and inspected under its own report and inspection frequency. The inspector shall, however, note within the 'Structure Specific Notes' of the supporting structure report the 'N' number structure, where its located and perform a cursory inspection of the noise barrier and note them within this section. If significant defects affecting the functionality of the barrier or the safety of the travelling public are discovered, the owner of the noise barrier shall be notified immediately. Non 'N' numbered noise barriers will not be assigned 'N' numbers in the future. Therefore, the inspector is required to include non 'N' numbered structure-mounted noise barriers within the supporting structure inspection report with the appropriate element and defects. Refer to Figure 4.5.1-4 through Figure 4.5.1-6 for views of structure-mounted noise barrier walls.

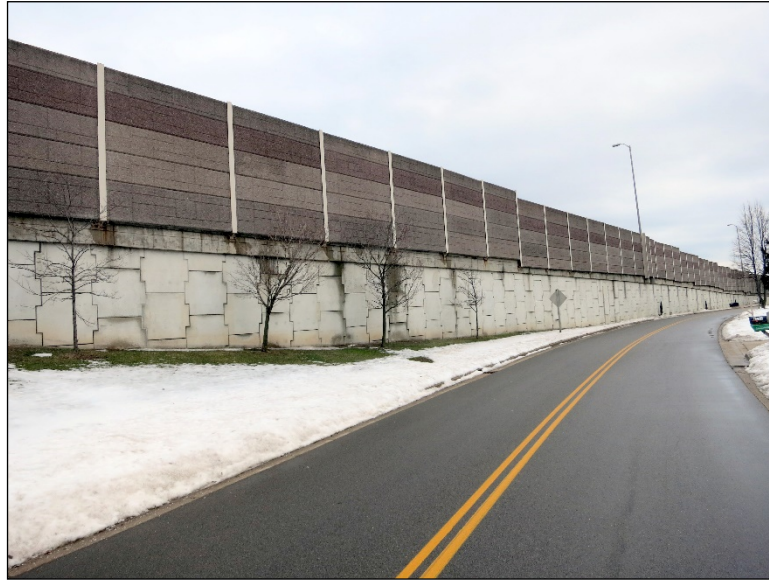
Figure 4.5.1-5: Precast Concrete Panel Noise Barrier Wall Mounted on a Retaining Wall.

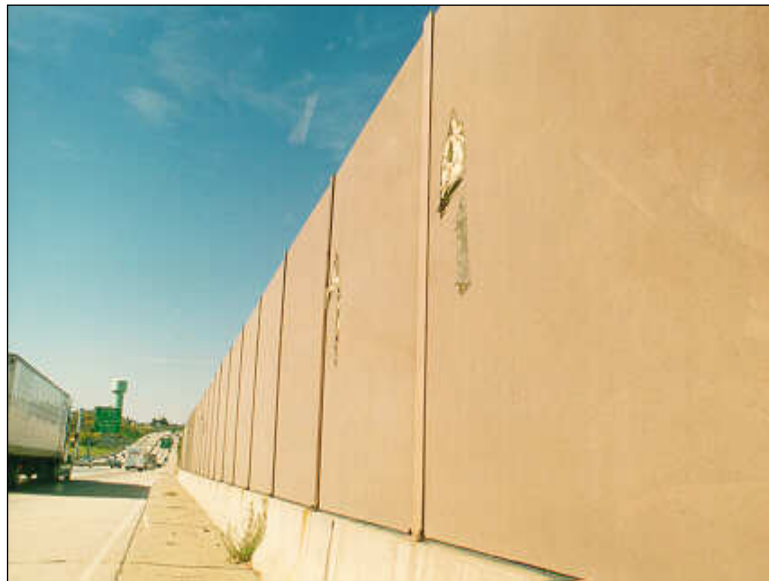
Figure 4.5.1-6: Precast Concrete Noise Barrier Wall Mounted on Concrete Vehicular Crash Barrier.

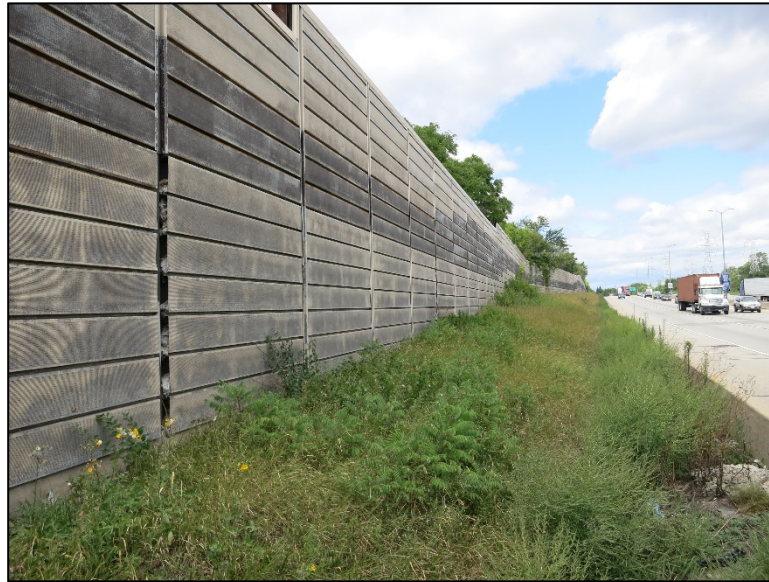
Noise walls that are not attached to other systems are considered ground mounted.

Figure 4.5.3-1: Ground Mounted Noise Wall.

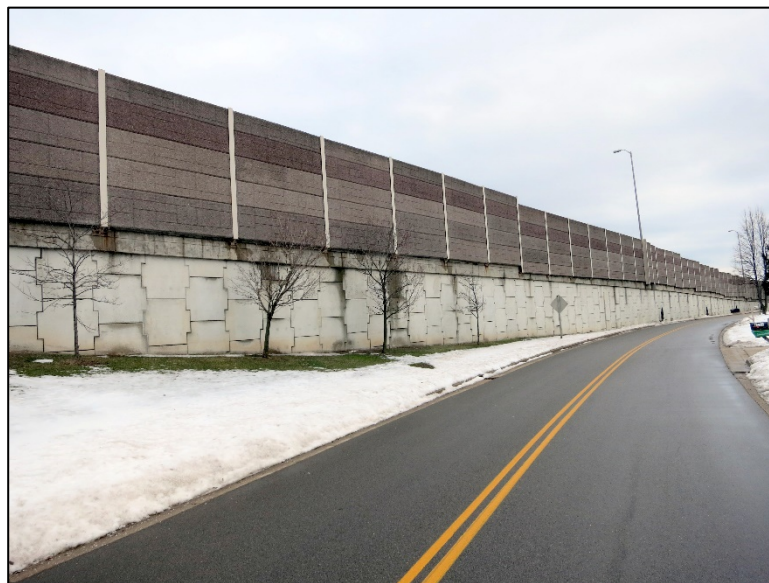
Noise walls that are attached to other systems are considered structure mounted. If the noise barrier is attached to the bridge and has an 'N' number assigned to it, then the noise barrier will not be recorded on the bridge inspection form. However, it is the inspector's due diligence to perform a cursory inspection of the noise barrier to ensure that the travelling public is not threatened by any notable deterioration of the noise barrier. Any areas of concern can be captured as maintenance items, but would not have the element associated with it.

Figure 4.5.3-2: Structure Mounted Noise Wall. Mounted to Retaining Wall Structure.

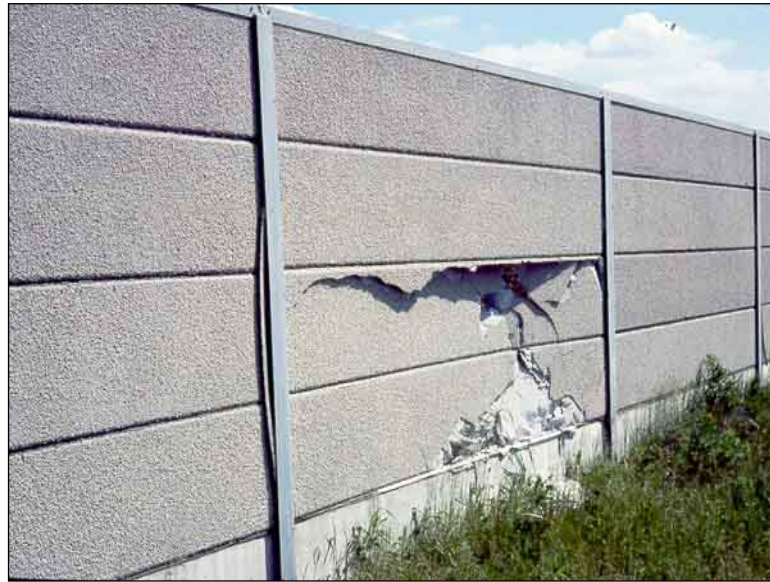
Figure 4.5.4-1: Impact Damage to a Noise Barrier Wall.

Impact damage is typically confined to an area directly adjacent to the point of contact and is characterized by distortion or crushing of the construction material at the point of contact with cracking, splitting, or splintering radiating from this point. Refer to Figure 4.5.4-1 through Figure 4.5.4-3 for views of impact damage.

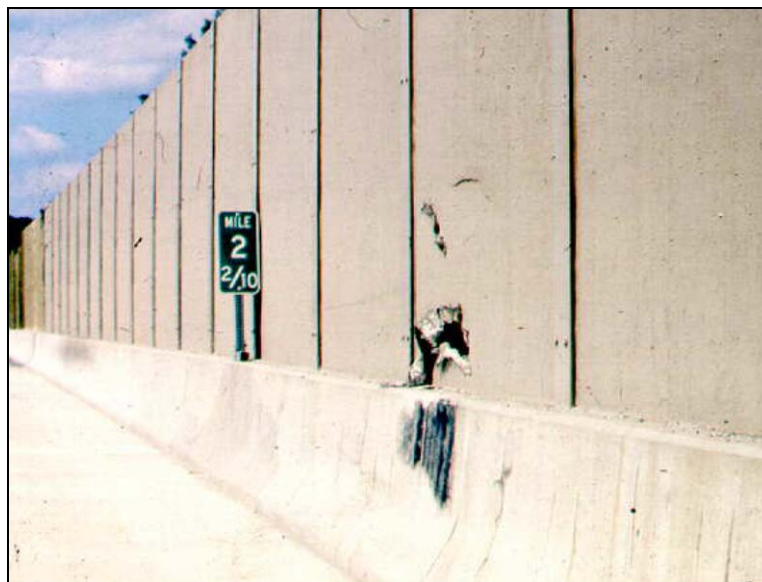
Figure 4.5.4-2: Impact Damage to a Noise Barrier Wall.

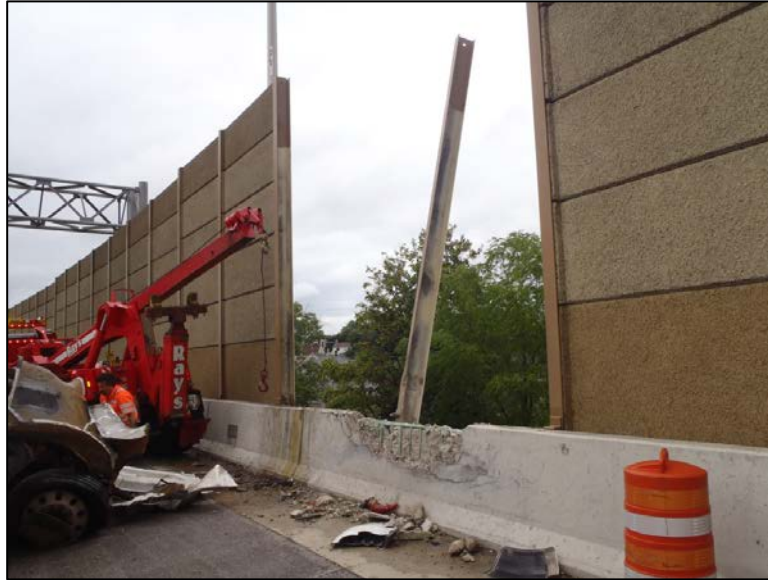
Figure 4.5.4-3: Impact Damage with Failed Post and Paneling of Structure Mounted Noise Wall.

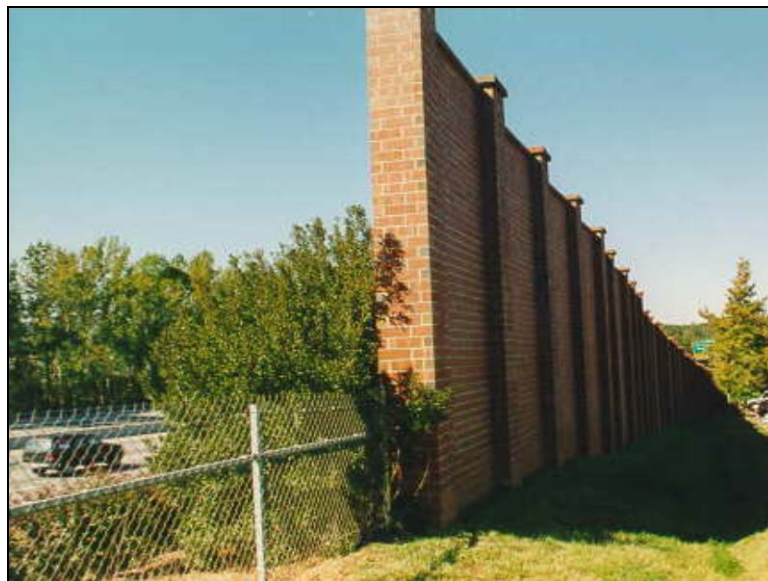
Figure 4.5.4-4: Typical Masonry Noise Barrier Wall.

The following is a discussion of different types of material defects that may be found when inspecting masonry units. Refer to Figure 4.5.4-4 for an overall view of a masonry noise barrier wall. Refer to Part 4, Section 4.3.1 for photographs of typical Masonry deterioration.

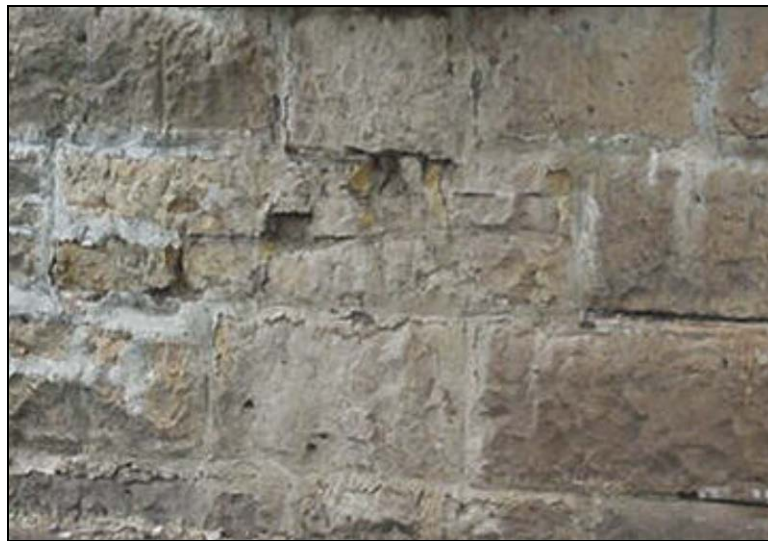
Figure 4.5.4-5: Heavy Scaling with Efflorescence on a Masonry Noise Barrier Wall.

- **Scaling:** This is a special type of freeze-thaw damage. It is generally characterized by significant exterior damage and crumbling, more so than typical freeze-thaw damage. Refer to Figure 4.5.4-5 for a view of heavy scaling on a masonry noise barrier wall.

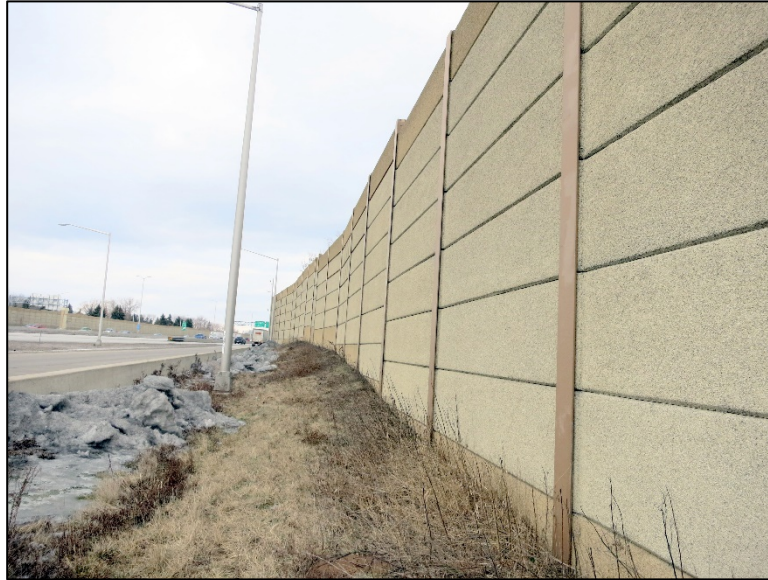
Figure 4.5.4-6: Overall View of a Concrete Noise Barrier Wall Comprised of Reinforced Concrete Core and Durisol (wood/cement fiber) Cladding.

The following is a discussion of different types of material defects that may be found when inspecting pre-fabricated concrete panels and cast-in-place concrete. Refer to Figure 4.5.4-6 for an overall view of a concrete noise barrier wall.

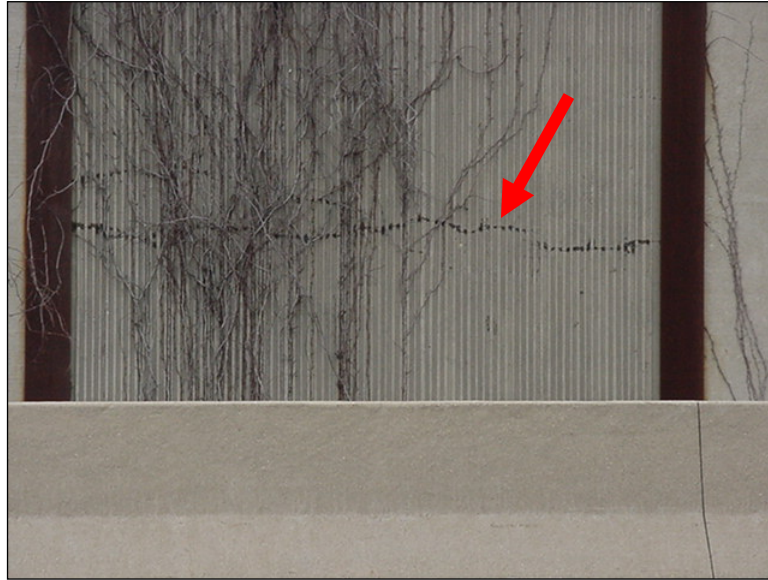
Figure 4.5.4-7: Concrete Panel Noise Barrier Wall with a Horizontal Crack at Mid-Panel.

- **Scaling:** This is a special type of freeze-thaw damage. It is generally characterized by significant exterior damage and crumbling.
- **Cracking:** Random cracks in the structure. Examples might include diagonal, straight, or horizontal crack propagation. Cracking may also occur longitudinally within the concrete core of the Durisol type panels which may not be visible except along the bottom face of the bottom panel of structure-mounted noise walls. Refer to Figure 4.5.4-7 for a view of a concrete panel with a horizontal crack. Refer to Figure 4.5.4-8 for a view of cracking along the underside of a bottom panel of a structure mounted noise wall.

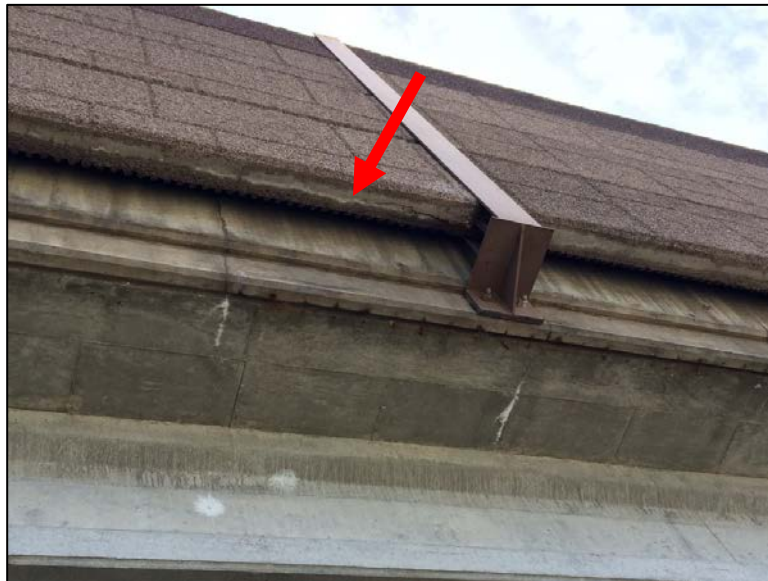
Figure 4.5.4-8: Cracking with Efflorescence Along Midline of Underside Panel.

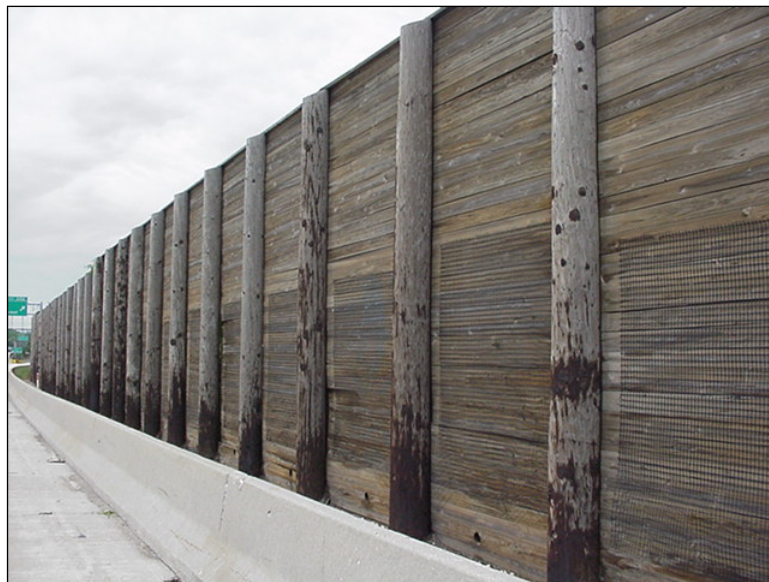
Figure 4.5.4-9: Timber Plank and Post Noise Barrier Wall.

The following is a discussion of different types of material defects that may be found when inspecting timber. Refer to Figure 4.5.4-9 for an overall view of a timber plank noise barrier wall and Figure 4.5.4-10 for a view of missing timber planks on a noise barrier wall.

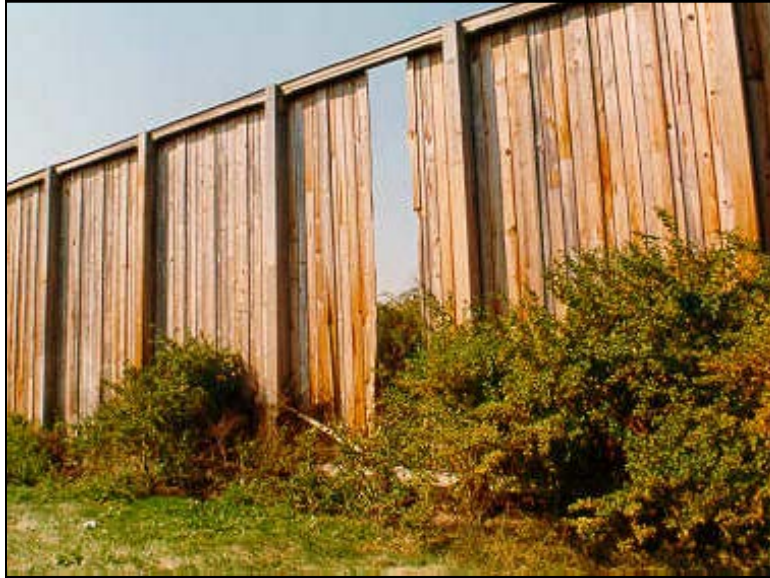
Figure 4.5.4-10: View of Broken and Missing Timber Planks.

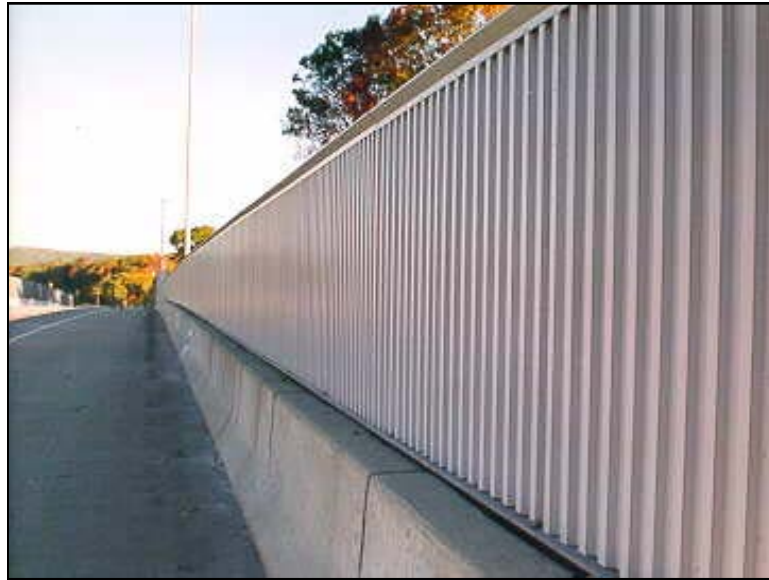
Figure 4.5.4-11: Steel Noise Barrier Wall.

The following is a discussion of different types of material defects that may be found when inspecting metal. Refer to Figure 4.5.4-11 for an overall view of a metal noise barrier wall.

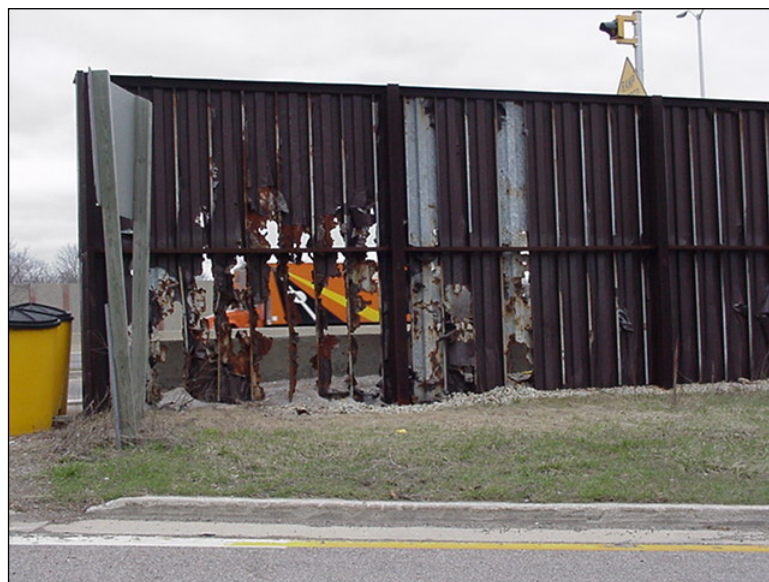
Figure 4.5.4-12: Severe Corrosion of a Metal Noise Barrier Wall.

- **Fatigue Cracking:** Cracks that have formed as a result of cyclic wind loading.
- **Corrosion:** This type of deterioration is the slow, steady deterioration of ferrous material due to exposure of bare metal, moisture and oxygen. Exposure to deicing chemicals act as a catalyst and accelerate metal corrosion. Refer to Figure 4.5.4-12 and Figure 4.5.4-13 for views of metal corrosion.

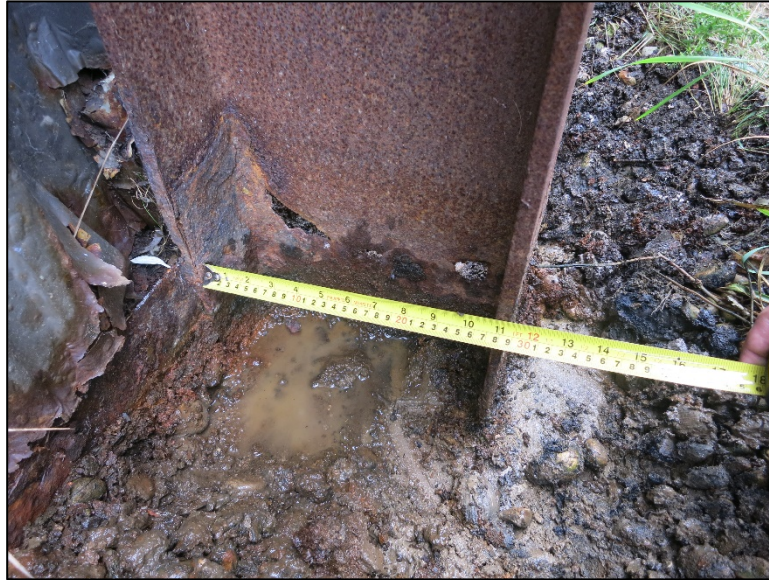
Figure 4.5.4-13: View of Through Section Loss Along the Base of a Post for a Post and Panel Noise Wall.

- **Corrosion:** Corrosion of the steel posts between panels will typically occur along the side facing the roadway spray and especially at the base where debris and deicing agents will accumulate. The inspector should check for scaling, pack rust and section loss. Digging out a few inches of material around the steel posts may be required to fully expose corrosion occurring at the groundline. Refer to Figure 4.5.4-13.

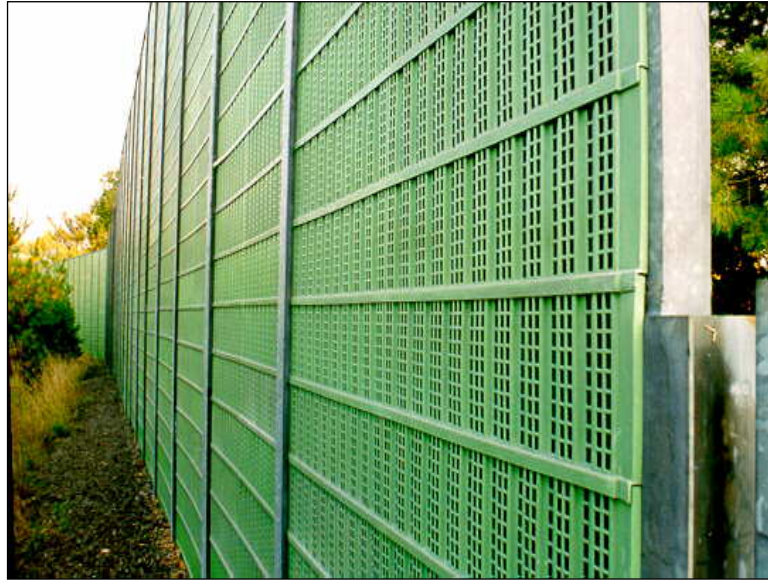
Figure 4.5.4-14: Plastic Composite Noise Barrier Wall.

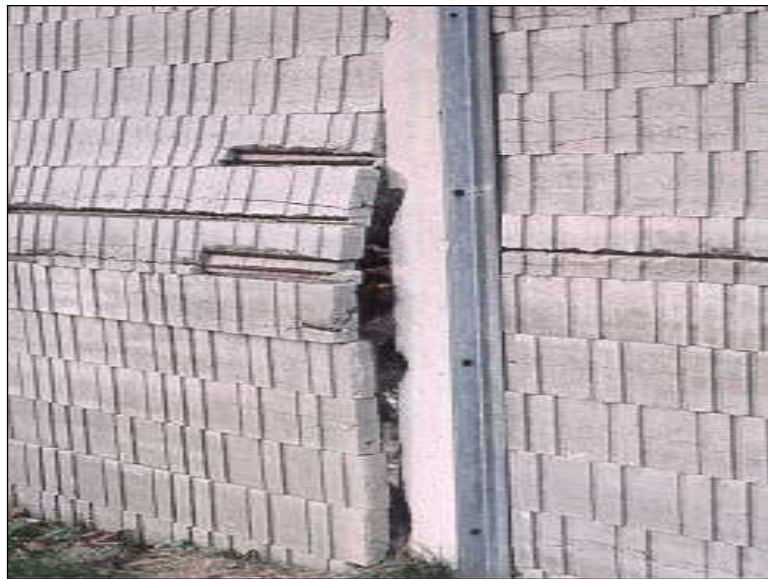
Figure 4.5.5-1: Lateral Movement of a Noise Barrier Wall.

The most common causes of lateral movement are slope failures; seepage; changes in soil characteristics (e.g., frost action and ice); and long term consolidation of the original soil. The most common causes of rotational movement are saturation of backfill due to clogged drains; erosion of the embankment along the front of the wall; and improper design. Refer to Figure 4.5.5-1 for a view of lateral wall movement and its effects on a wall. Refer to Figure 4.5.5-2 for a view of a failed drain tile system resulting in the washout out of material below a noise wall.

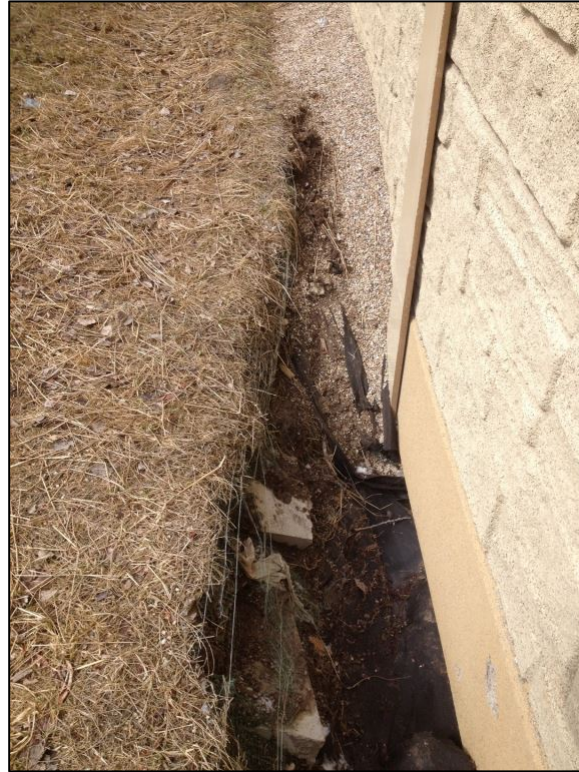
Figure 4.5.5-2: Drain tile system failure below noise wall resulting in loss of material and exposure of noise wall footing.

Noise walls secured to footings in the ground may also exhibit lateral and rotational movement if there is improper drainage or excessive freeze/thaw in the soils. When drainage systems along the wall are not properly removing water from the adjacent soils, the soils can become saturated forcing any additional water to “find” another means of outletting. This can result in slope damage or erosion around the base of the footings. Saturated soils of less cohesive make ups could slide potentially failing the noise wall.
