Staged Concrete Bridge Deck Pours Adjacent to Live Traffic

This brief summarizes Project 0092-16-04,
“Staged Concrete Bridge Deck Pours Adjacent to Live Traffic”
Wisconsin Highway Research Program

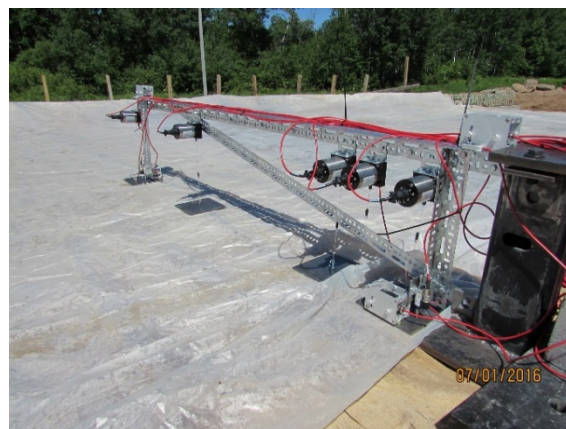
Instrumentation to monitor deflection set over curing concrete.

The team also monitored two bridges throughout the staged-construction process to measure the relative displacements at the longitudinal joint as the concrete on the second stage cured. Instrumentation was set up on the hardened concrete deck of the first stage and extended over the freshly-placed concrete of the second. Measurements from string potentiometers, linear variable

differential transformers, accelerometers and tiltmeters were used to calculate relative displacement. Measurements were repeated 20 days later, allowing comparison between fresh and hardened concrete.
