# Evaluation of the Effects of Deicers on Concrete Durability

Department of Civil and Environmental Engineering  
University of Wisconsin-Platteville

WisDOT ID no. 0092-17-03

June 2018

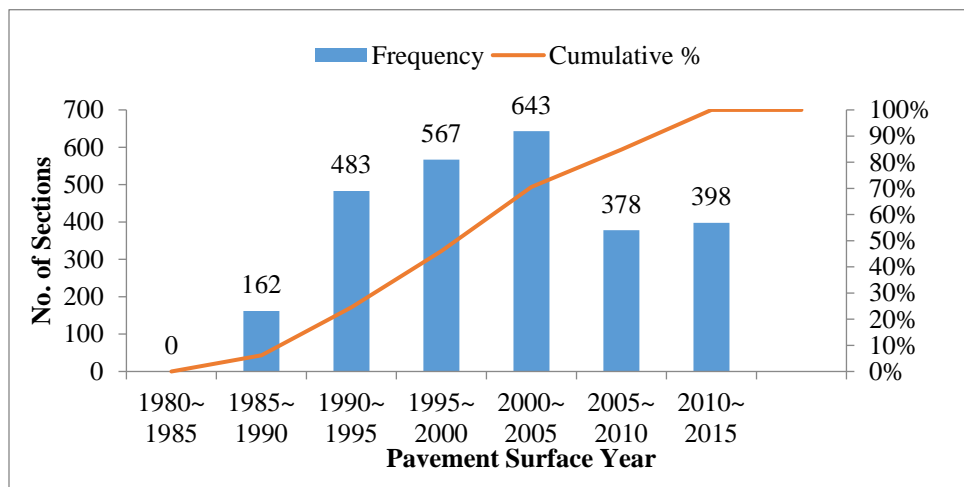
**Figure 4.6 Histogram of Surface Year for Type 8 JPCP Pavements**

The available pavement performance data contains a total of 52,640 data records (Sequence Numbers), in which 10,002 records are for Type 8 (JPCP) pavements. These data were collected from 8/18/2008 to 12/31/2015. Each section contains a maximum of four performance records, corresponding to the four data collection cycles, 2008~09, 2010~11, 2012~13, and 2014~15. These data were for 2,631 individual sections (counted by Sequence Number), with a total length of 2,858 miles and average section length of 1.1 mile. In terms of pavement age, these sections were constructed between 1986 and 2015, with the majority between 1995 and 2005, as shown in Figure 4.6.

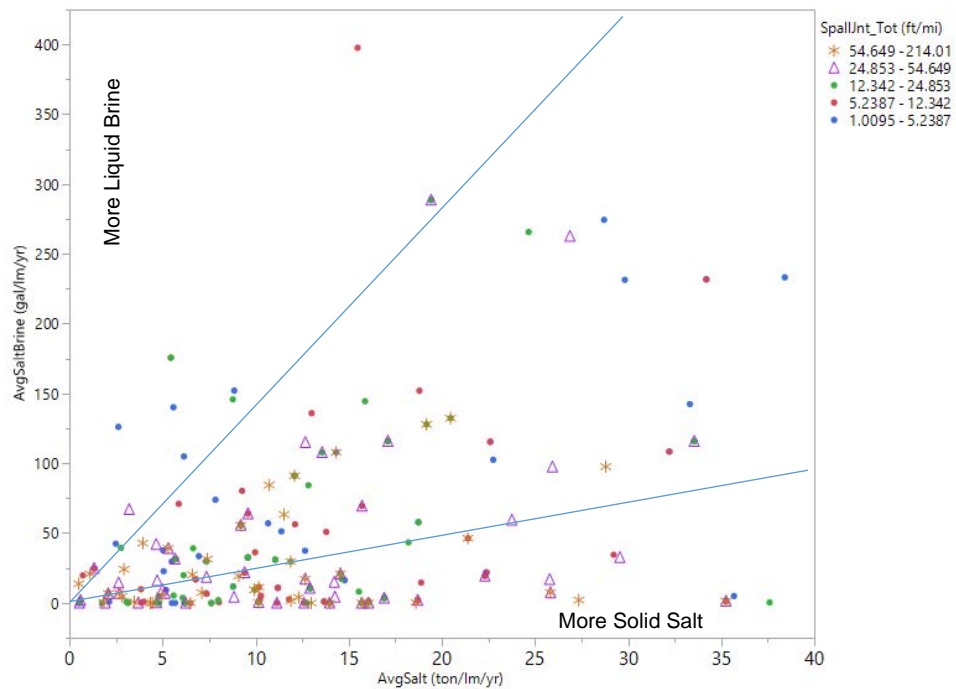
**Figure 4.16 Scatterplot of salt, brine, and joint spalling**

Since Figure 4.16 contains all pavements with construction year from 1988 to 2014, and the statewide application of salt brine did not surpass salt until 2005 (Figure 4.9), another analysis was conducted looking at pavements after 2005. As shown in Figure 4.17(b), the joint spalling is less for newer pavements (maximum value of 60 vs. 220 for y-axis). The average value is slightly different but when variation is considered, there is no significant difference between solid salt and liquid salt brine ( $p$ -value=0.5507).

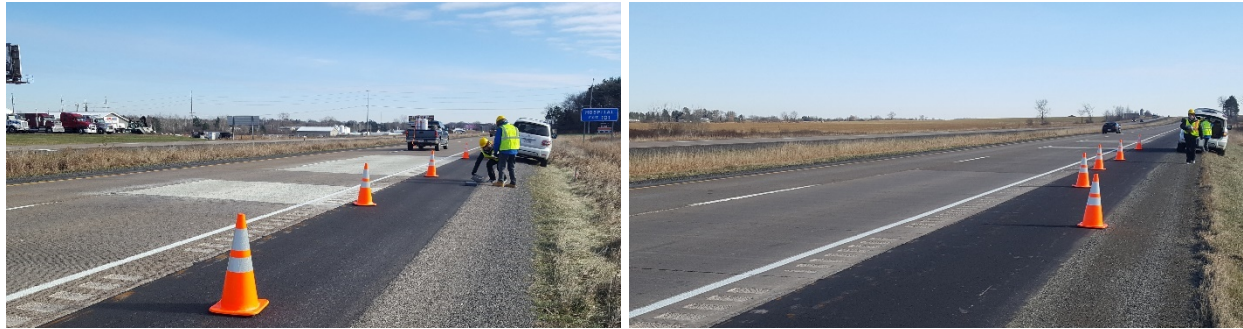
(a) Chippewa County, logmile 100~101

(b) Clark County, logmile 104

**Figure 5.3 Field study of Site #1, US 29, Eastbound**

Site #1 is on US 29 near the border of Chippewa and Clark Counties. The eastbound was visited on Nov. 19, 2017 as shown in Figure 5.3. According to the inventory data, both sections were reconstructed in 1994, with 11 in. concrete surface over the old concrete pavement. Joints were skewed at a spacing of 18 ft. Other features include widened slab (14 ft), transverse tining and unsealed narrow joints.

Distresses observed during the field visit were primarily half-slab or full slab replacement and transverse crack. Figure 5.4 shows the performance records retrieved from the pavement management system. Clearly joint spalling is accelerating at both sections (3 miles on both sides of the county line) for this 23-years-old pavement. In addition, Chippewa County does seem to experience a higher speed of deterioration. A t-Test was also performed to test whether the performance in the latest PMS survey was statistically different. The *p*-value was reported as 0.068. This means that the performance is indeed different at the 90% confidence level. Since the two sections have the same pavement structure, traffic, and climate condition, this acceleration of performance could be attributed to the different practice of winter maintenance between Chippewa and Clark Counties.

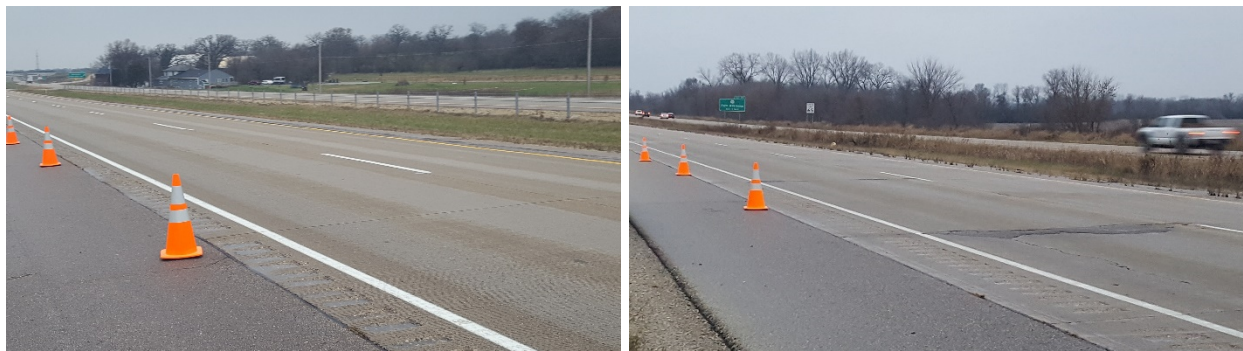
(b) Rock County, logmile 6~7

(b) Jefferson County, logmile 21~22

Site #6 is US 26 on the boarder of Rock and Jefferson County. The northbound was visited on Nov. 17, 2017 as shown in Figure 5.5. According to the inventory data, the section in Rock County between John Paul Rd and Town Hall Rd was built in 1999, with 10'' concrete over 4'' open graded base course and 6 in. crushed aggregate base. The section in Jefferson County between Whitetail Lane and USH 12 interchange was constructed in 1995, with 9'' concrete over 4 in. open graded base course and 6 in. crushed aggregate base. Joint spacing for both sections is 20 ft. According to Storm Report, Jefferson County applied more CaCl<sub>2</sub> (0.26 ton/lm/year) than Rock County did (0.00057 ton/lm/year).

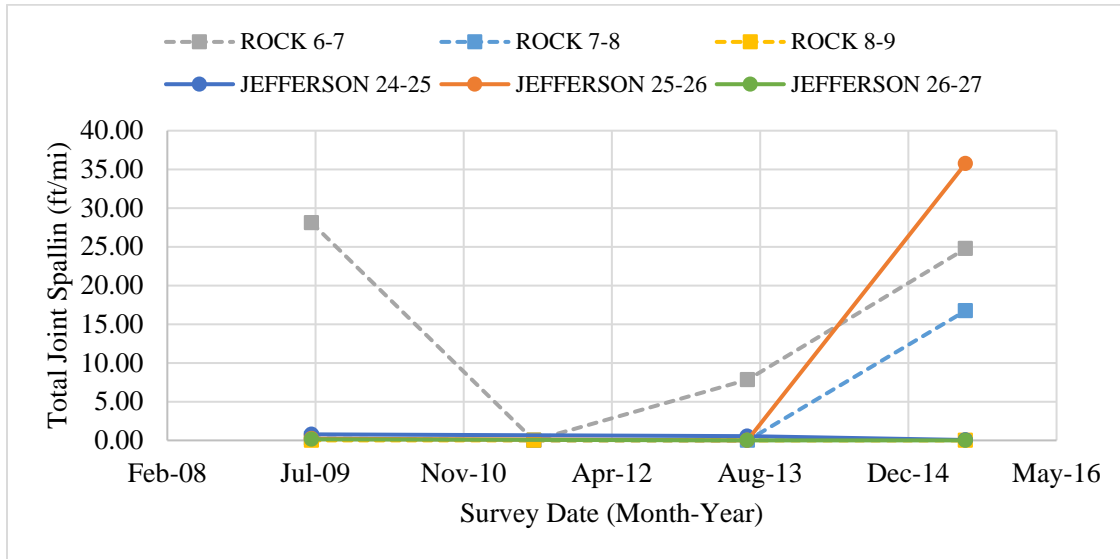
urban area in Janesville, WI. Jefferson County 25-26 had more joint spalling than Rock County 7-8 in the 2015 survey.

**Figure 5.6 Pavement Performance of Site #6, US 26, Northbound**

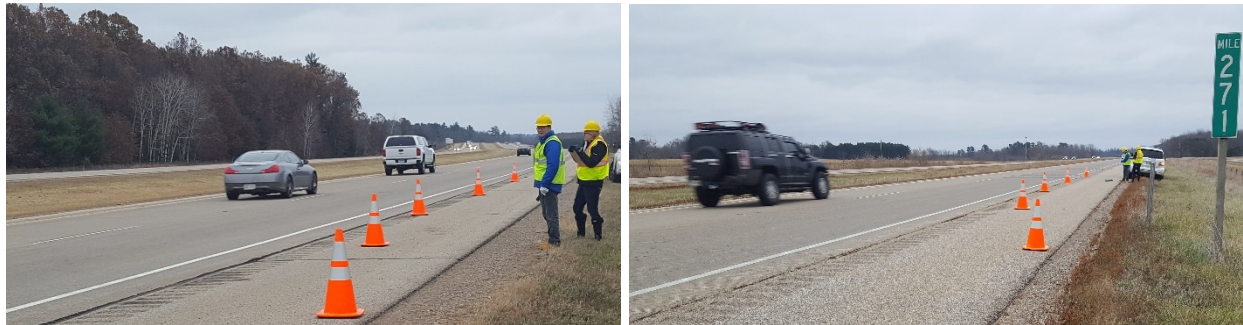
(a) Waupaca County, logmile 268~269

(b) Winnebago County, logmile 271

Site #8 was on eastbound of US 10 near the border of Waupaca County and Winnebago County, Figure 5.7. Inventory data shows that both sections were constructed in 2003 with a structure of 10 in. concrete + 4 in. open graded base + 6 in. crushed aggregate base. Other features include transverse tining, narrow saw cut joints unsealed, perpendicular joints at spacing of 20 ft, and widened slab to 14 ft. Rumble strips are on the asphalt shoulder. Storm Report indicates that Winnebago County used more NaCl and more  $MgCl_2$  than Waupaca County did (Table 5.4).
