2020

STRUCTURE INSPECTION FIELD MANUAL

Wisconsin Department of Transportation

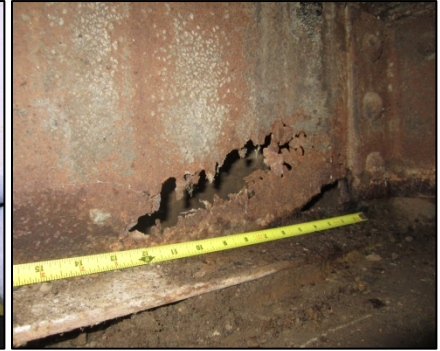
Defect	CS 1	CS 2	CS 3	CS 4
	Good	Fair	Poor	Severe
Material Defects				
Corrosion (1000)	None	Freckled rust. Corrosion of the steel has initiated.	Section loss is evident or pack rust is present but does not warrant structural review.	The condition warrants a structural review to determine the effect on strength or serviceability of the element or bridge; OR a structural review has been completed and the defects impact strength or serviceability of the element or bridge.
Cracking (1010)	None	Crack that has self-arrested or has been arrested with effective arrest holes, doubling plates, or similar.	Identified crack exists that is not arrested but does not warrant structural review.	
Connection (1020)	Connection is in place and functioning as intended.	Loose fasteners or pack rust without distortion is present but the connection is in place and functioning as intended.	Missing bolts, rivets, or fasteners; broken welds; or pack rust with distortion but does not warrant a structural review.

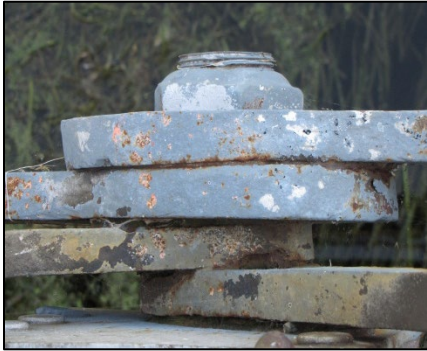
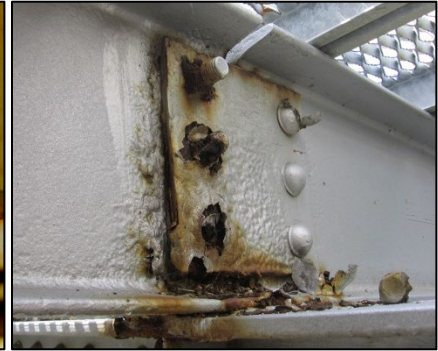
Cracking (1010)

- **Defect 1000** - Section loss is not defined by a localized area but as the section loss of an entire member by cross-sectional area.
- **Defect 1010** - Any steel cracks not previously detected should be evaluated to determine the potential for fracture. The amount of redundancy and the number of affected primary members will influence the placement of this defect in CS 3 or 4; i.e., the greater the redundancy and/or fewer members that have cracking will most likely be in CS 3.
